# M2G Biodiversity Offset Monitoring Report

Autumn 2015

Prepared for  
**Icon Water**

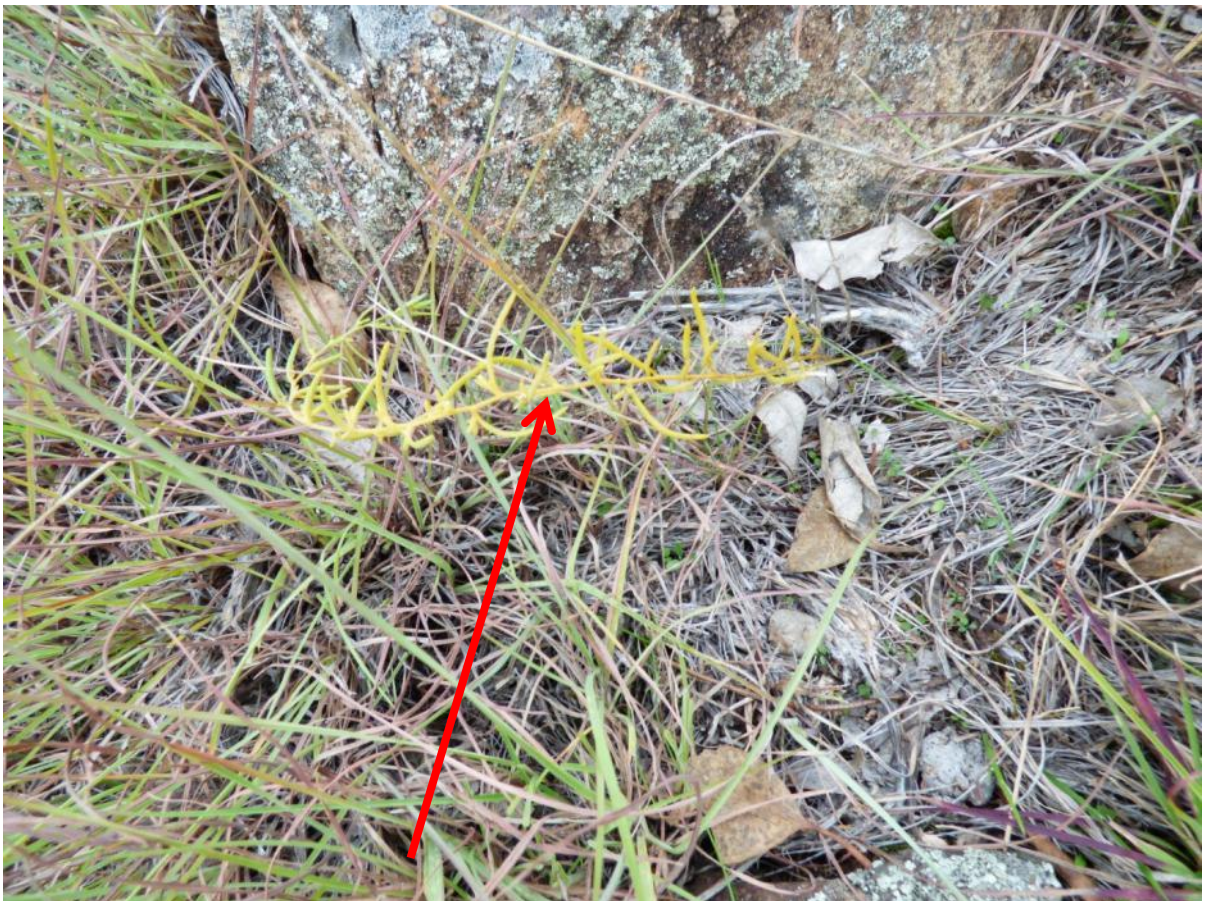
**Figure 3: *Thesium australe* (Austral Toadflax)**

The autumn 2015 surveys recorded the presence of *Thesium australe* (Austral Toadflax) within the offset site. Austral Toadflax is a small semi-parasitic herb which is often associated with dense areas of *Themeda triandra* (Kangaroo Grass). The species is characterised by its yellow-green colouration and small white flowers, and is listed as vulnerable under the EPBC Act (see **Figure 3**).

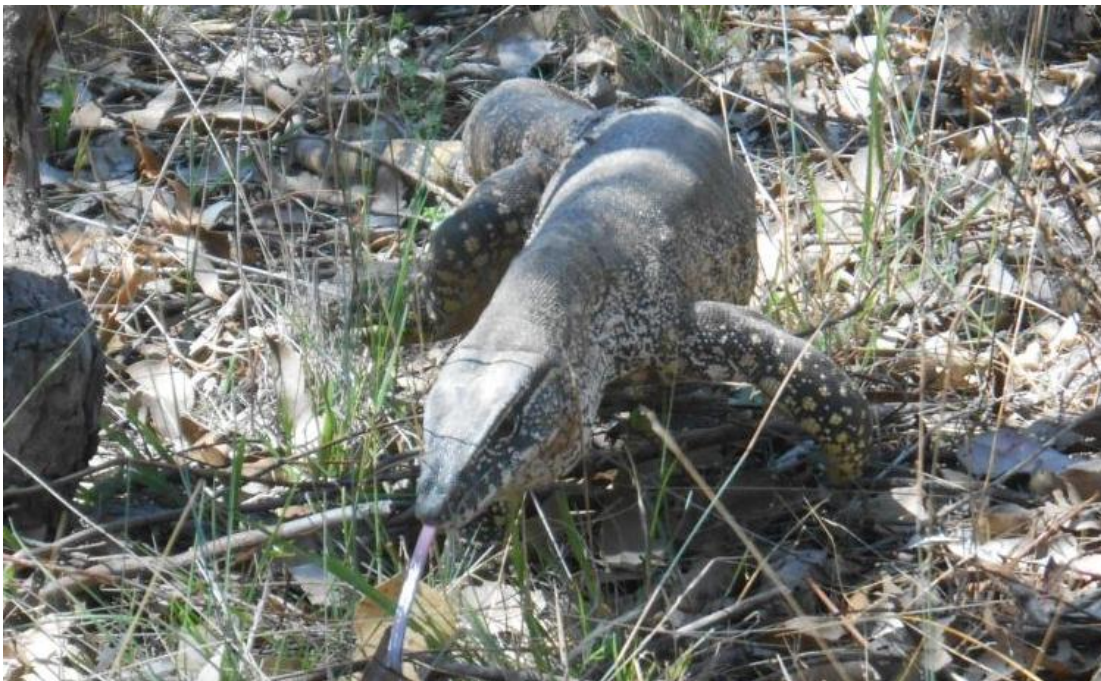
**Figure 5:** *Varanus rosenbergi* - Rosenberg's Goanna within the offset site (photo by Grant Morey, Icon Water)

Icon Water staff (John Turville and Grant Morey) also recorded the presence of *Varanus rosenbergi* (Rosenberg's Goanna – see **Figure 5**) within the offset site during a recent site visit in 2015. Rosenberg's Goanna are known from the local area, and have large home ranges. Rosenberg's Goanna are known to be associated with termite mounds which they utilise for the incubation of their eggs. Termite mounds are relatively rare within the offset site compared with similar environments around Canberra, however, the species is likely to utilise the offset site periodically for foraging and potentially breeding where termite mounds are available.

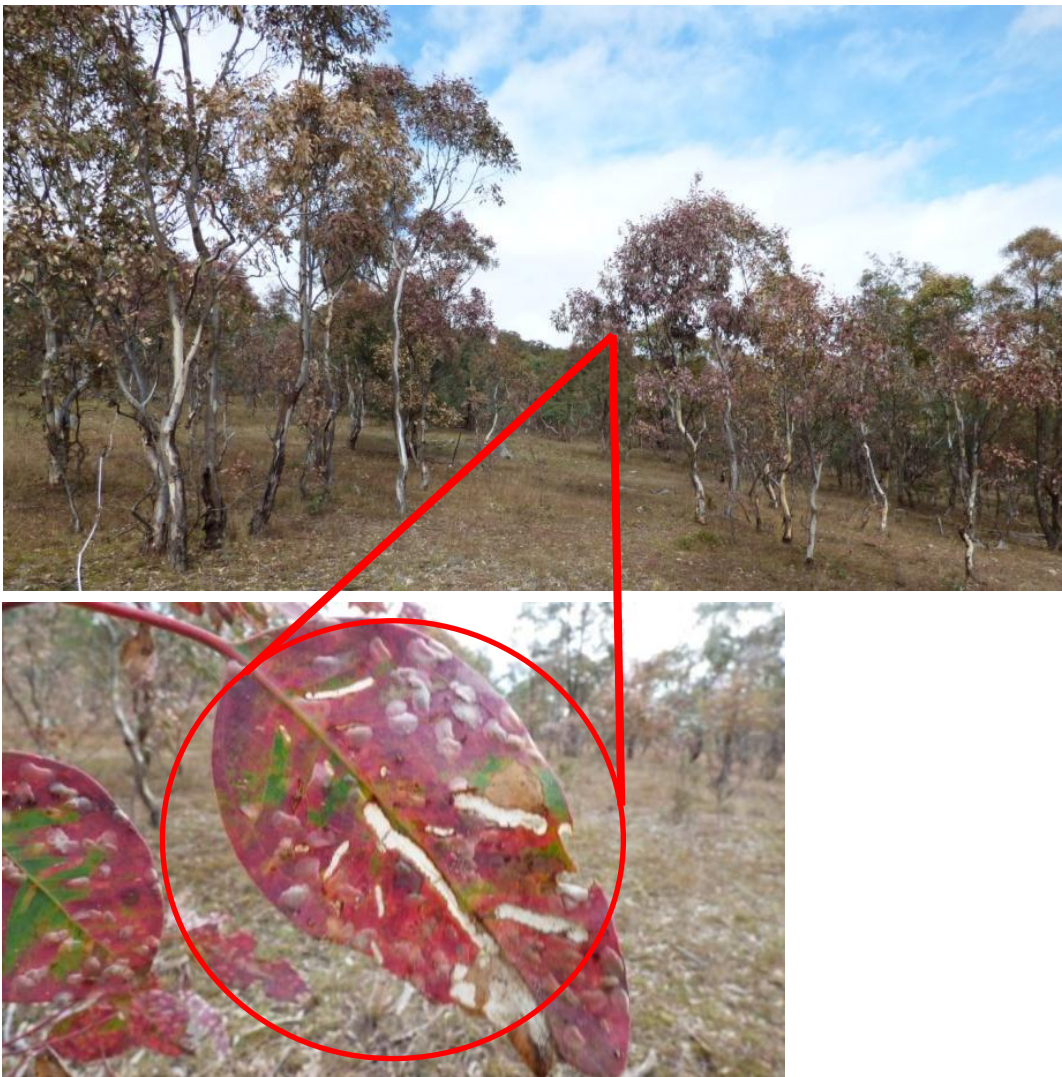
**Figure 6: Lerps on a *Eucalyptus blakelyi* leaf and associated damage**

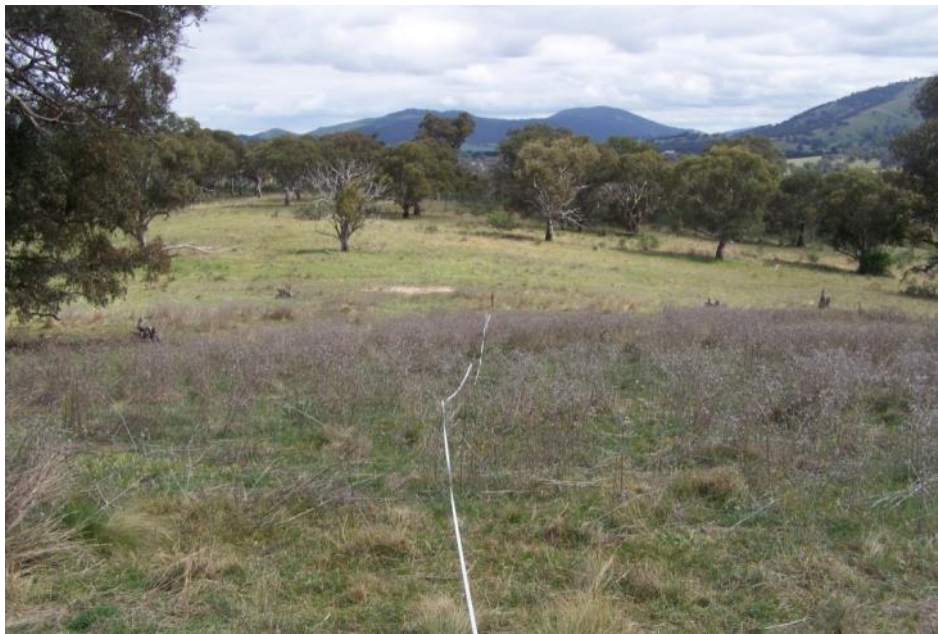
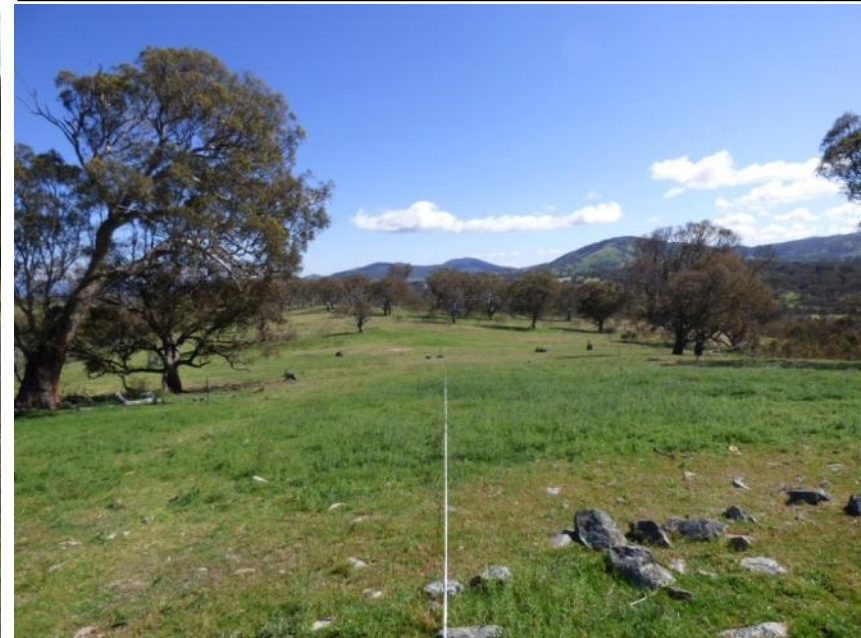
Figure 9: Monitoring Plot 1. (Left: Baseline monitoring photo, October 2011. Right: Monitoring photo April 2015)

**Monitoring plot 1** is located within MU1A on the southern offset. The plot is composed of relatively lower condition Box-Gum Woodland. Few eucalypt saplings were observed in the vicinity of the plot but none were recorded in the plot or along the transect. Native species diversity was low-moderate (11 species), marginally more than recorded in the autumn 2013 surveys. 9 introduced species were recorded, with the number of species and cover being considerably higher than recorded during the baseline survey. *Carthamus lanatus* and *Trifolium subterraneum* dominate the plot. More frequent native species included *Austrostipa scabra*, *Bothriochloa macra* and *Carex inversa*. Fauna habitat features within MU1A have not changed noticeably since the baseline surveys. Native plant species richness, overstorey cover and the total length of fallen logs are well below benchmark values (Sharp & Milner 2014).

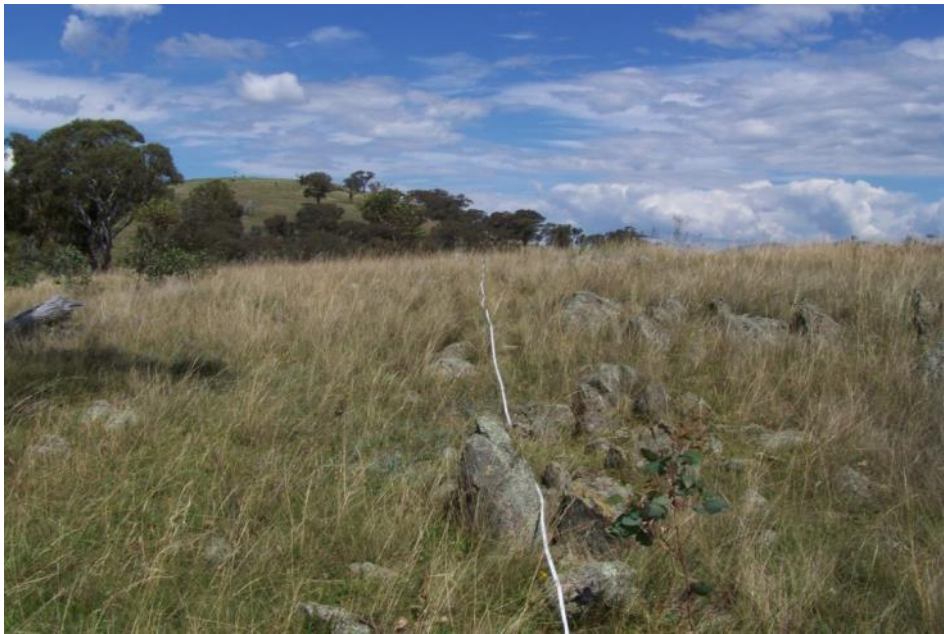
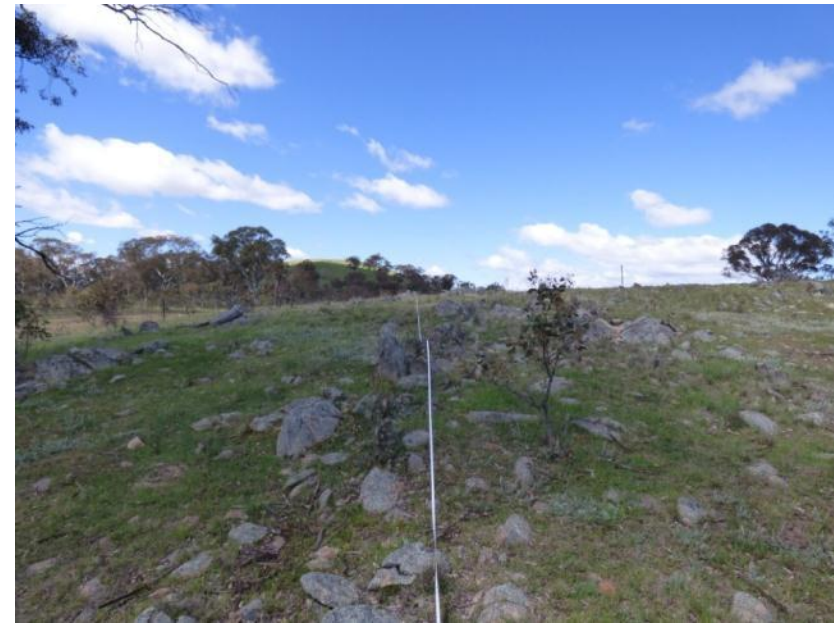
Figure 10: Monitoring Plot 2. (Left: Baseline monitoring photo, March 2012. Right: Monitoring photo April 2015)

**Monitoring plot 2** is located within MU2B within the southern offset. It is situated on a rocky hill containing Pink-tailed Worm Lizard habitat. Outcropping and surface rocks constitutes over 10% of the ground cover. It contains relatively good condition mature Box-Gum Woodland with scattered eucalypt saplings present. A total of 33 native species were recorded within the plot, two (2) more than during the baseline surveys. Frequent native species include *Chrysocephalum apiculatum*, *Austrostipa bigeniculata* and *Bothriochloa macra*. 15 introduced species were recorded, which is five (5) more than recorded in autumn 2013. Fauna habitat features within MU2B have not changed noticeably since the baseline surveys. Native plant species richness is above benchmark values (Sharp & Milner 2014), however overstorey cover and the total length of fallen logs are well below.

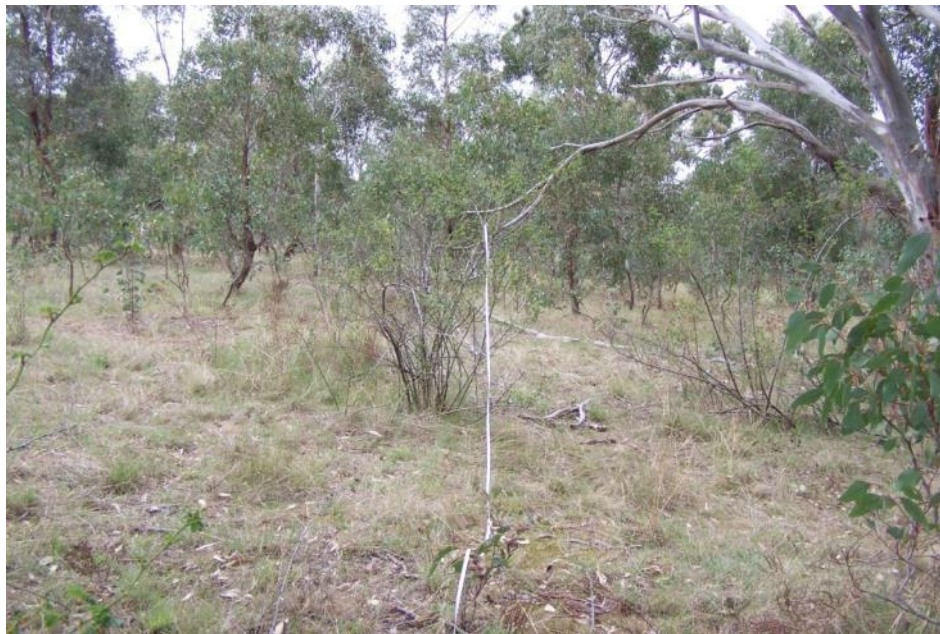
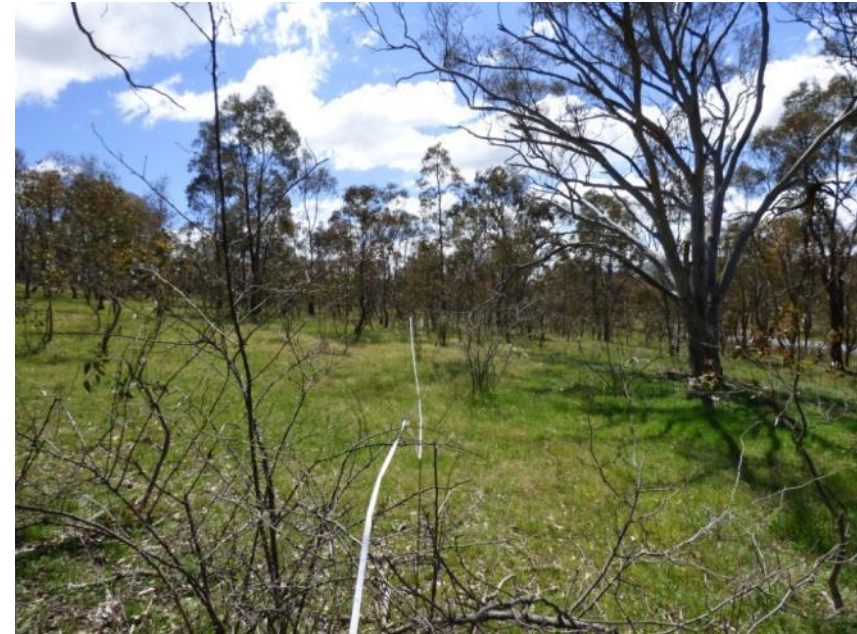
Figure 11: Monitoring Plot 3. (Left: Baseline monitoring photo, October 2011. Right: Monitoring photo April 2015)

**Monitoring plot 3** is located within MU3 in the southern offset. The plot is located in moderate to good quality Box-Gum Woodland. A significant number of eucalypt saplings are present. A total of 38 native species were recorded within the plot, eight (8) more than during the autumn 2013 surveys. The understorey is dominated by *Themeda triandra*, with co-occurring native species having significantly lower cover values. The native mid-storey species *Bursaria spinosa* was present but rare. 22 introduced species were recorded, which was nine (9) more than that recorded in autumn 2013. Frequent weeds include *Aira* spp. and *Hypochaeris glabra*. Fauna habitat features within MU3 have not changed noticeably since the baseline surveys. Native plant species richness is above benchmark values (Sharp & Milner 2014), however overstorey cover and the total length of fallen logs are well below.

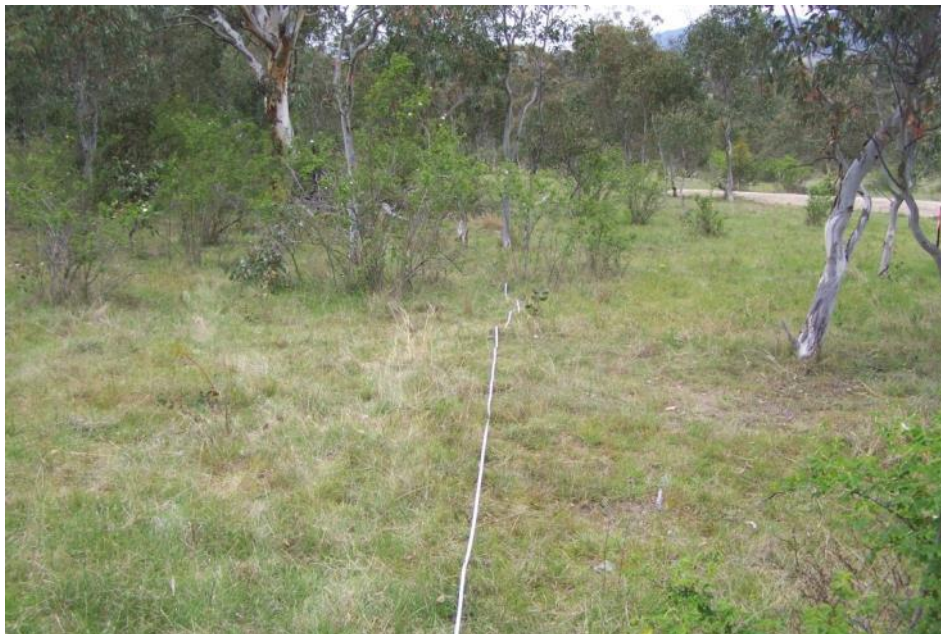
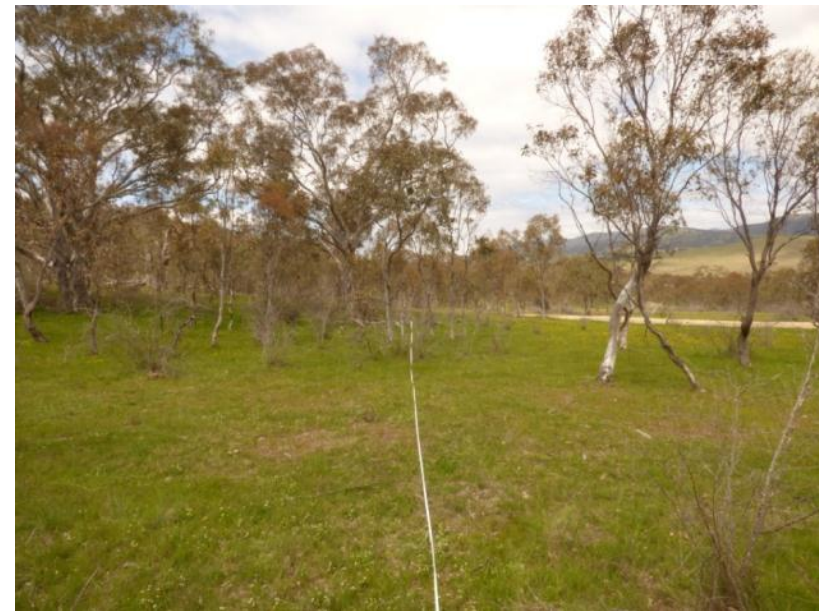
Figure 12: Monitoring Plot 4. (Left: Baseline monitoring photo, October 2011. Right: Monitoring photo April 2015)

**Monitoring plot 4** is located in the northern offset in MU4. It is located in moderate to good quality Box-Gum Woodland dominated by *E. blakelyi*. Good numbers of eucalypt saplings are present compared to the baseline survey. A total of 33 native species were recorded within the plot, one less than that recorded in the autumn 2013 monitoring. The understorey is dominated by *Themeda triandra*, *Microlaena stipoides*, *Asperula conferta* and *Haloragis heterophylla*. 12 introduced species were recorded, two more than the number recorded in the autumn 2013 monitoring. Frequent weeds include *Bromus hordeaceus* and *Hypochaeris radicata*. Control of *R. rubiginosa* seems to be now under control when compared to earlier years. Fauna habitat features within MU4 have not changed noticeably since the baseline surveys. Most site parameters are just below, within or above benchmark values (Sharp & Milner 2014), except for total length of fallen logs.

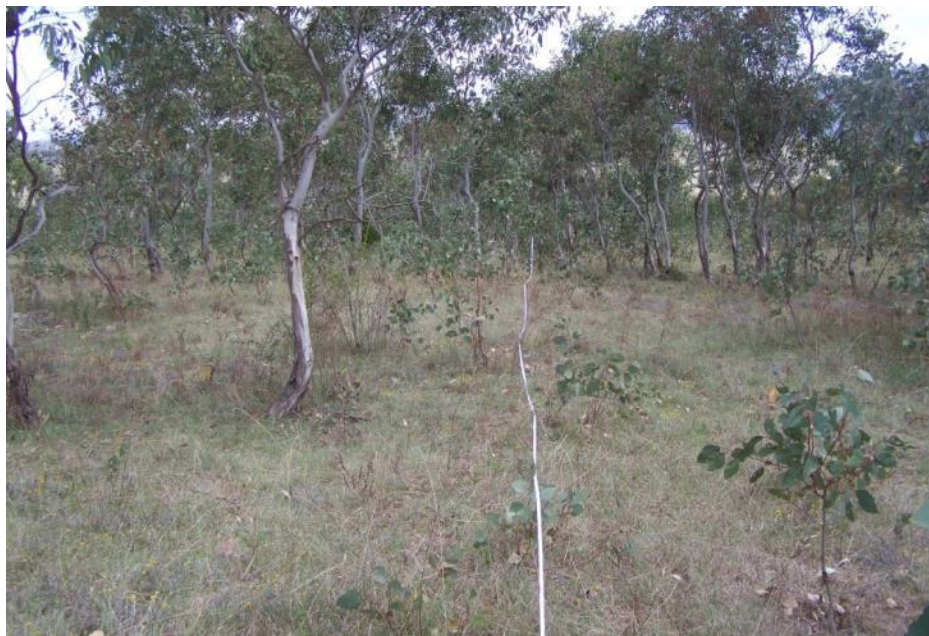
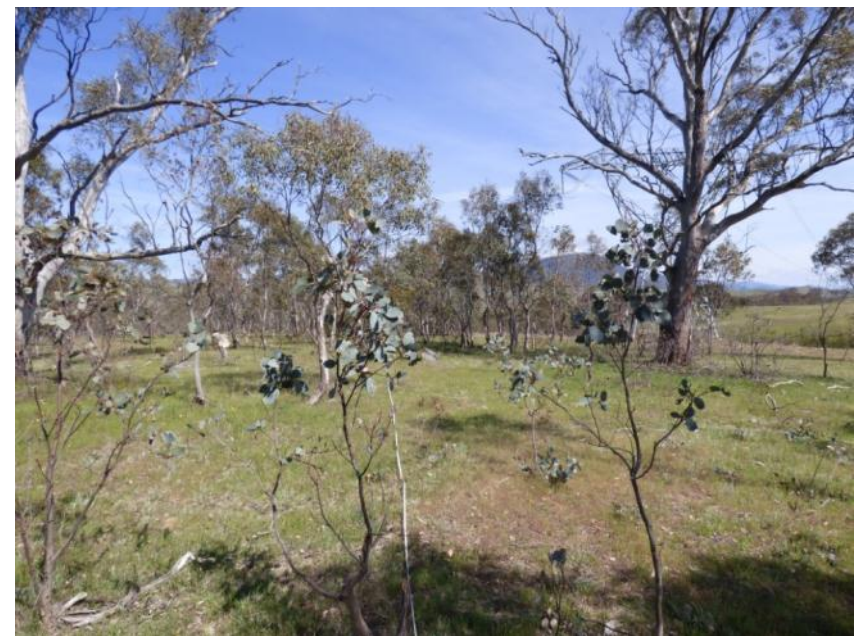
Figure 13: Monitoring Plot 5. (Left: Baseline monitoring photo, October 2011. Right: Monitoring photo April 2015)

**Monitoring plot 5** is a control plot located in MU5. No management actions will occur within the boundaries of the plot. Plot 5 is located in moderate-good quality Box-Gum Woodland dominated by *E. blakelyi* with a significant amount of natural regeneration present. The plot supports a highly diverse understorey of graminoids and forbs with 37 native species recorded in autumn 2015, 10 species more than the autumn 2013 monitoring. The understorey is dominated by *Themeda australis* and *Chrysocephalum apiculatum*. 10 introduced species were recorded, which is a reduction of one since autumn 2013; however, no weed species currently has a cover value exceeding 5%. Fauna habitat features within MU5 have not changed noticeably since the baseline surveys. Native plant species richness is above benchmark values (Sharp & Milner 2014), however overstorey cover and the total length of fallen logs are well below.

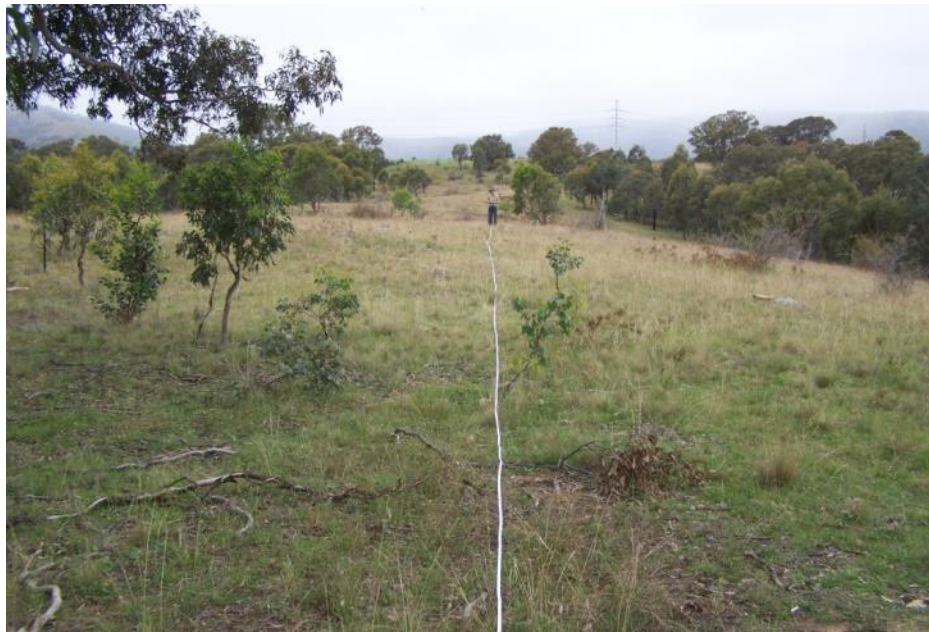
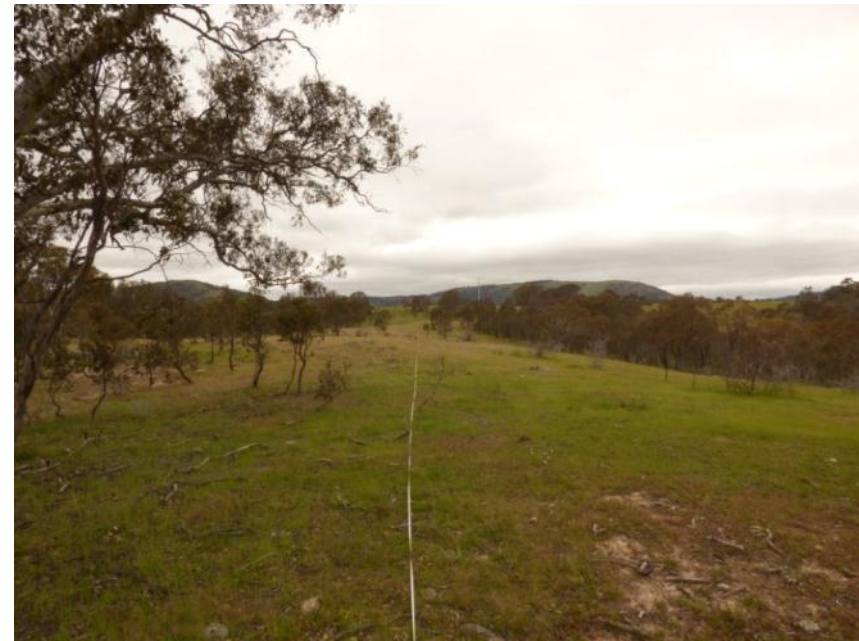
Figure 14: Monitoring Plot 6. (Left: Baseline monitoring photo, March 2012. Right: Monitoring photo April 2015)

**Monitoring plot 6** is located in MU6, along the central ridge line of the property, in moderate-good quality Box-Gum Woodland dominated by *E. blakelyi*. The plot is situated in an intersection between the woodland and derived grassland forms of the ecological community. Various sized *E. blakelyi* saplings are present within the plot. The plot supports a diverse understorey of grasses and forbs with no species dominant. 35 native species were recorded in autumn 2015, compared with 21 species in the autumn 2013 monitoring. 13 introduced species were recorded, an increase of three (3) species since autumn 2013. Frequent weeds include *Trifolium arvense*, *Tolpis umbellata* and *Vulpia* spp. Fauna habitat features within MU6 have not changed noticeably since the baseline surveys. Native plant species richness is above benchmark values (Sharp & Milner 2014), however overstorey cover and the total length of fallen logs are well below.

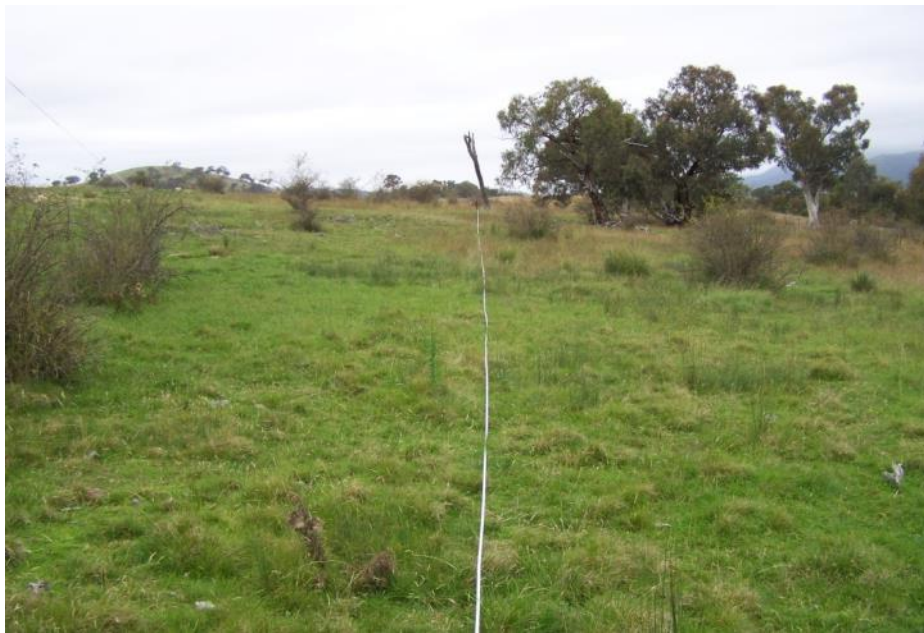
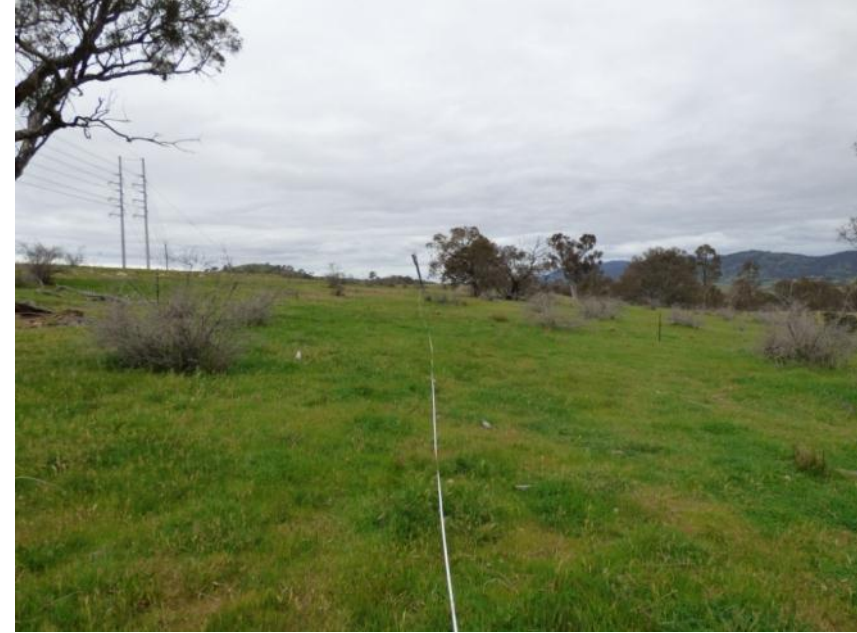
Figure 15: Monitoring Plot 7. (Left: Baseline monitoring photo, March 2012. Right: Monitoring photo April 2015)

**Monitoring plot 7** is located within MU7 in the northern offset. The management unit is composed of degraded Box-Gum Woodland with the overstorey dominated by *E. blakelyi*. No recruitment of *E. blakelyi* was observed. Native species diversity in the plot was low (16 species), though this was an increase since the autumn 2013 monitoring by six (6) species. Only *Carex inversa* was common, though with less than 5% cover. Introduced species dominate the site, with 23 species recorded in autumn 2015, an increase of 14 species since the autumn 2013 monitoring. Dominant weeds in autumn 2015 were *Bromus diandrus* and *Trifolium subterraneum*. Fauna habitat features within MU7 have not changed noticeably since the baseline surveys. All site parameters were well below benchmark values (Sharp & Milner 2014), except for native understorey (other) cover.

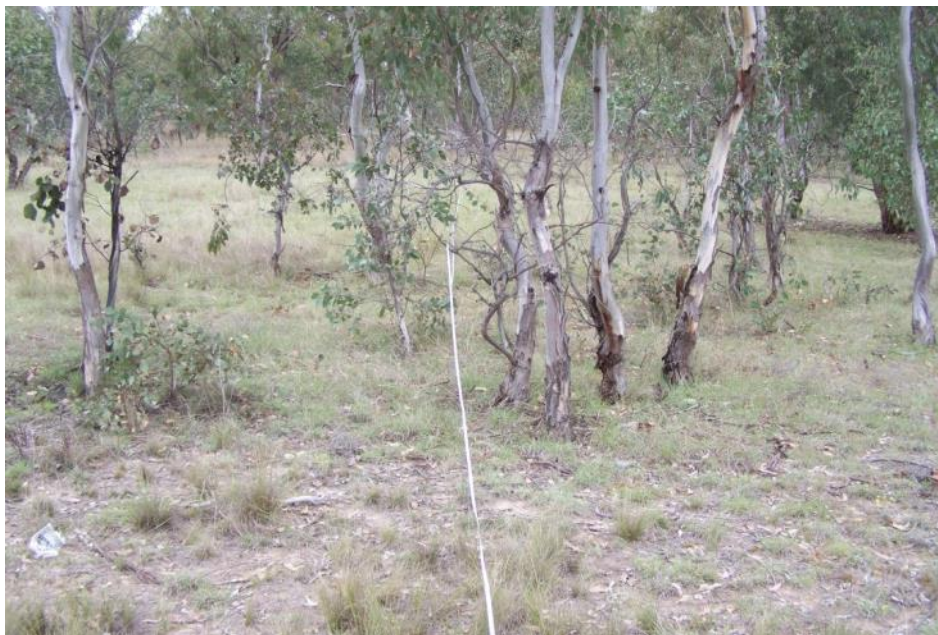
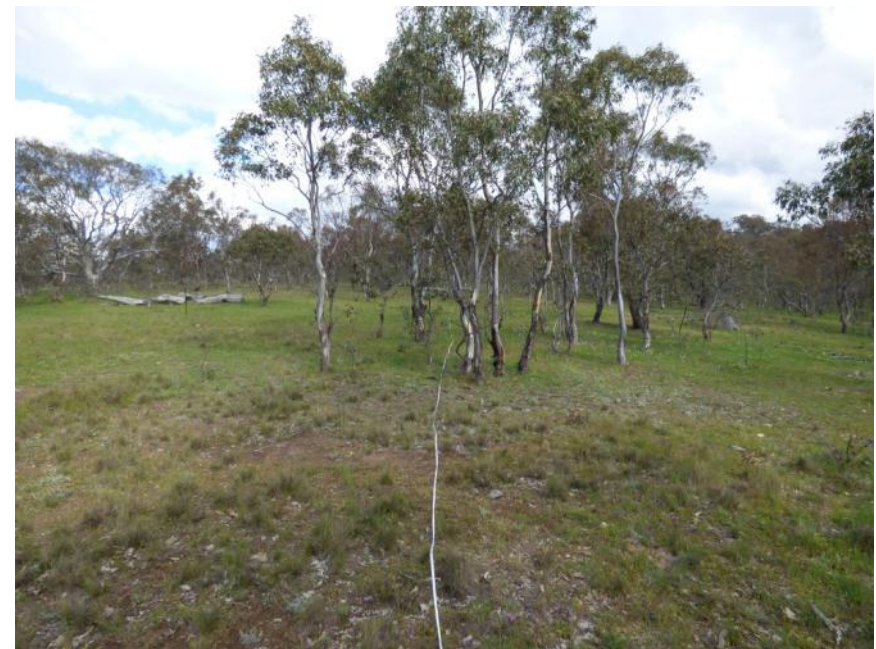
Figure 16: Monitoring Plot 8. (Left: Baseline monitoring photo, October 2011. Right: Monitoring photo April 2015)

**Monitoring plot 8** is a control plot located in MU3. No management actions are proposed to occur within the bounds of the plot. The plot is located in good quality Box-Gum Woodland dominated by *E. blakelyi*. Various sized *E. blakelyi* saplings are present within the plot. The understorey species is dominated by *Themeda triandra* with a diverse range of co-occurring graminoids and forbs. 36 native species were recorded in autumn 2015, an increase of 10 species since the autumn 2013 surveys. 13 introduced species were recorded, seven (7) more than the number recorded in the baseline survey. Fauna habitat features have not changed noticeably since the baseline surveys. Native plant species richness is above benchmark values (Sharp & Milner 2014), however overstorey cover and the total length of fallen logs are well below.

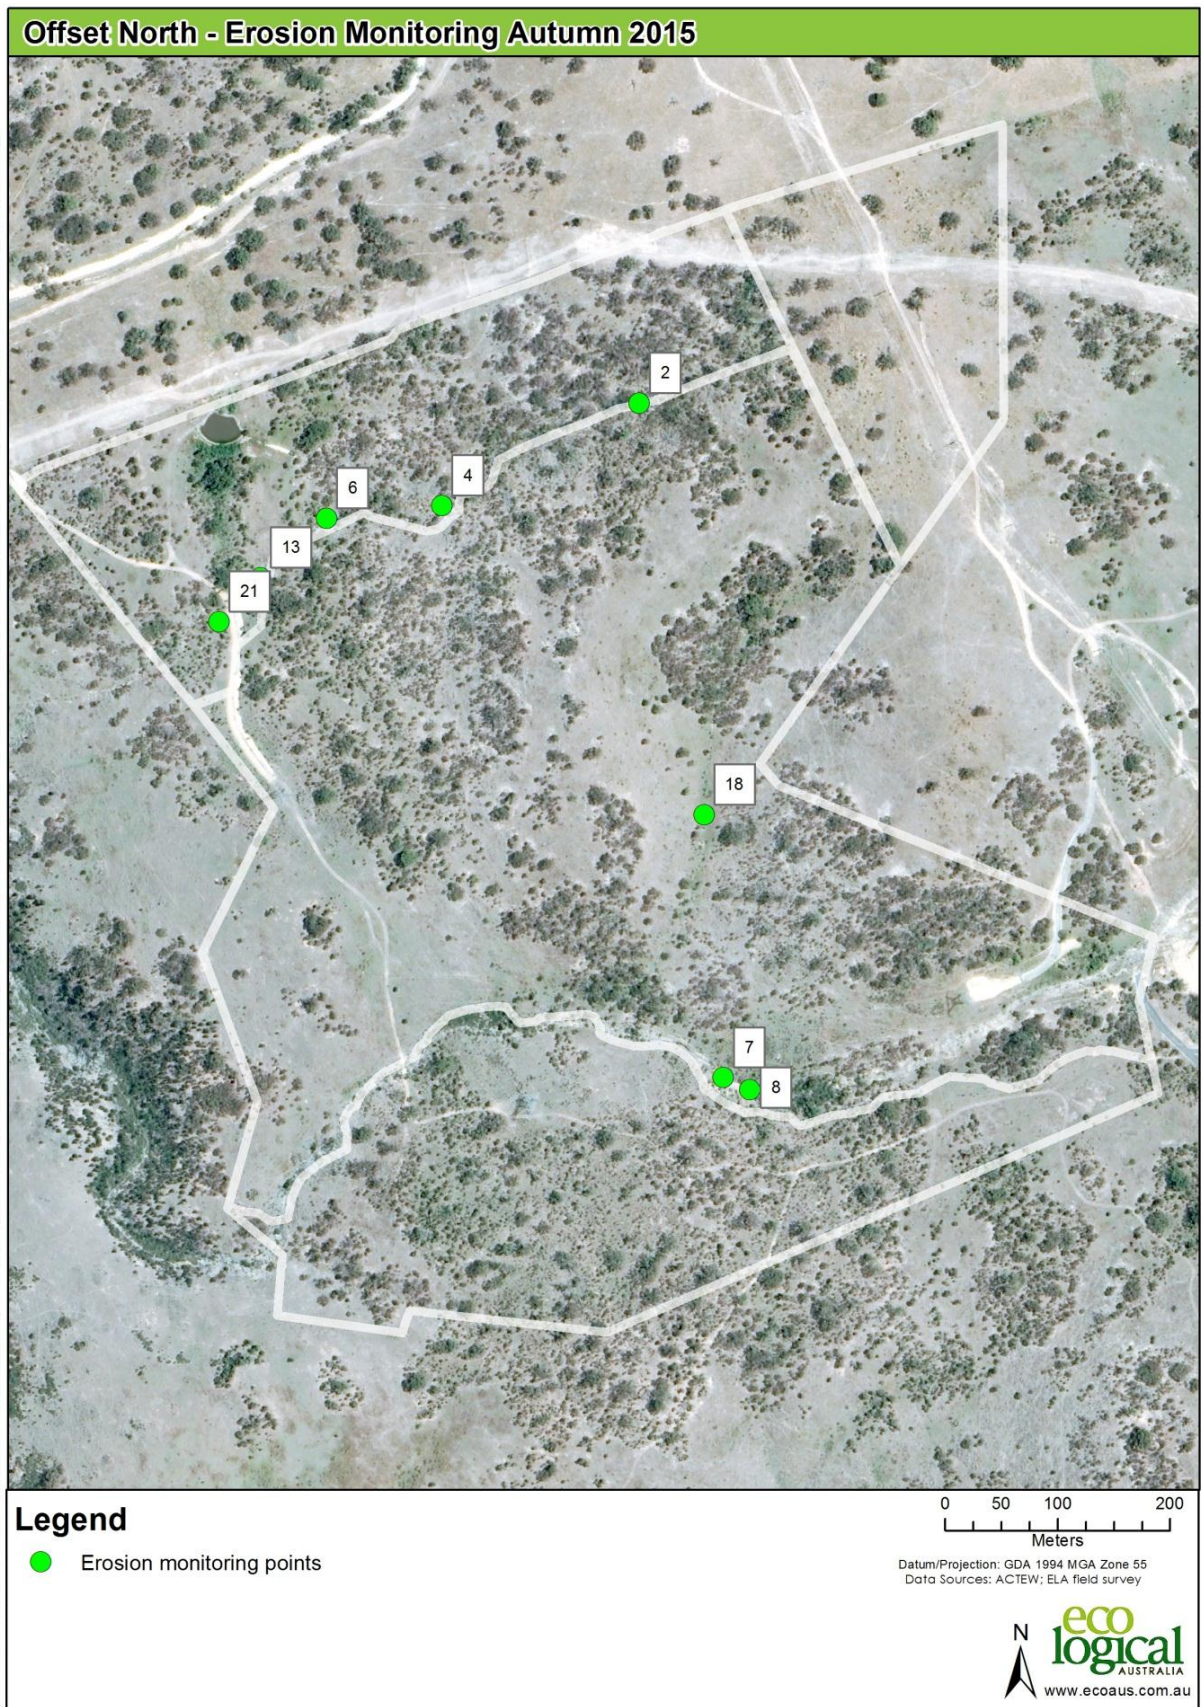
Figure 19: Erosion monitoring points in northern offset

The majority of erosion monitoring points are located along ephemeral drainage lines in the northern offset. The erosion points are in a variety of conditions; however, vegetative cover surrounding each point is generally sufficient to limit erosion potential. All of the monitoring points are currently stable, but some may require minor remediation works in the future if they are found to be continuously active and/or active following a significant rain event.

It should be noted that approval is required to undertake any remediation works within a drainage line (see erosion sub-plan), and may influence the type of work to be undertaken. A summary of the erosion points monitored within the offset property is provided below with a detailed description of each point and an accompanying photo.

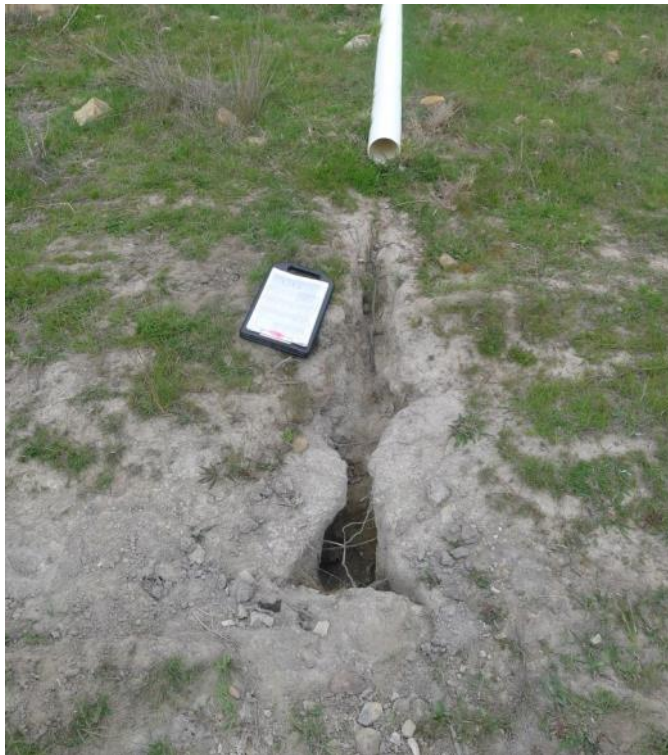
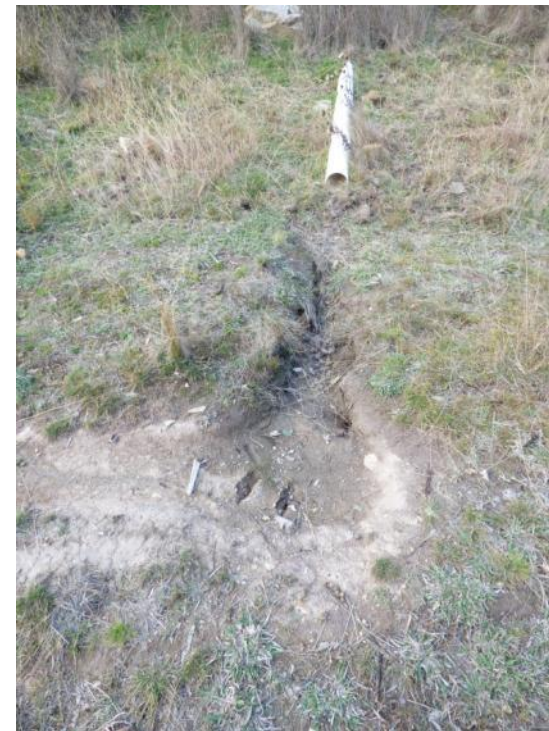
**Erosion Point 22:** Point established at overflow point of southern dam during the spring 2013 monitoring surveys.

*Action required:* No works required at this stage
