M2G Biodiversity Offset Monitoring Report

Spring 2015

Prepared for
Icon Water

November 2015

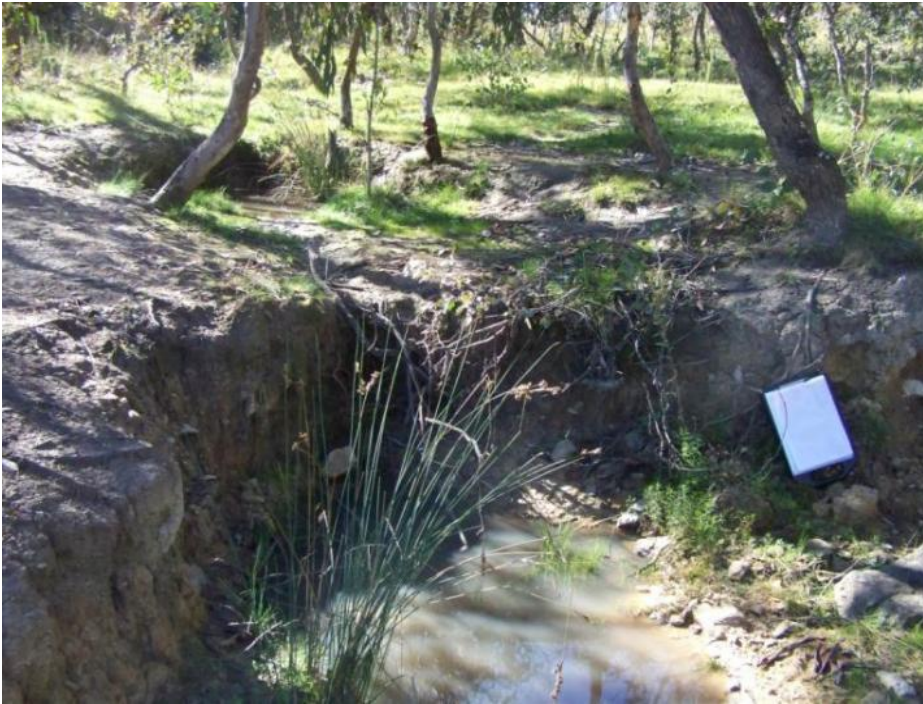
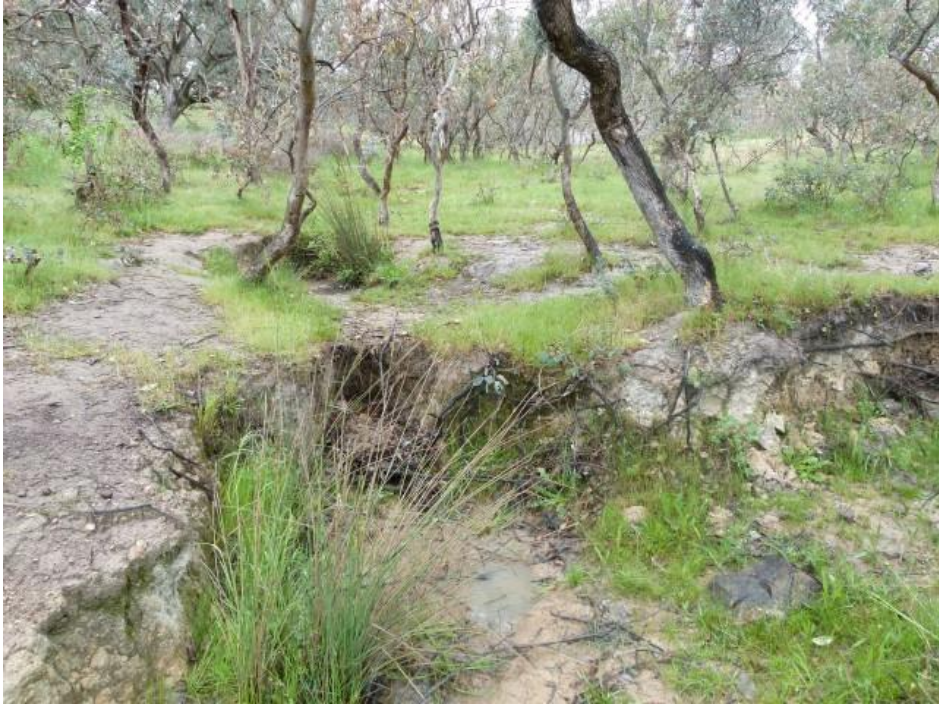
Erosion Point 2:

Change: No significant change observed since baseline monitoring survey.

Action required: No works required at this stage.

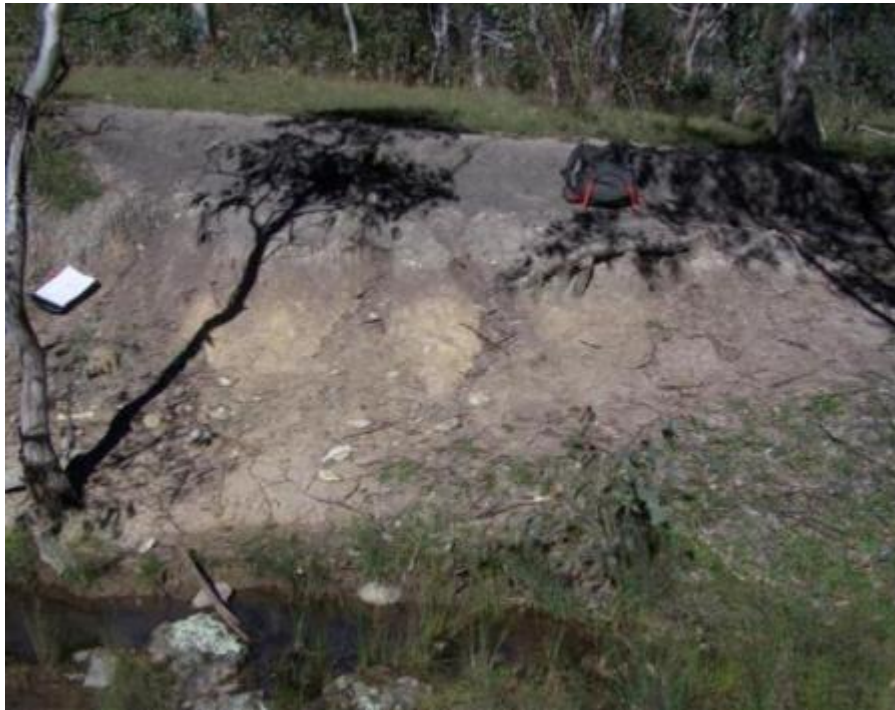
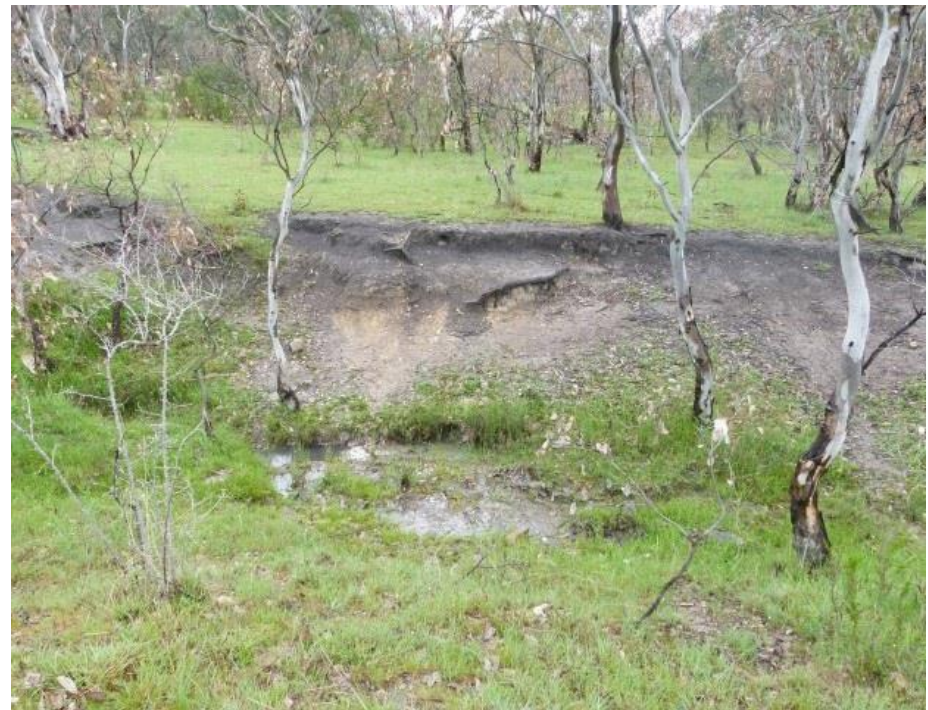
Erosion Point 6:

Change: No change observed since baseline monitoring survey.

Action required: Consider removing erosion point from future monitoring surveys.

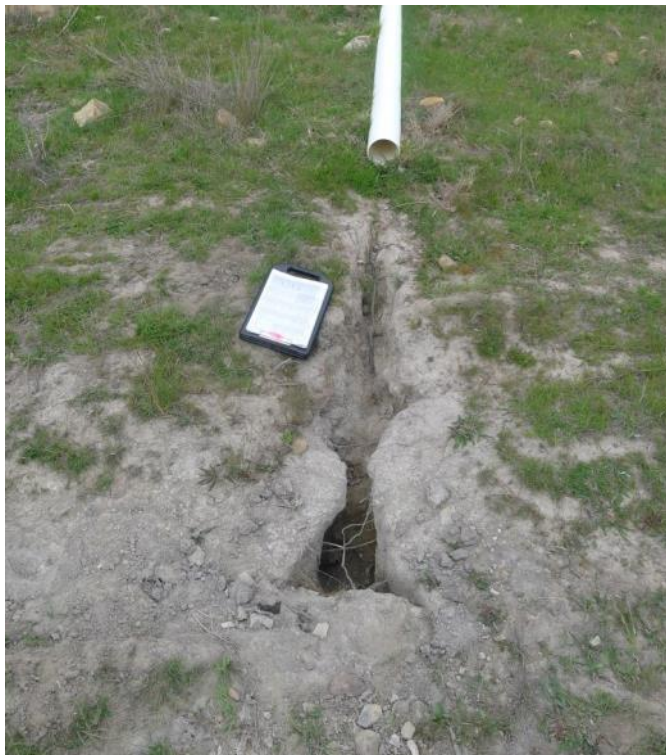
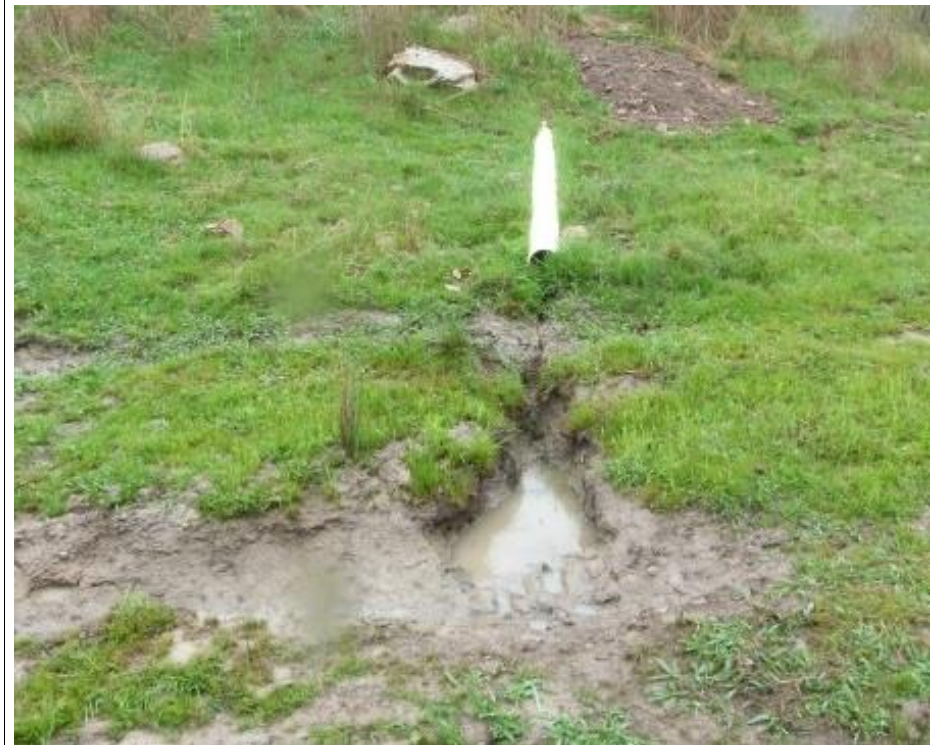
Erosion Point 22: Point established at overflow point of southern dam during the spring 2013 monitoring surveys.

Action required: No works required at this stage
