Murrumbidgee Ecological Monitoring Program

Observation Report – Autumn 2024

Icon Water Limited

5 June 2024

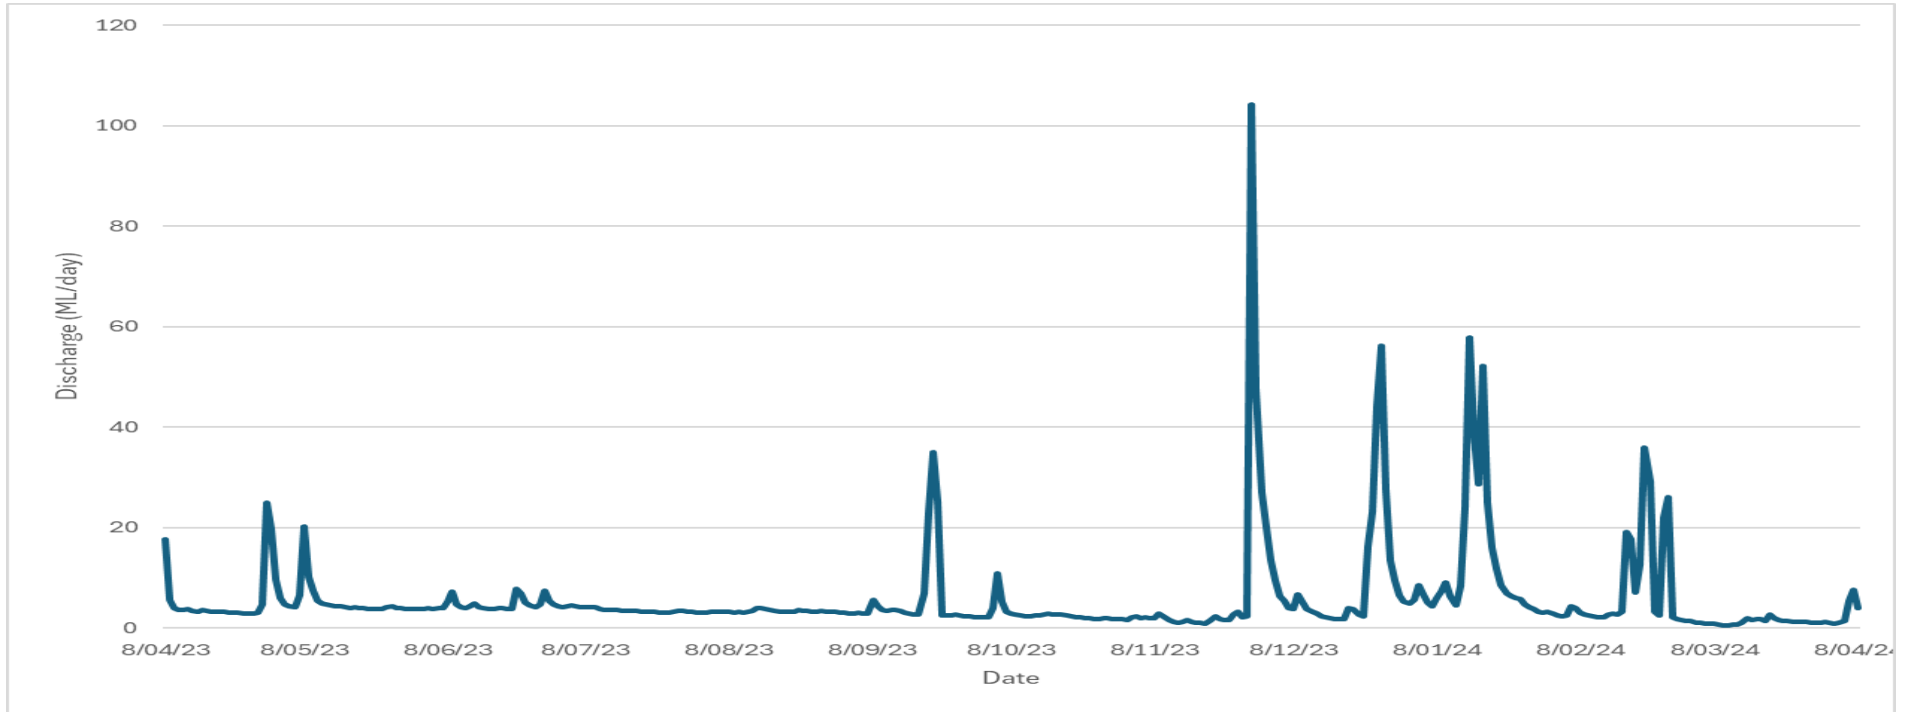
Figure 4 Hydrograph for Burra Creek at the Burra Weir gauging station (410774) for the 12 months up until monitoring

There was no water being discharged from M2G into Burra Creek at the time of monitoring. During monitoring on 8 April 2024, daily discharge at Burra Weir gauging station (410774) was 4.06 ML/day (Figure 4). This was above the median daily flow of 3.28 ML/day when averaged across the previous year. The rainfall event over the two days prior to monitoring resulted in daily discharge increasing to a peak of 7.69 ML/day on 7 April 2024. However, the discharge had decreased prior to monitoring.

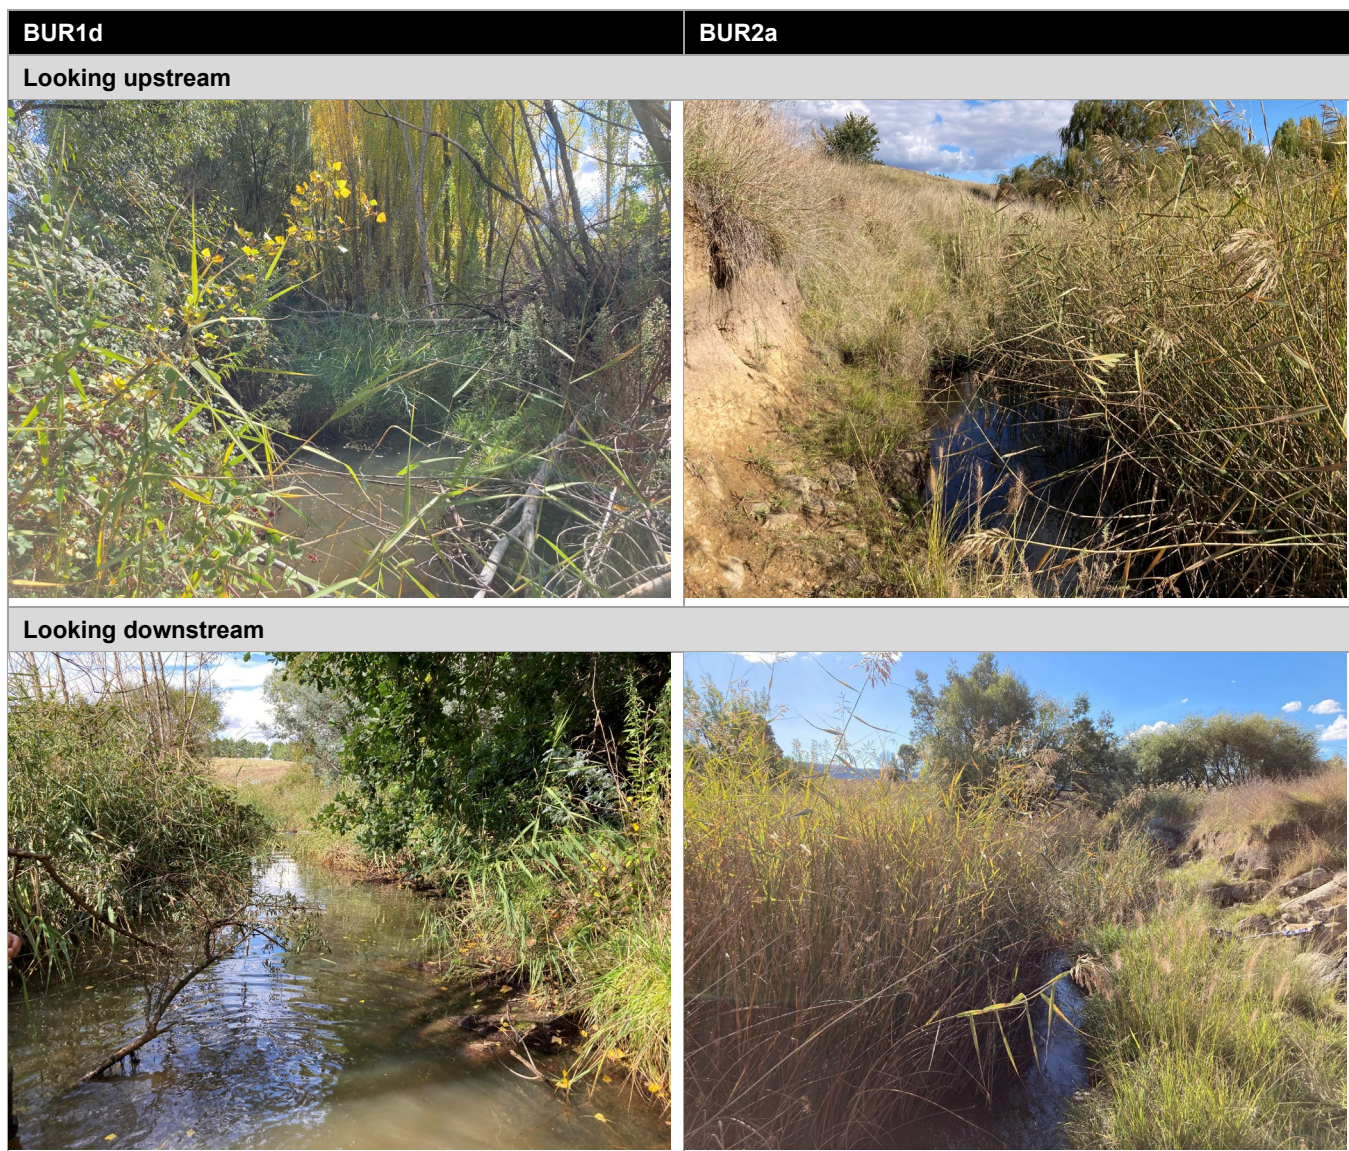
Table 5 Photos of Burra Creek monitoring sites

Photographs of the monitoring sites are shown in Table 5. Emergent and riparian vegetation appeared similar to previous years with dense beds of aquatic macrophytes in the form of reeds (*Typha* spp. and *Phragmites australis*), and sedges (Great Bulrush - *Schoenoplectus validus*). There was no nuisance periphyton or filamentous algae growth observed at either of the sites and there was no erosion or changes in geomorphology observed that were considered abnormal or exacerbated. However, cutbank erosion at BUR1a is continuing to encroach upon Burra Road.

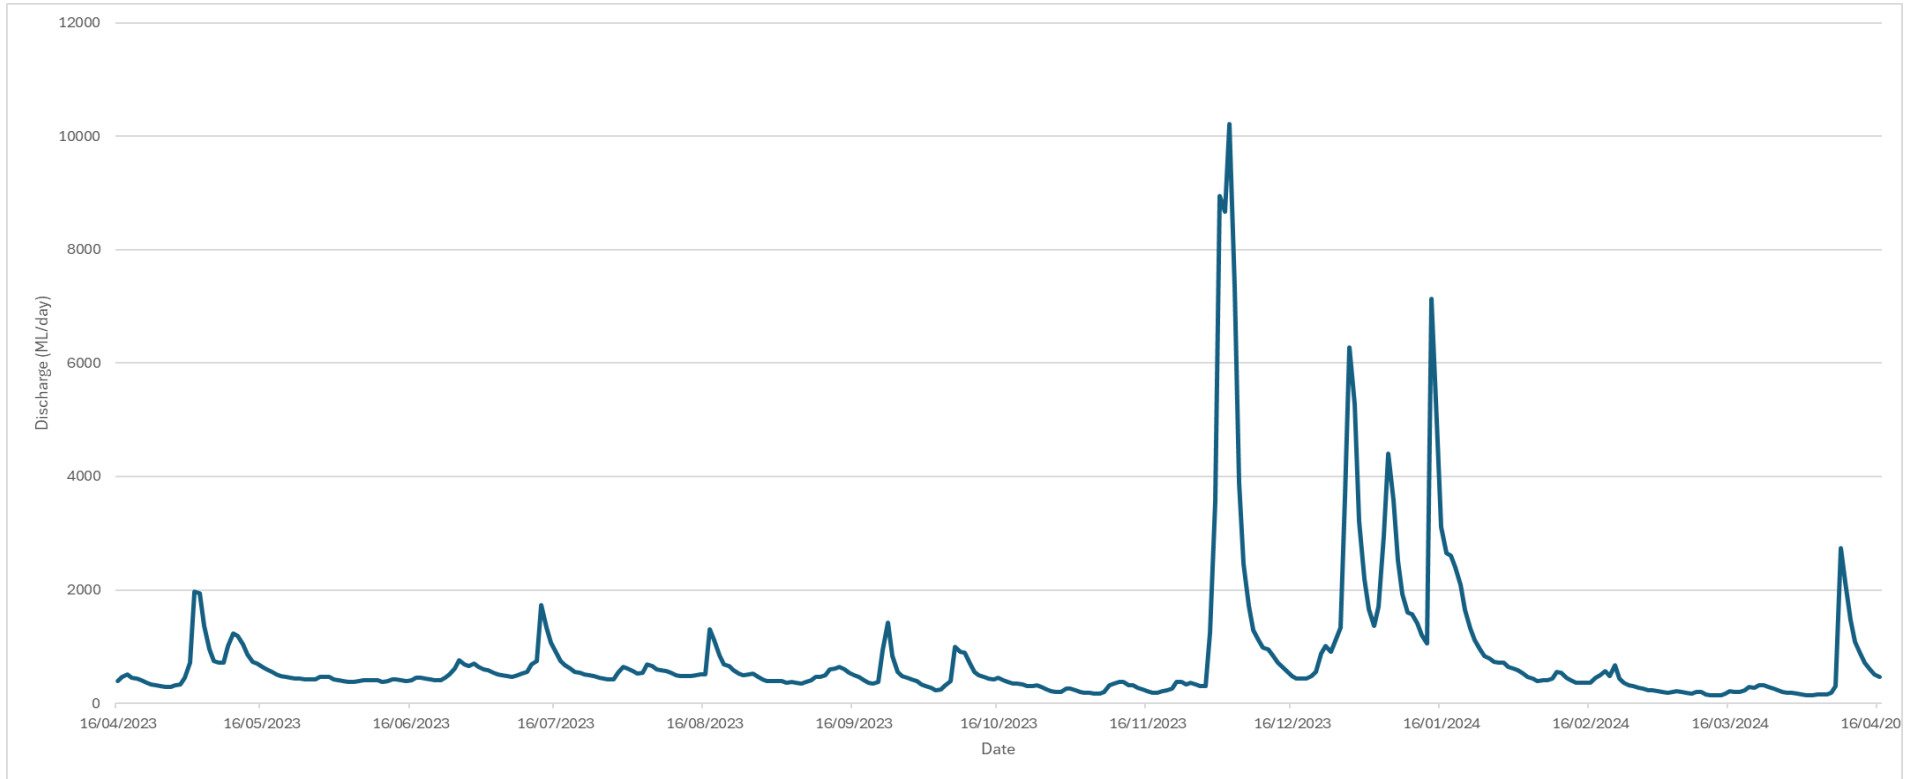
Figure 5 Hydrograph for the Murrumbidgee River Upstream of Angle Crossing (41001702) for the past 12 months.

There has been no water abstracted from the Murrumbidgee River by the M2G since September 2020. During monitoring mean daily discharge at the gauging station upstream of Angle Crossing (41001702) was 485 ML/day (Figure 5). This is consistent with the median daily discharge of 464 ML/day when averaged across the previous year. As with Burra Creek, there was a moderate rainfall event which occurred during the two days prior to monitoring which resulted in daily discharge rising to a peak of 2743 ML/day on 8 April. However, water flows receded steadily before the monitoring.

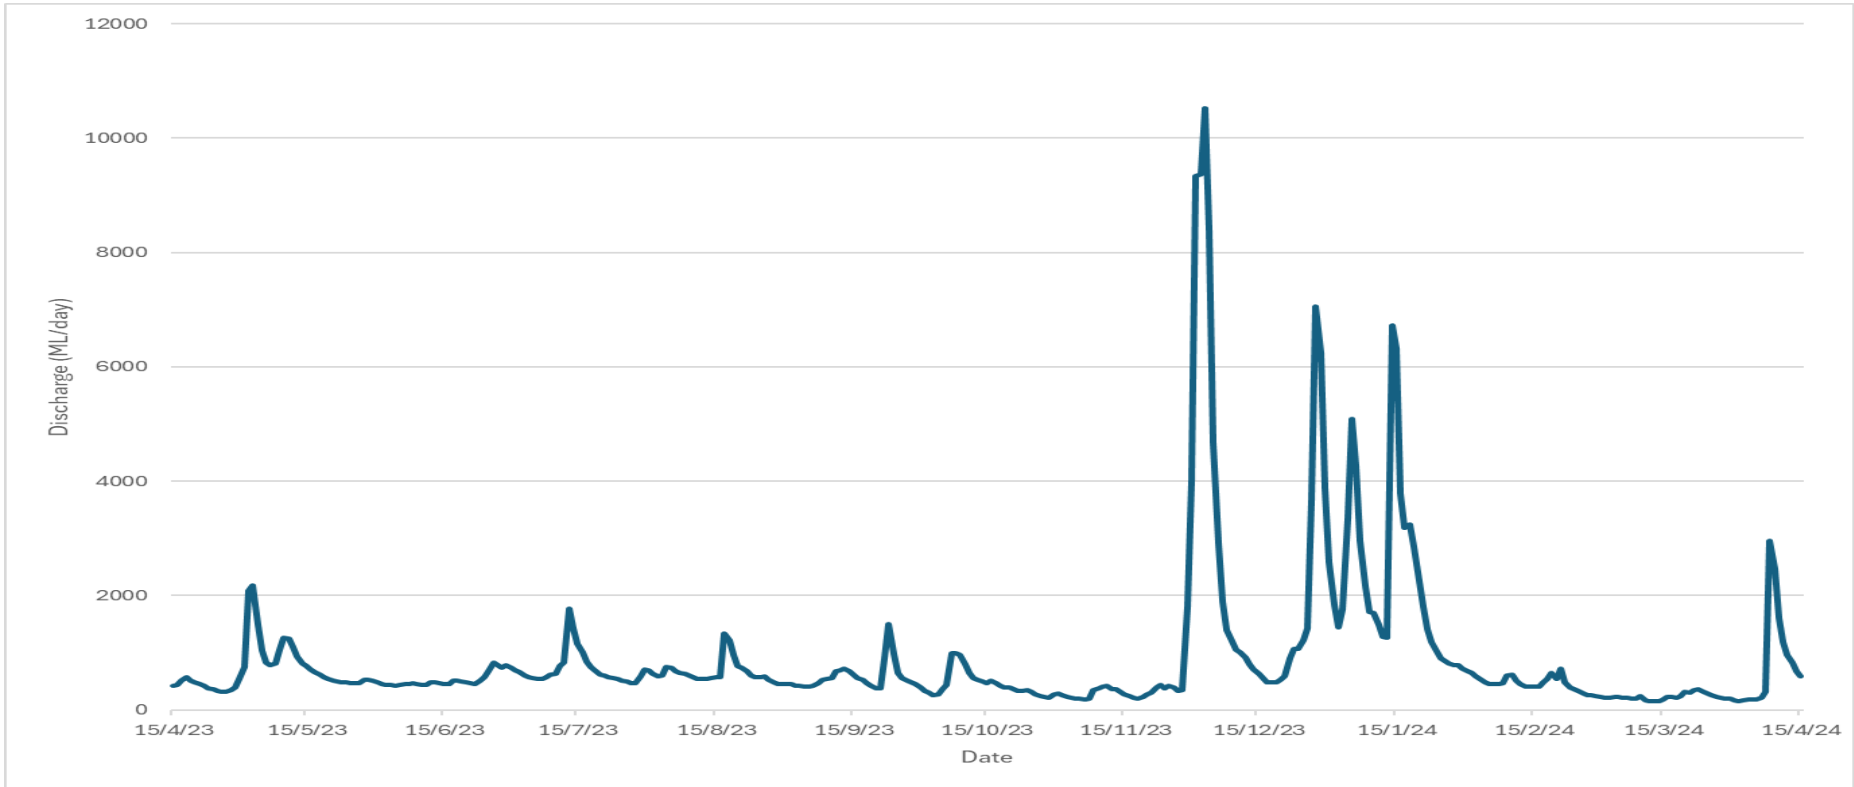
Figure 6 Hydrograph for the Murrumbidgee River below of Lobbs Hole Creek (410761) for the past 12 months.

During monitoring of the two MPS sites on 15 April 2024, daily discharge in the Murrumbidgee River (Below Lobbs Hole Creek, gauging station 410761) was 582.3 ML/day (see Figure 6). This is slightly elevated compared to the median daily discharge of 523 ML/day when averaged across the previous year. Like the other MEMP monitoring sites, moderate rainfall within the two days prior to monitoring resulted in a peak discharge of 2,957 ML/day on 8 April. However, water flows receded steadily before the monitoring.
