ACTEW Water  
Murrumbidgee Ecological Monitoring Program  
Burra Creek Geomorphology Update

June 2015

This report serves as an update to the previous report in April 2014. Updates to some site surveyed transects have been included along with visual inspections at key sites. Updated transects have been overlaid with previous transects for ease of comparison.

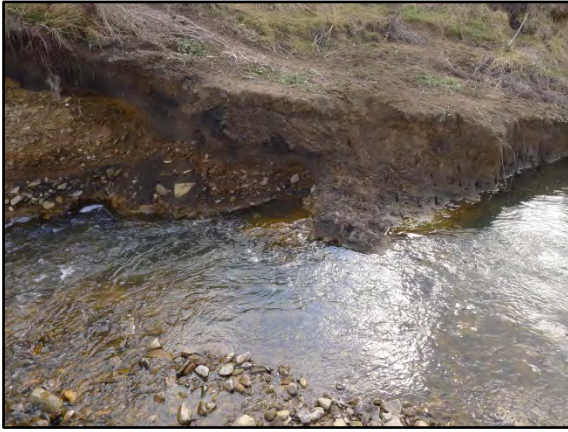
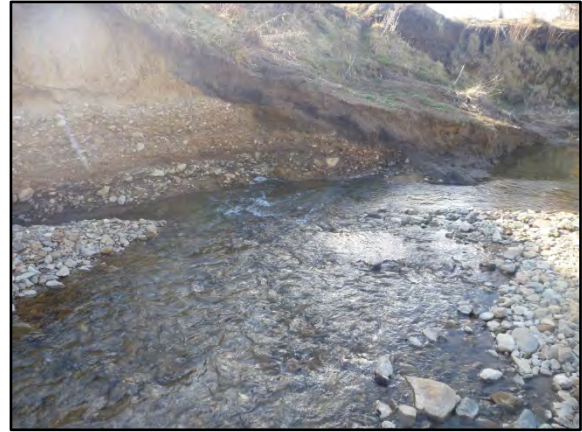
The bank area at Pool 5, immediately upstream of the BUR2C macroinvertebrate sampling site, continues to show the highest potential for substantial erosion. This bank area has been made vulnerable by the high flow events which have scoured the bank and undercut sections over time. Photos of the bank in 2012 are shown in Photo 1 to Photo 2, indicating erosion potential along the bottom of the bank which will increase the undercutting of the bank, resulting in bank collapse into the creek. Photo 3 and Photo 4 show the state of the bank in September 2014.

Photo 1 - High erosion potential area downstream of Pool 5 during July (left) and August (right) 2012

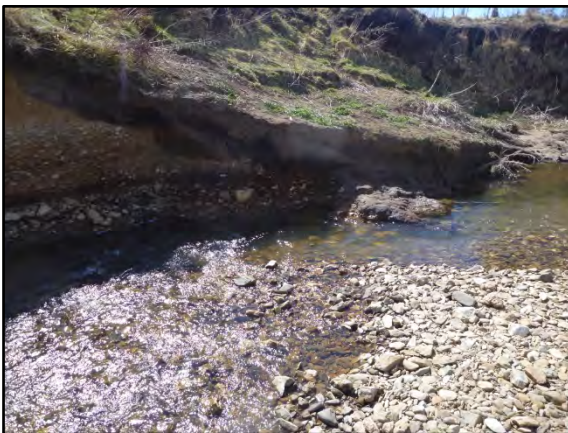
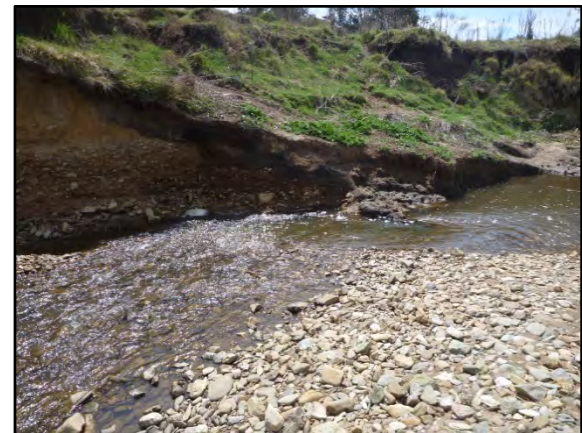
Photo 2 - High erosion potential area downstream of Pool 5 during September (left) and October (right) 2012

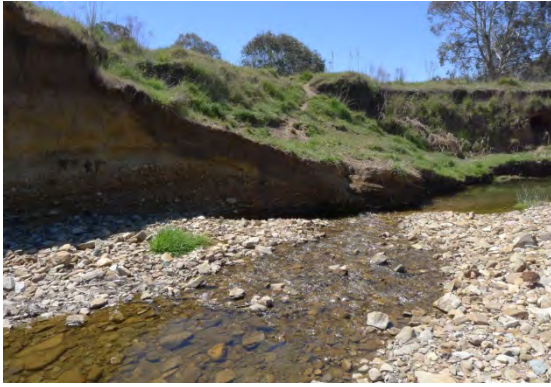
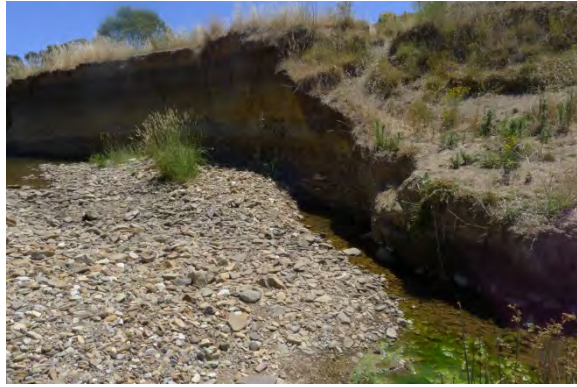
Photo 3 - Erosion potential area downstream of Pool 5 during October 2013 (Left) and January 2014 (Right)

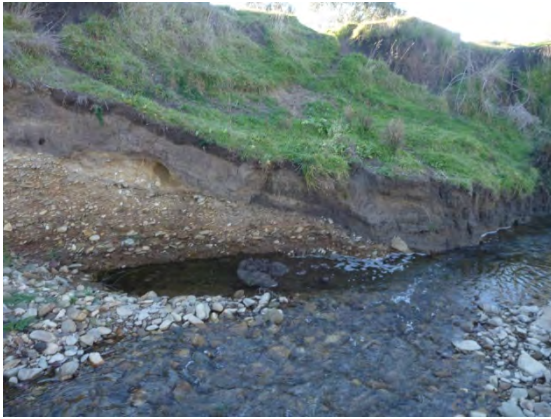
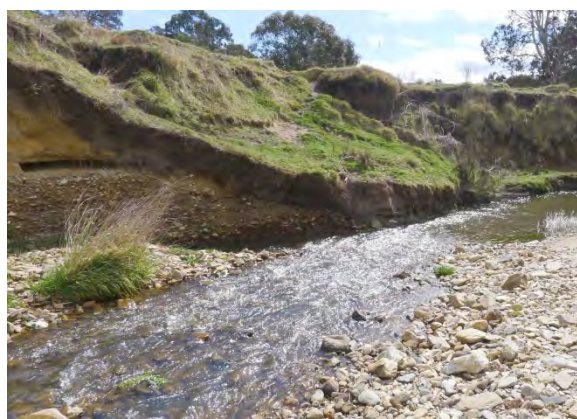
Photo 4 - Erosion potential area downstream of Pool 5 control in June 2014 (left) and September 2014 (right)  
 –new erosion above gravel layer in embankment

The bank immediately upstream of the location shown in Photos 4 and 5 has also started to collapse in sections and eroded significantly since 2009 (refer to photos in Appendix K- BUR 2C: Site Survey).

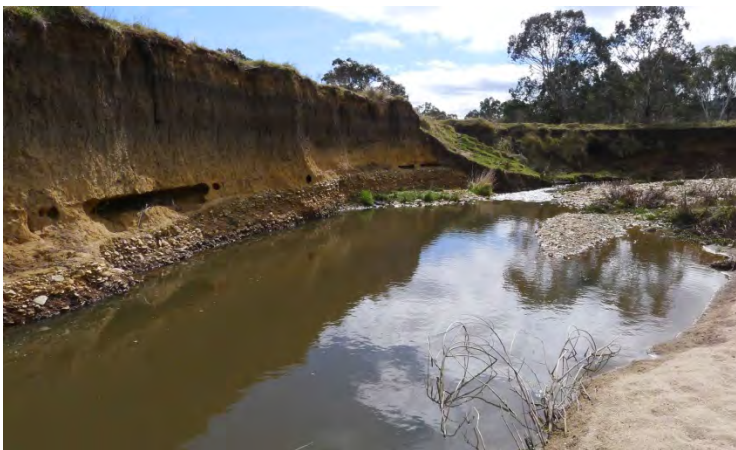
Photo 5 – Pool 5 left hand side bank starting to erode out above the gravel/boulder layer (September 2014)

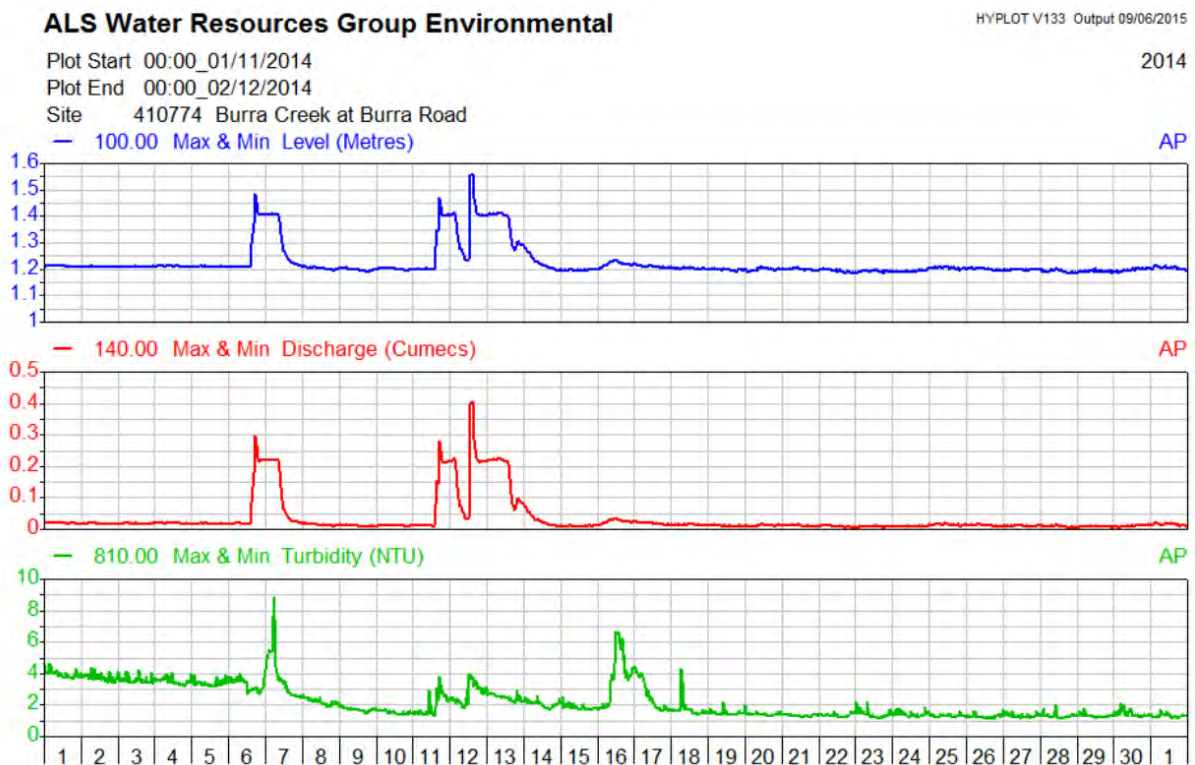
Sediment transport during maintenance events shows a first flush effect, with a peak followed by a rapid decrease in turbidity as fine particulate matter is moved. Figure 4 below shows level, discharge and turbidity during a maintenance run in November 2014. The hydrograph shows that pumps were in operation during the 6<sup>th</sup>, 7<sup>th</sup>, 11<sup>th</sup>, 12<sup>th</sup> and 13<sup>th</sup> of the month. The initial pumping produced a sharp peak in turbidity which rapidly reduced as the cleaner Murrumbidgee water flowed through the system. When the pumps were switched on again on the 11<sup>th</sup> and 12<sup>th</sup> the turbidity peaks were far lower as fine material had already been transported during the initial pump event on the 6<sup>th</sup>.

In contrast we can see that a minor natural event on the 16<sup>th</sup> produced a large turbidity spike in comparison with the discharge, as a result of sediment entering the waterway from rainfall runoff.

Figure 4 - Burra Weir (410774) flow and turbidity data Nov 2014 maintenance

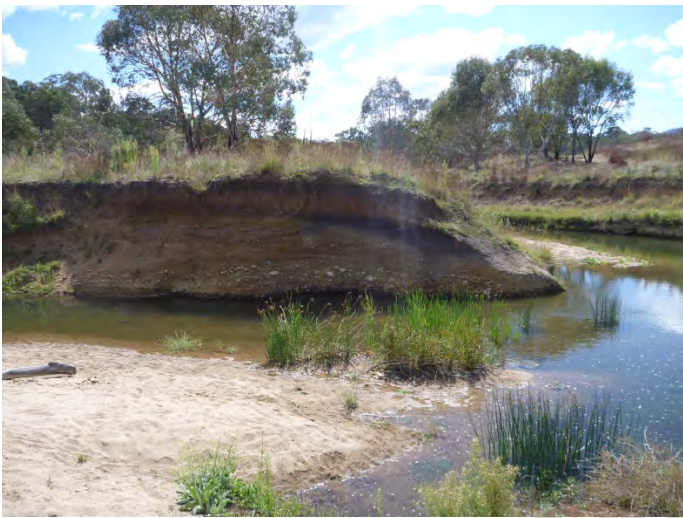
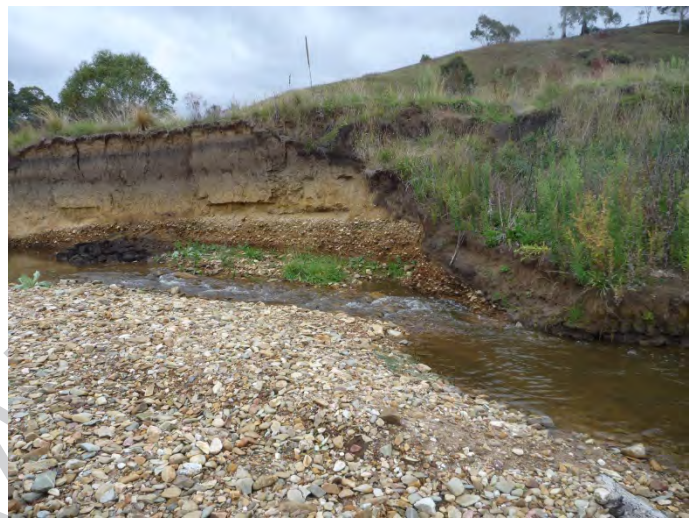
Bend U/S BUR2C Riffle

There was no visually detectable change at sites except for the embankment at bend U/S BUR2C riffle where erosion had occurred.

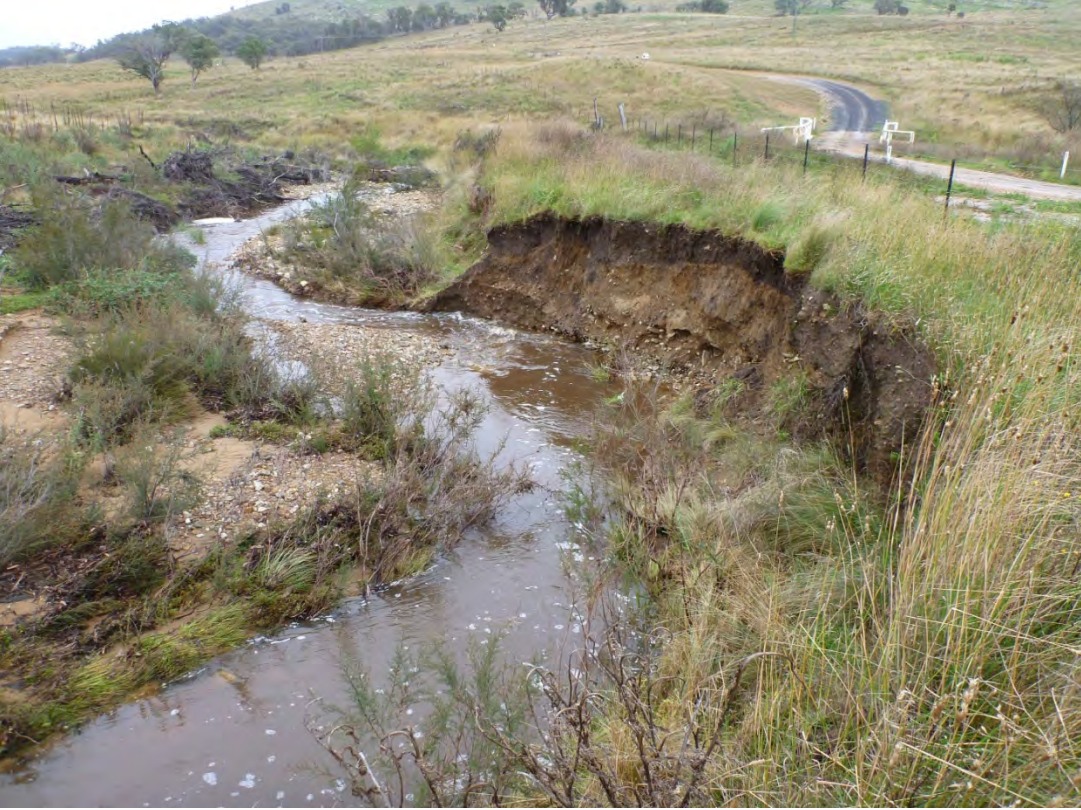
<p data-bbox="167 963 534 996">Photo 12 - BUR1 8/3/2012</p>	<ul style="list-style-type: none"> <li data-bbox="1244 179 1500 291">- Evidence of additional bank erosion on outside of bend</li> <li data-bbox="1244 302 1500 414">- Bankside grass vegetation on LHS flattened by previous flow.</li> </ul>

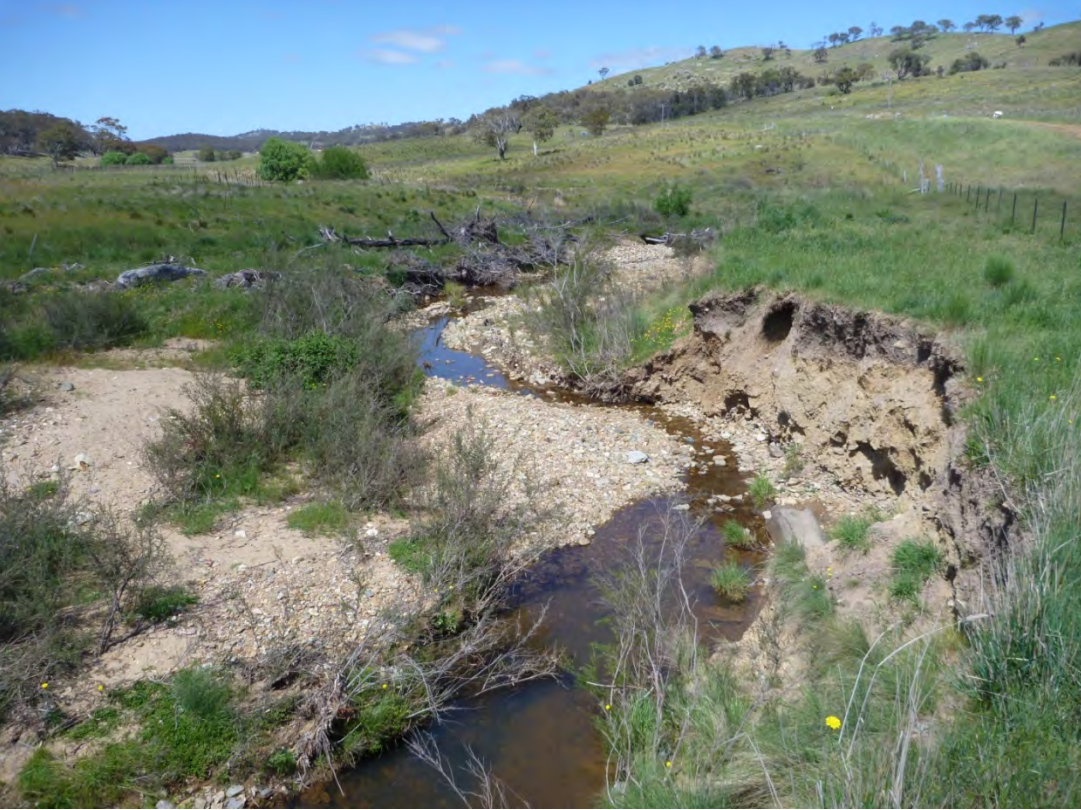
<p data-bbox="167 1836 534 1870">Photo 13 - BUR1 20/11/2012</p>	<ul style="list-style-type: none"> <li data-bbox="1244 1019 1500 1131">- Bank shows signs of minor erosion from October '12 event</li> <li data-bbox="1244 1142 1500 1310">- Bankside vegetation recovered And growing strongly after decent rainfall</li> </ul>

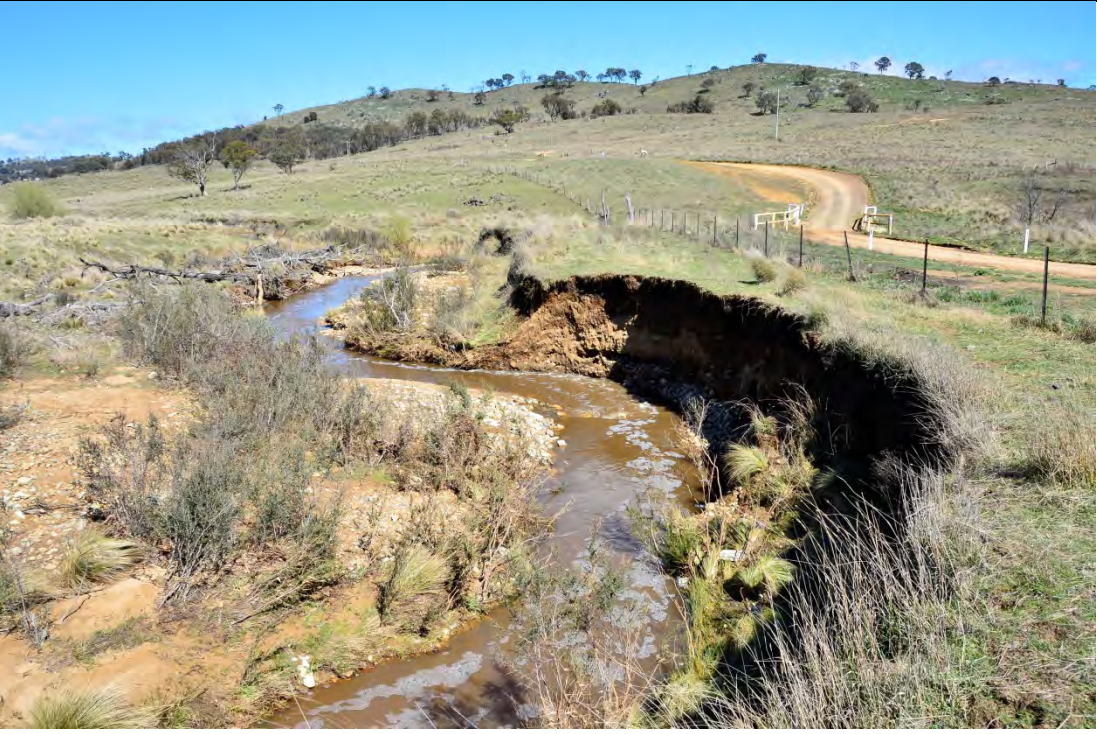
<p data-bbox="165 880 552 909">Photo 16 - BUR1 19/9/2013</p>	<ul style="list-style-type: none"> <li>- Significant removal of material from right hand bank from large event.</li> </ul>

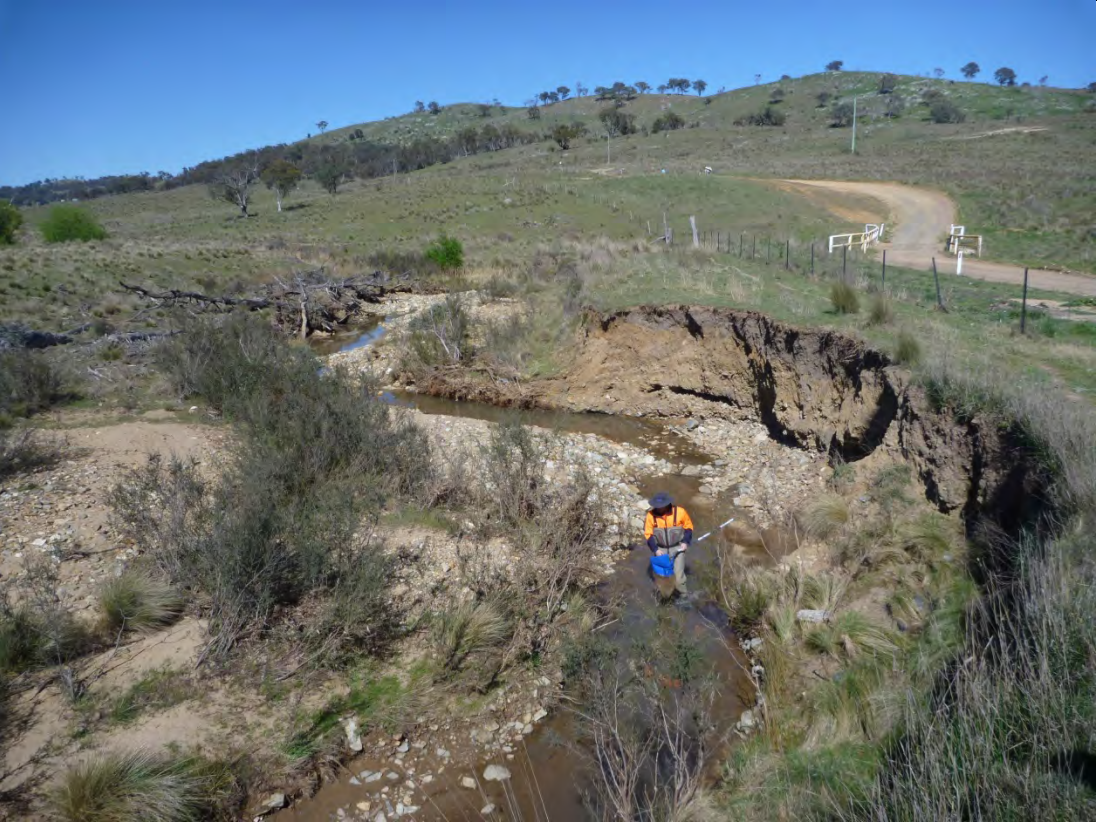
<p data-bbox="165 1760 552 1792">Photo 17 - BUR1 15/10/2013</p>	<ul style="list-style-type: none"> <li>- Right hand side bank collapse and deposition of material on outside of bend.</li> <li>- Majority of bankside vegetation retained through event.</li> </ul>

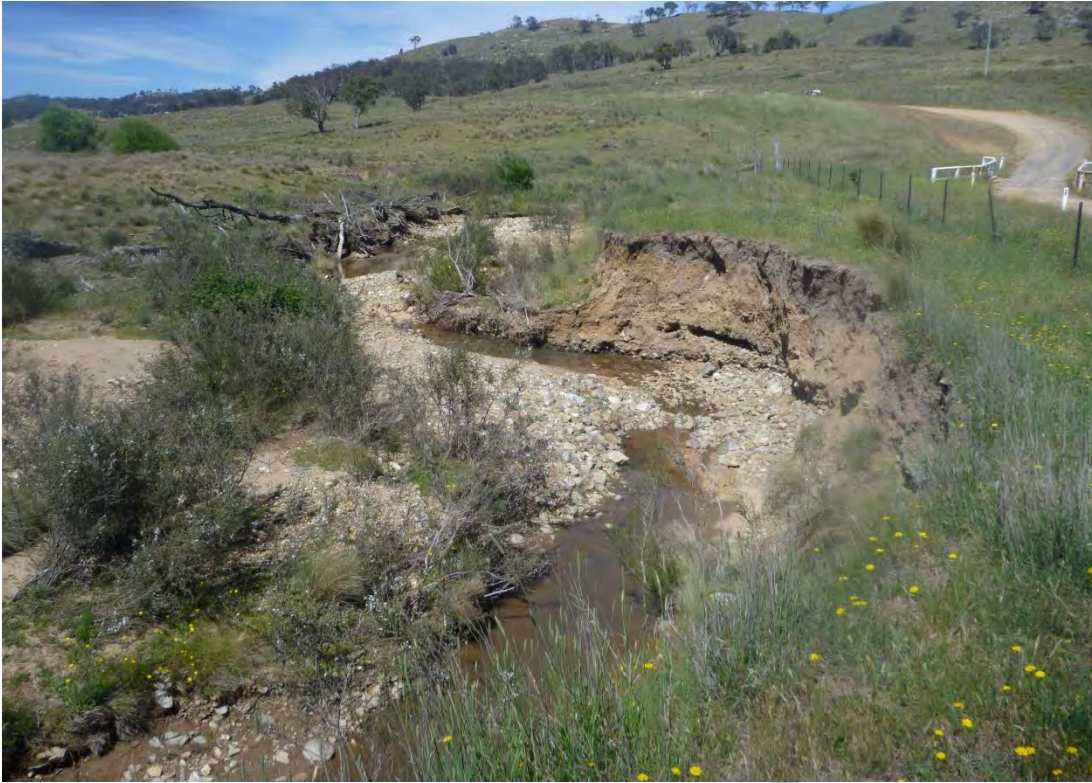
Photo 18 - BUR1 12/12/2013

- Strong vegetation growth after rain and warm weather.

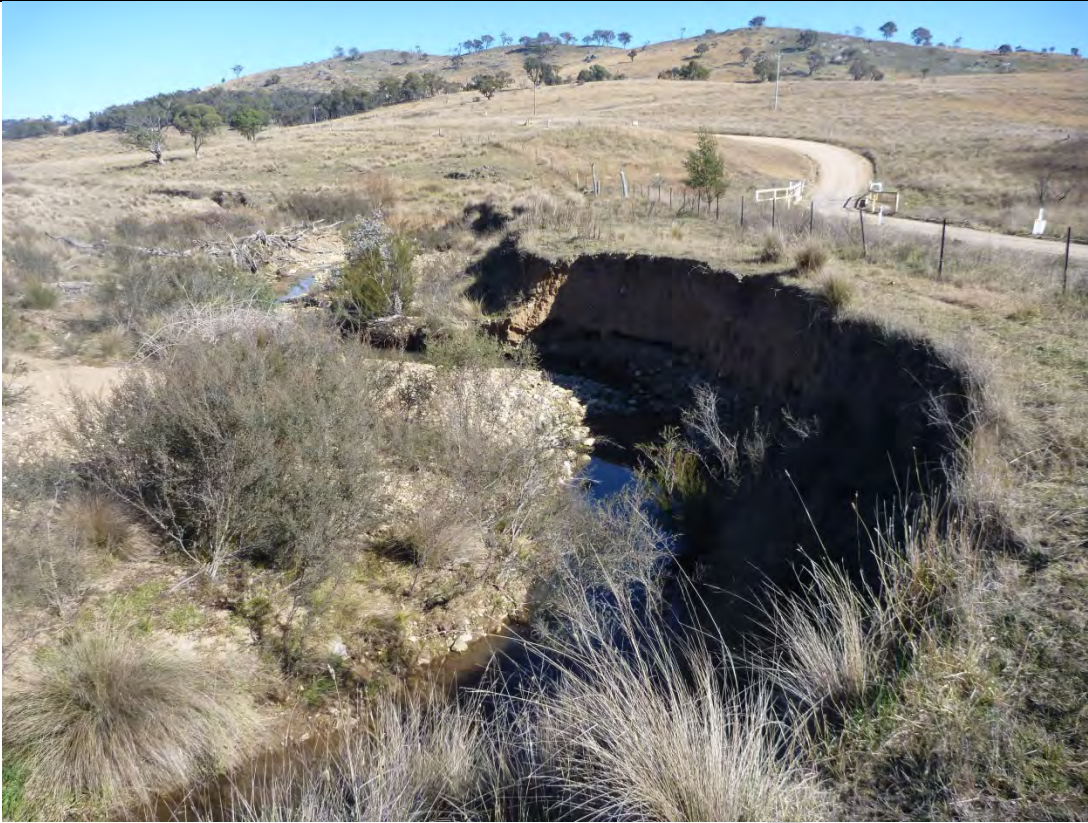
Photo 26 - BUR1 15/5/2015

- Little change, evidence of some weathering on right hand side bank

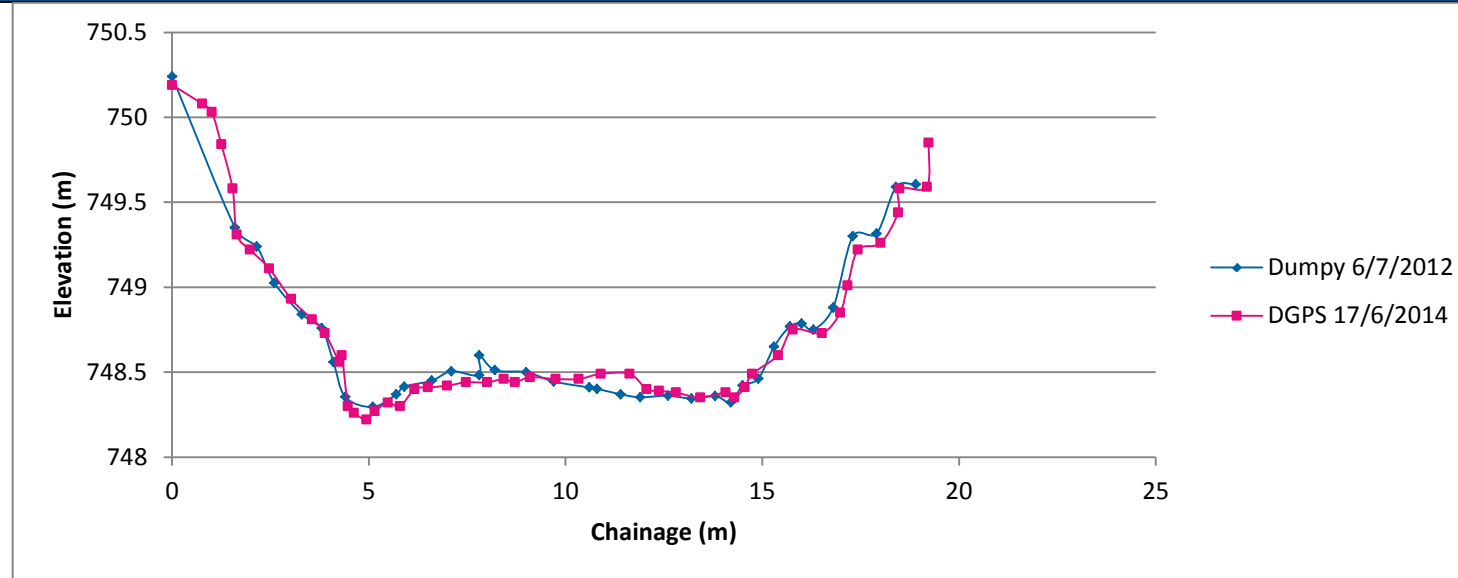
Figure 24 - BUR1C XS-1A

- XS-1B lies perpendicular to the channel while XS-1A starts at the same point but runs at an angle to the channel to a different end point DS..
- Cross Sections from 2012 and 2014 closely match, differences due to slightly different line taken over/through vegetation.

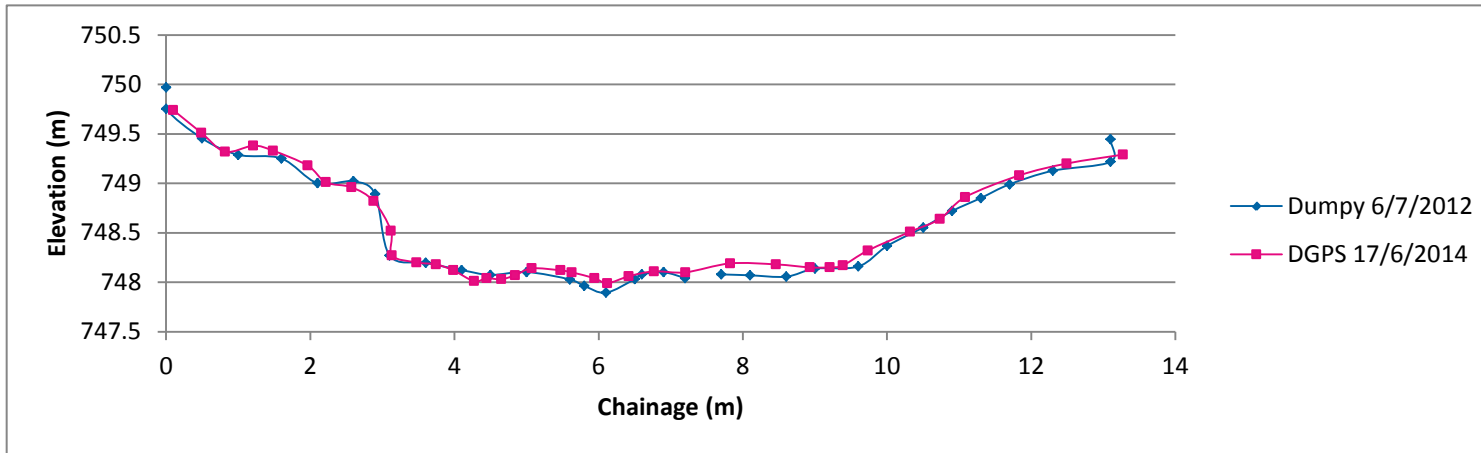
Figure 26 - BUR1C XS-2

- 2012 and 2014 cross sections closely match, differences due to variations in vegetation growth.
- There has been some deepening of the central channel at chainage 6m.

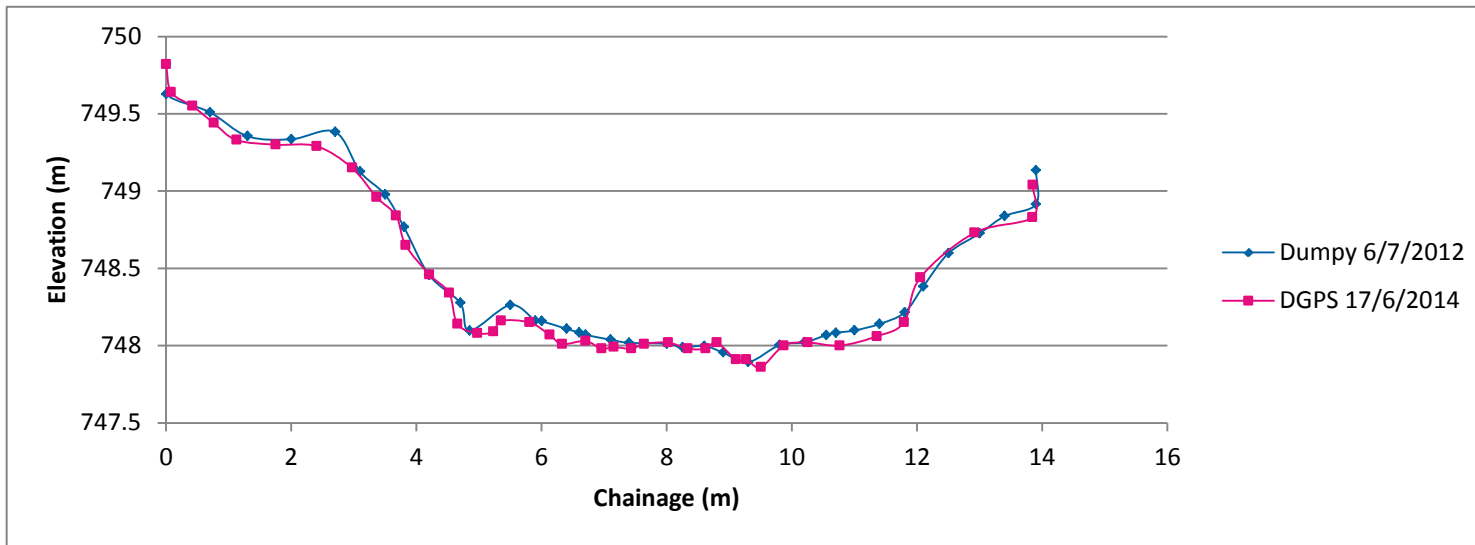
Figure 28 - BUR1C XS-4

- Resurvey of cross section with DGPS required to complete/append to DGPS model
- 2012 and 2014 cross sections closely match, minor differences due to vegetation.

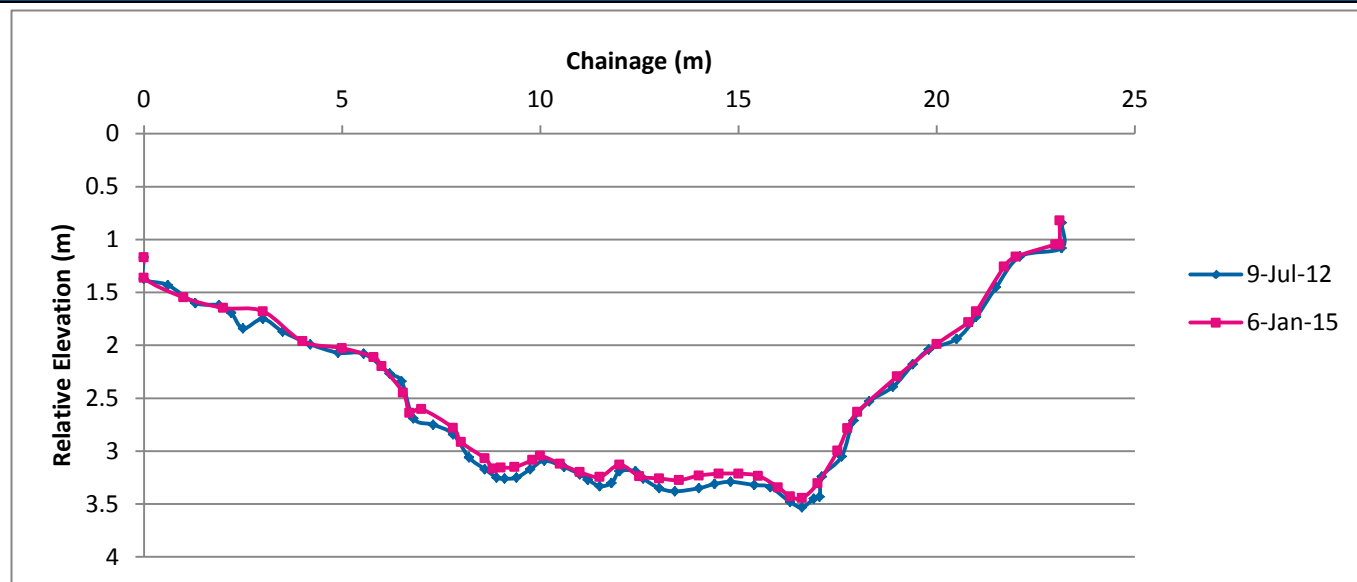
Figure 35 - BUR2A XS-1 \_ 2012

- There is little difference between the pre and post commissioning cross sections.
- Variation in sections from ~8m to ~17m due to summer macrophyte growth in channel

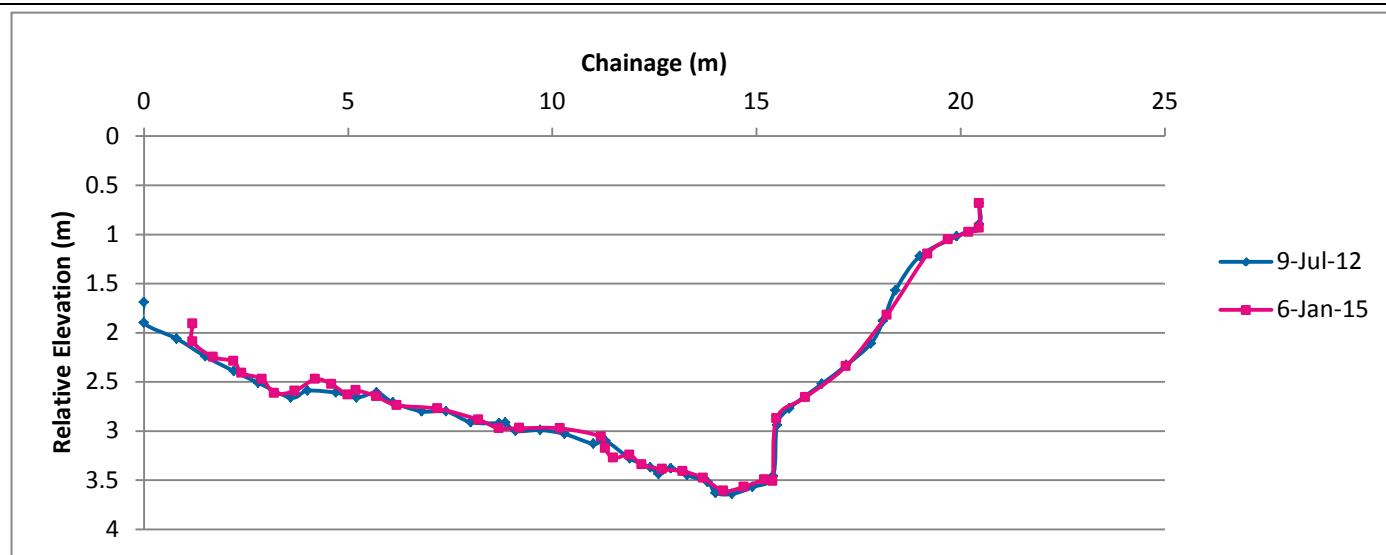
Figure 36 - BUR2A XS-2 \_ 2012

- No observable difference between pre and post commissioning sections
- Left hand side peg had been knocked out and was repositioned due to wombat activity.

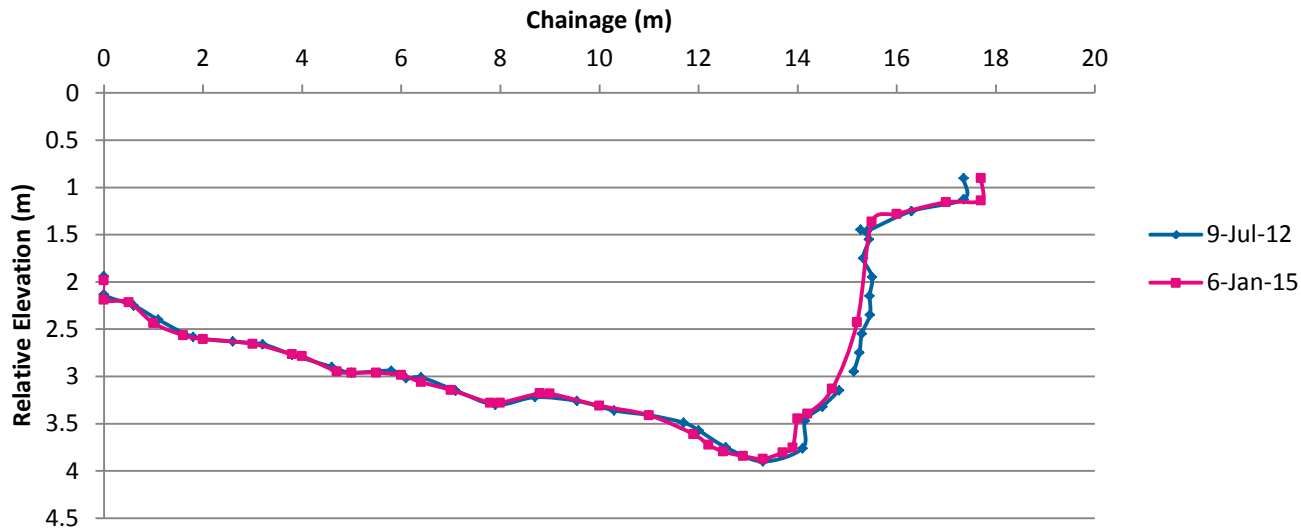
- No significant difference between pre and post commissioning sections.
- RHS peg was knocked out and slightly repositioned.

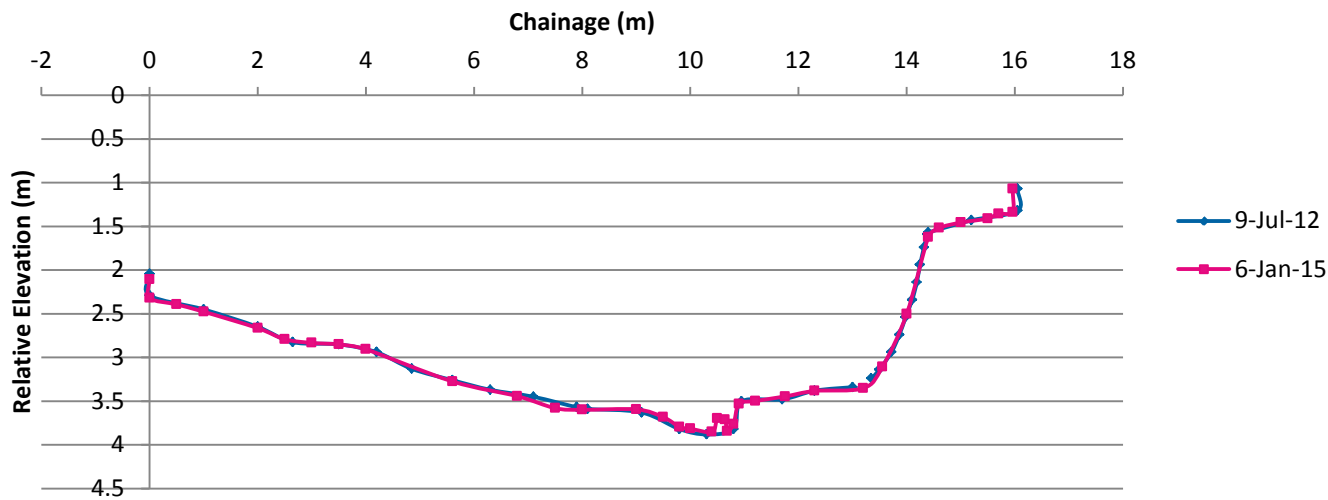
Figure 38 - BUR2A XS-4\_2012

- No notable difference between pre and post commissioning surveys.
- Variations between sections at ~11m due to a rock that was not picked up in 2012.

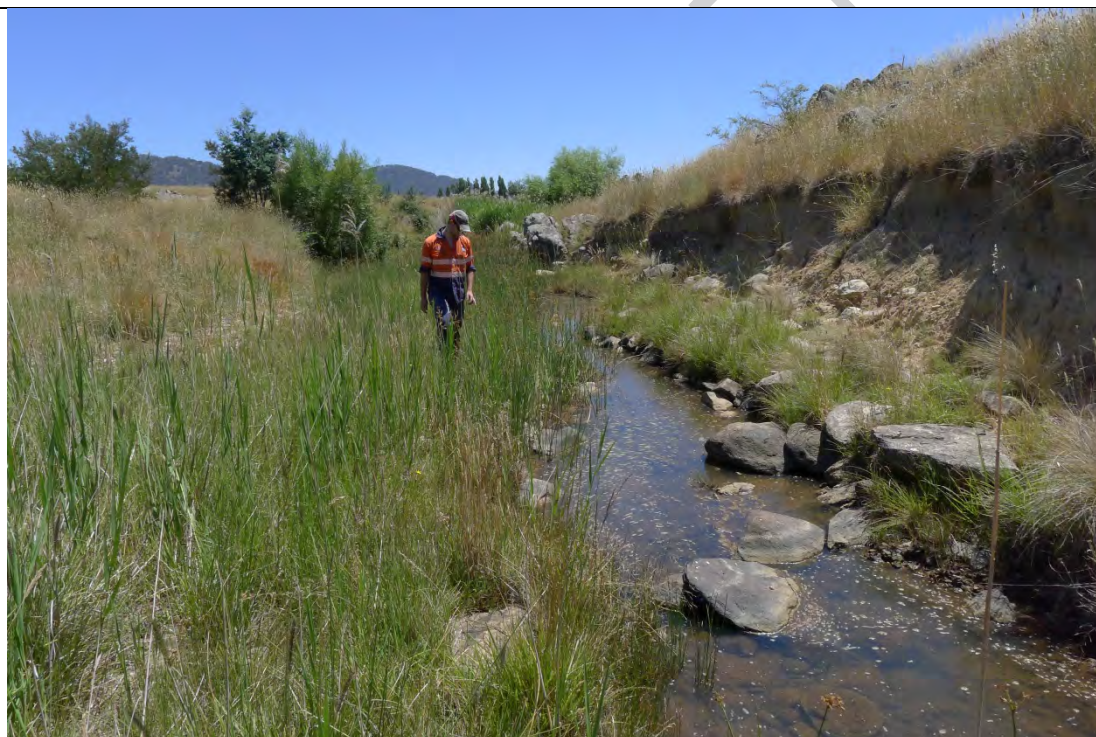
Photo 34 - BUR2A 13/1/2014

- Bank has remained stable

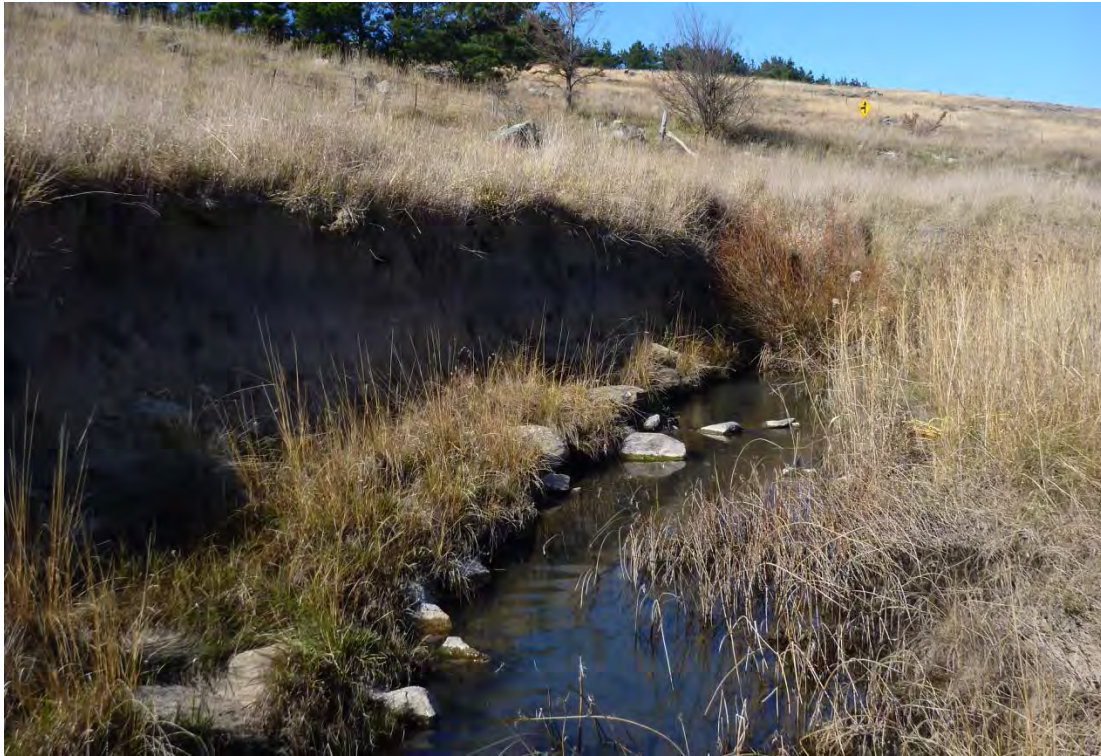
Photo 37 - BUR2A 18/5/2015

- No evidence of change
- Autumn die-back of vegetation

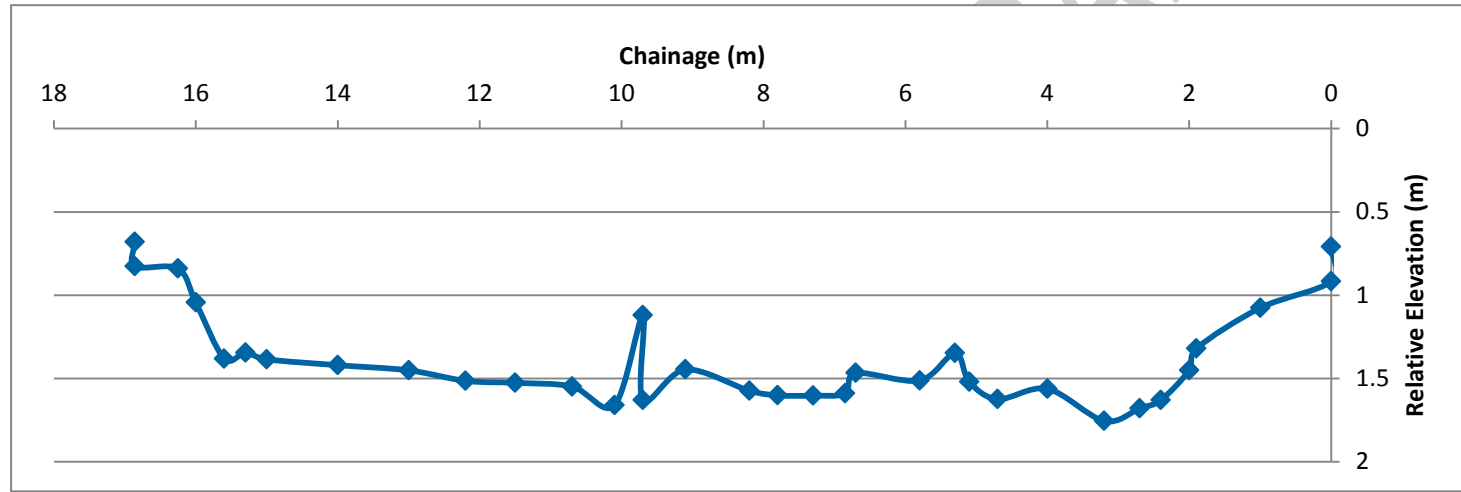
Figure 41 - BUR U/S Pool 50 XS-1 \_ 2012

- DGPS survey longer than Dumpy cross section to accommodate 3D profiling
- Original survey pegs could not be found at time of 3D survey.
- Channel sections indicate similar profile, accurate survey needed to re-establish section

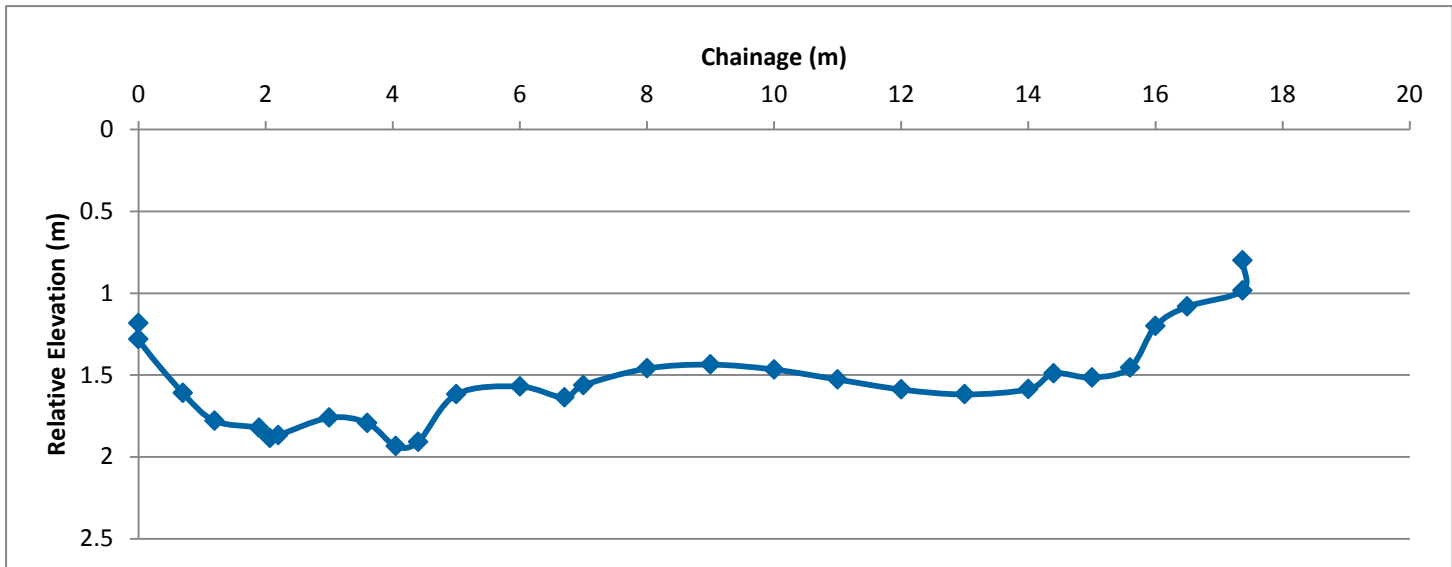
Figure 43 - BUR U/S Pool 50 XS-2 \_ 2012

- DGPS survey longer than Dumpy cross section to accommodate 3D profiling
- Original survey pegs could not be found at time of 3D survey.
- Channel sections indicate similar profile, accurate survey needed to re-establish section
- Differences due to rock outcrops picked up in ~1m misalignment of cross sections

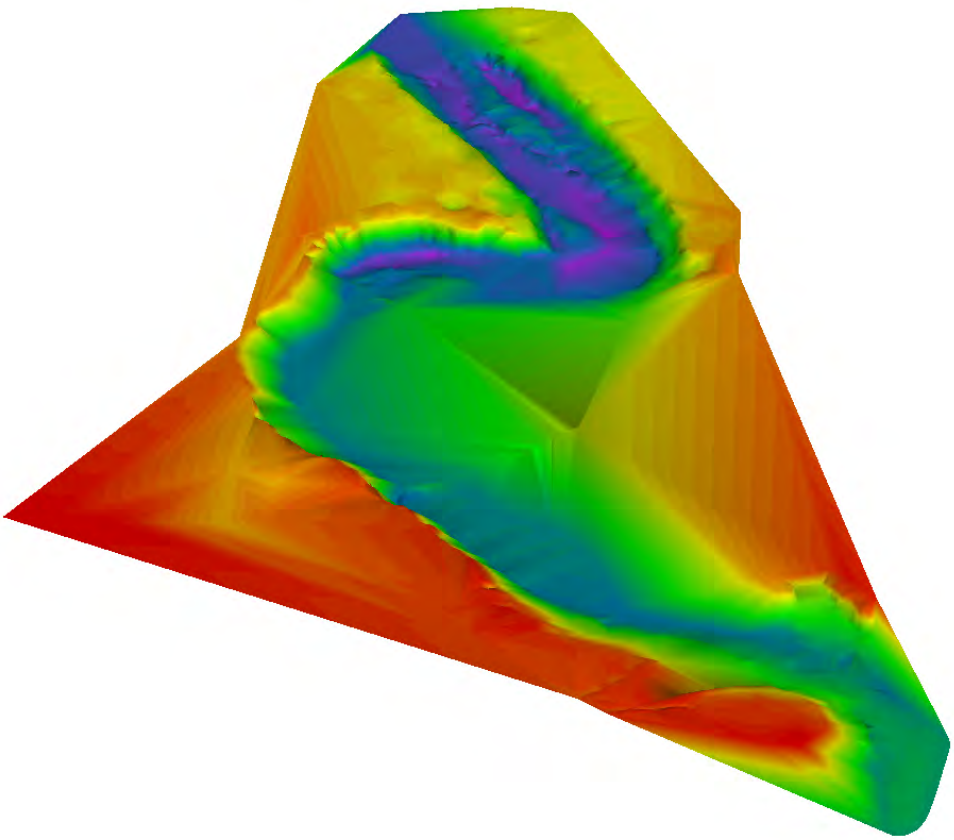
Figure 47 - BUR2C DGPS 3D Model (July 2013)

- In-stream points U/S of Riffle absent due to water level or loss of DGPS correction signal at base of embankment during survey.

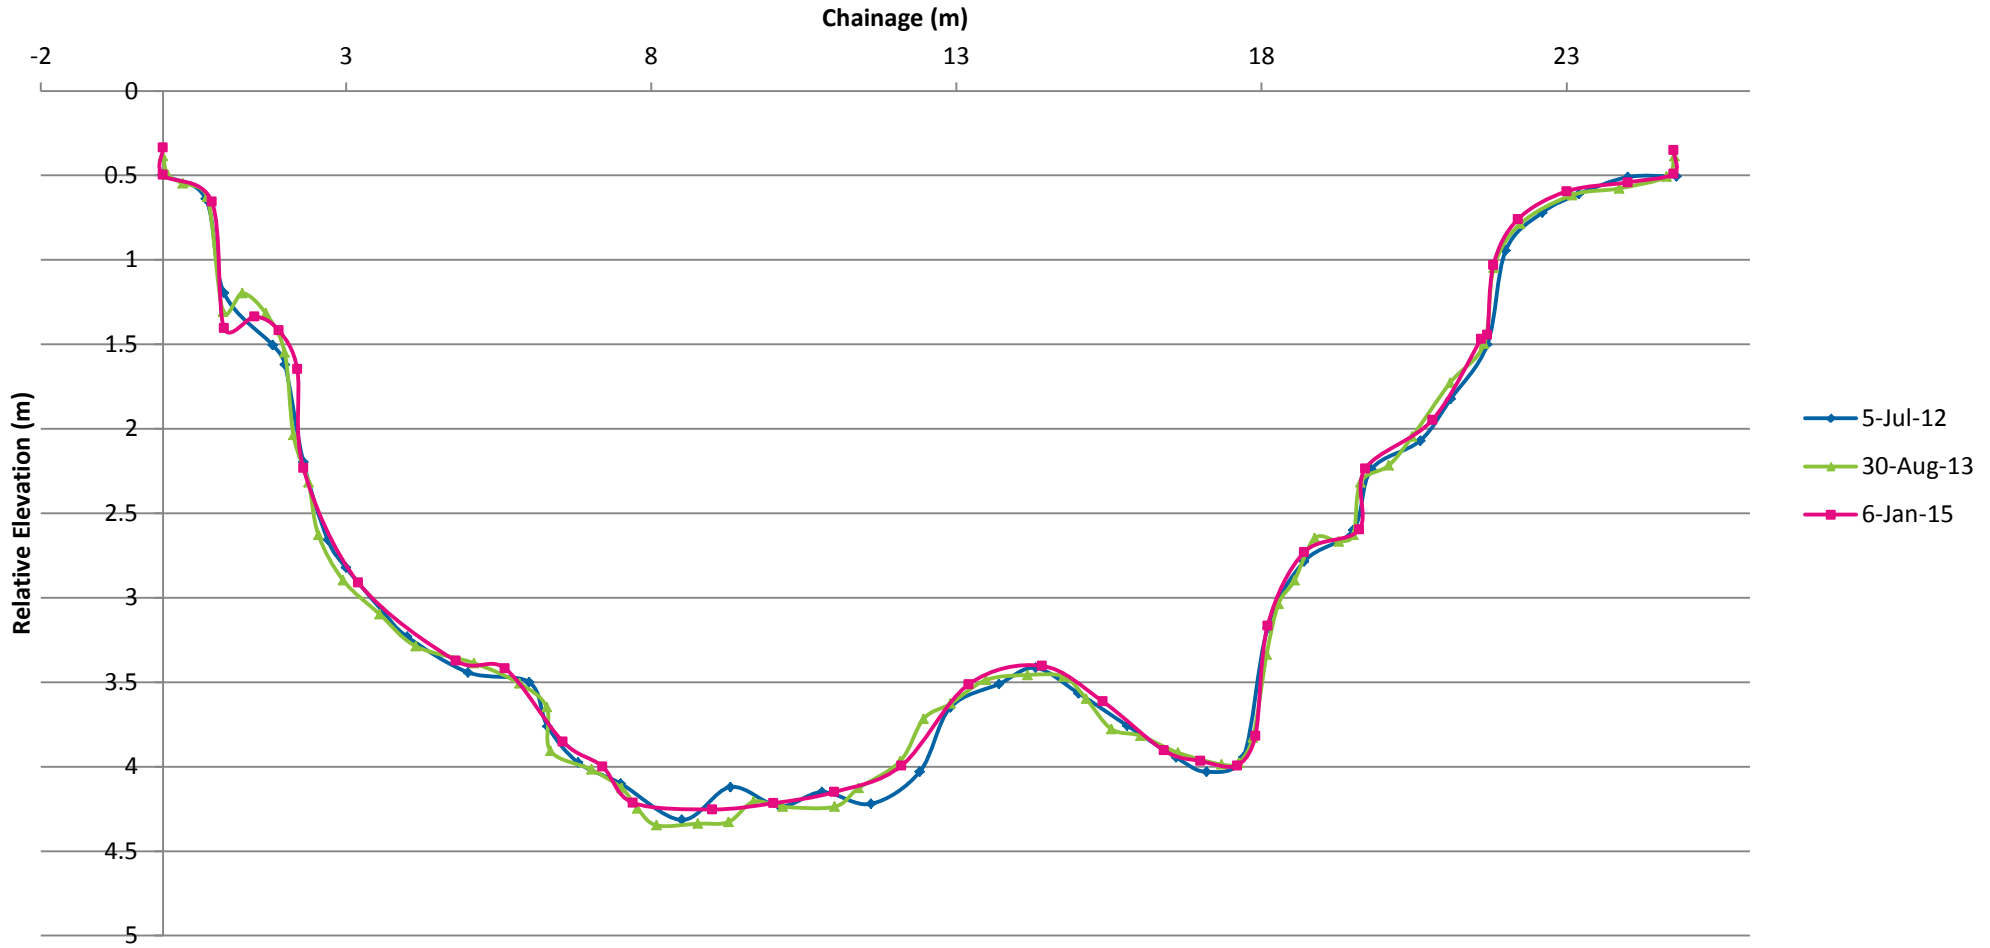
D/S Site 2C XS-4

Cross sections all closely match  
Material in central channel has shifted slightly
