ACTEW Water  
Murrumbidgee Ecological Monitoring Program  
Burra Creek Geomorphology Update

June 2015

This report serves as an update to the previous report in April 2014. Updates to some site surveyed transects have been included along with visual inspections at key sites. Updated transects have been overlaid with previous transects for ease of comparison.

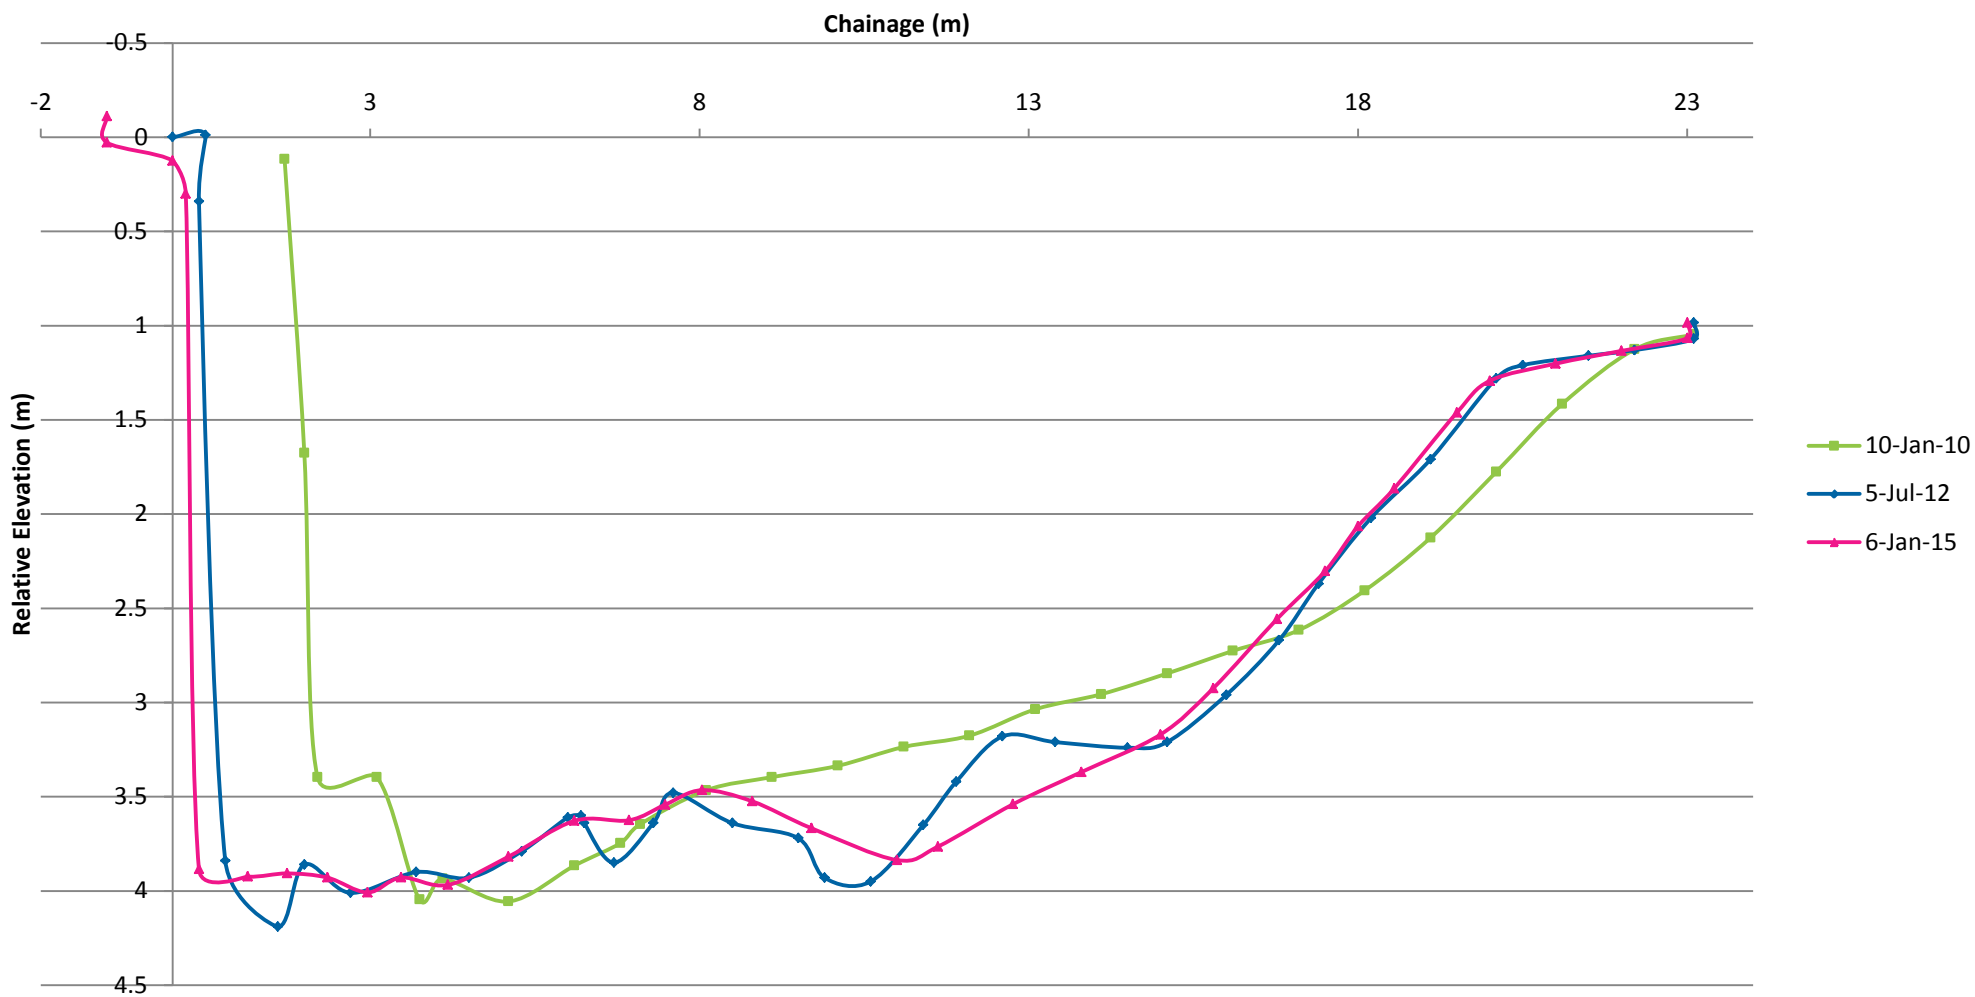
U/S 2C @ Bend XS-3

Continued erosion from left hand side bank.  
 LHS peg repositioned again.  
 Some reforming of sand bar on right hand side bank at ~13m

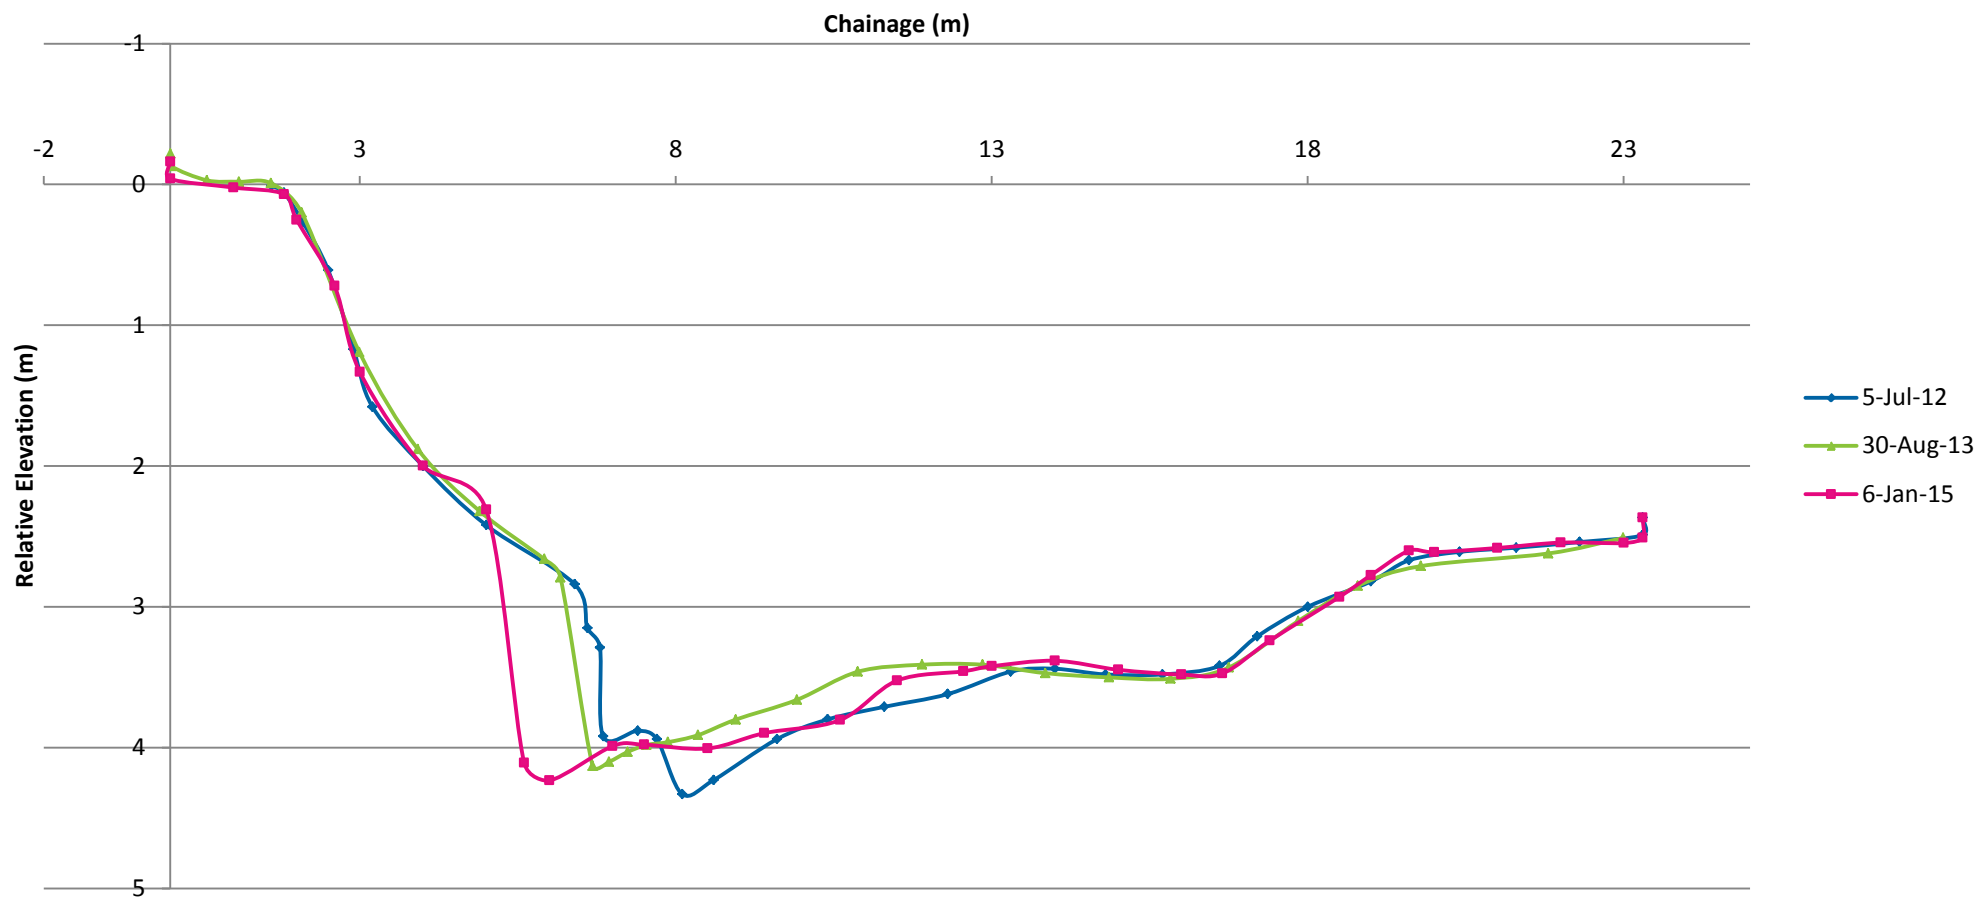
BUR2C @ Undercut Bank XS-2

Central channel continues to erode the bank on left hand side  
Sand has been eroded on RHS bank at ~10m

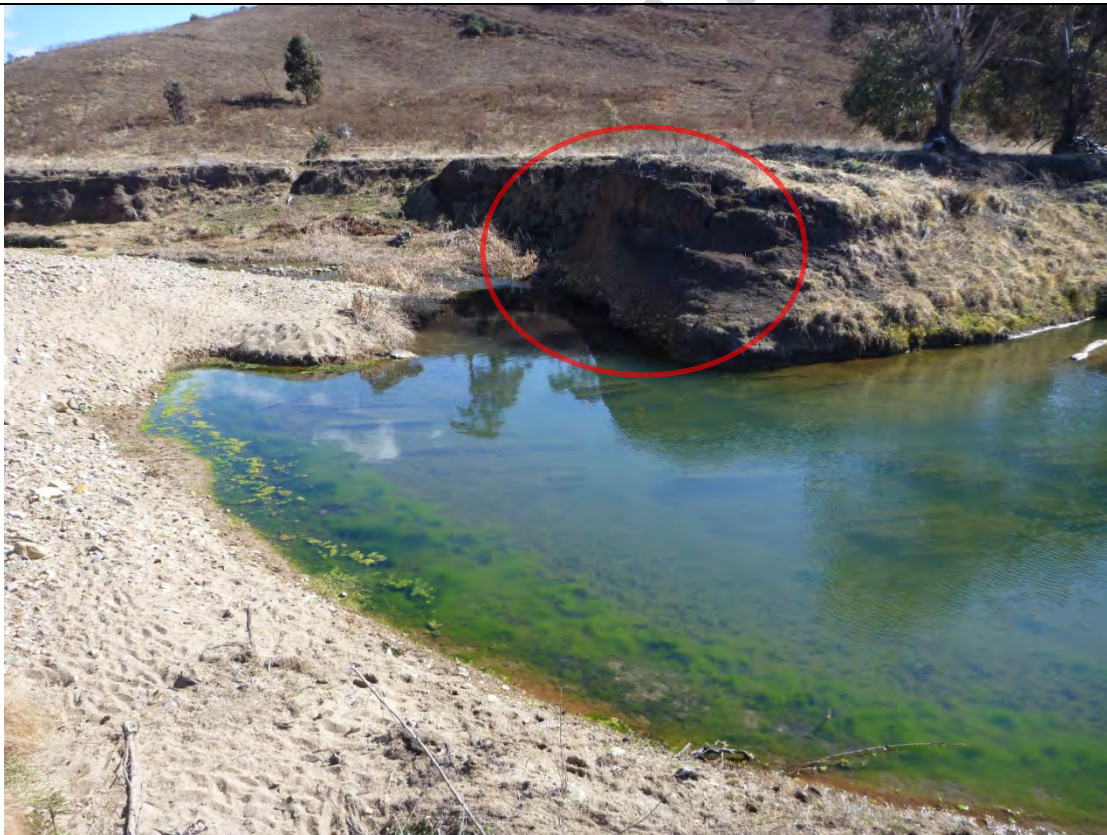
Photo 41 - BUR2C 3/8/2011

- Ongoing bank erosion
- Site of XS-3
- High algal growth due to elevated nutrient levels and warmer water temperature as vegetation previously shading the creek was washed out during flood

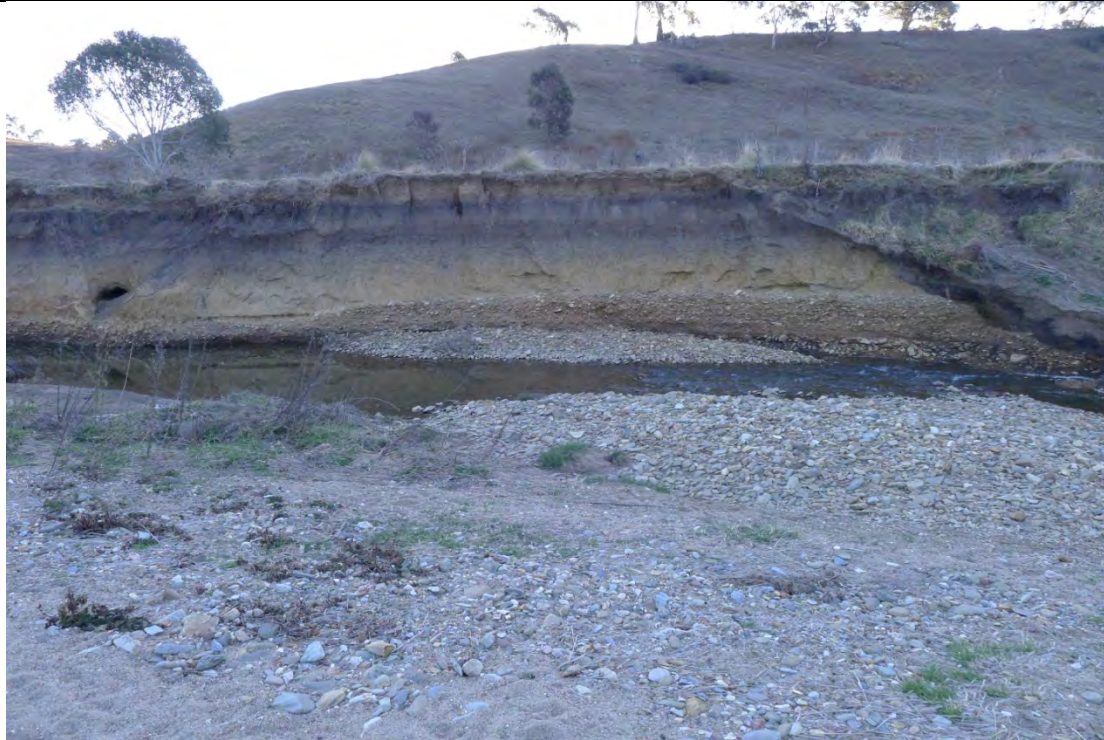
Photo 48 - BUR2C 3/9/2012

- Sediment deposition evident on outside of bend.

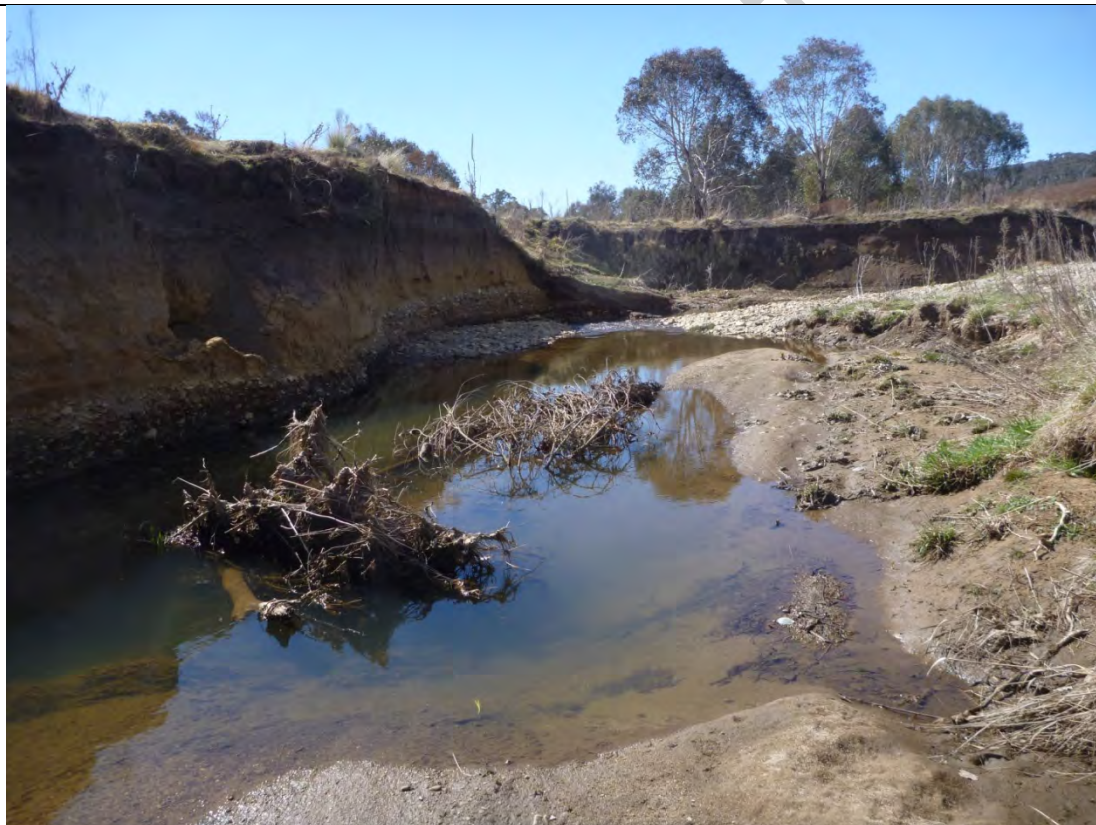
Photo 49 - BUR2C 10/9/2012

- Woody debris present in channel
- Fine Sediment deposit evident
- Eroded banks too steep to allow easy vegetation regrowth for stability

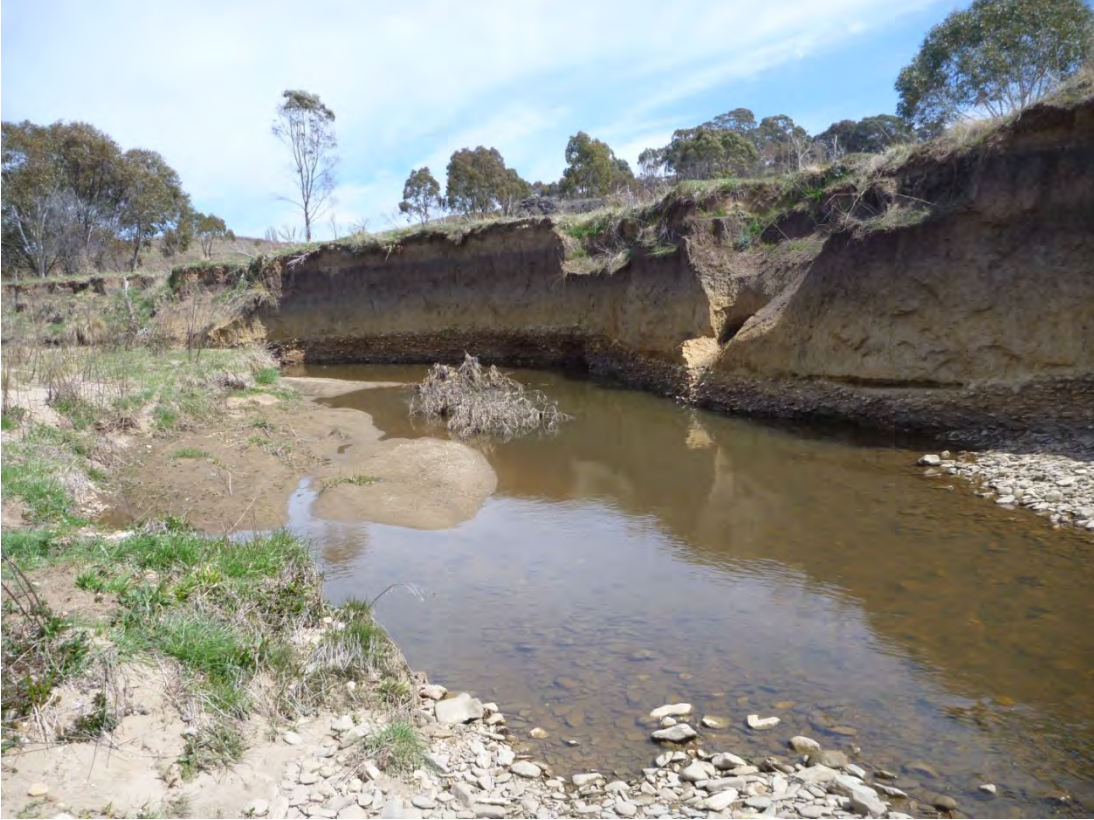
<p data-bbox="181 969 592 1003">Photo 50 - BUR2C 3/10/2012</p>	<ul data-bbox="1299 181 1445 237" style="list-style-type: none"> <li>- Bank collapse</li> </ul>

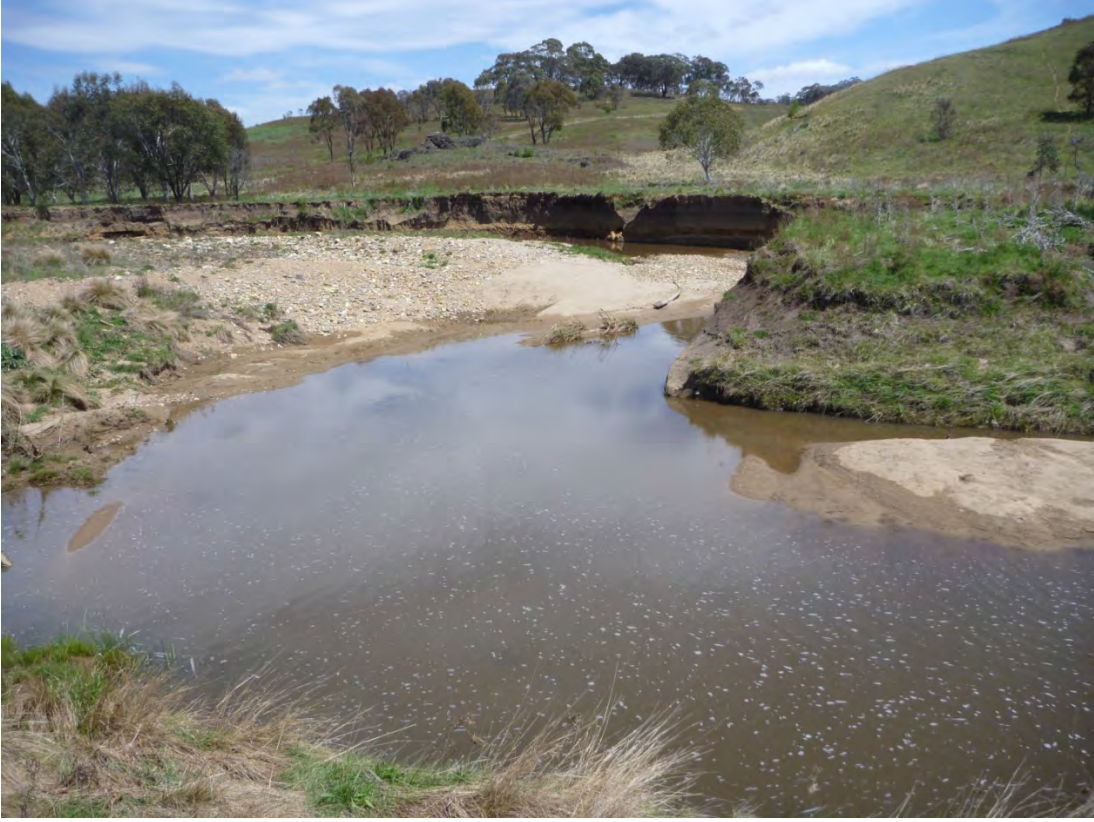
<p data-bbox="181 1888 611 1921">Photo 51 - BUR2C 18/10/2012</p>	<ul data-bbox="1299 1070 1509 1182" style="list-style-type: none"> <li>- Sediment deposits in areas of low velocity</li> </ul>

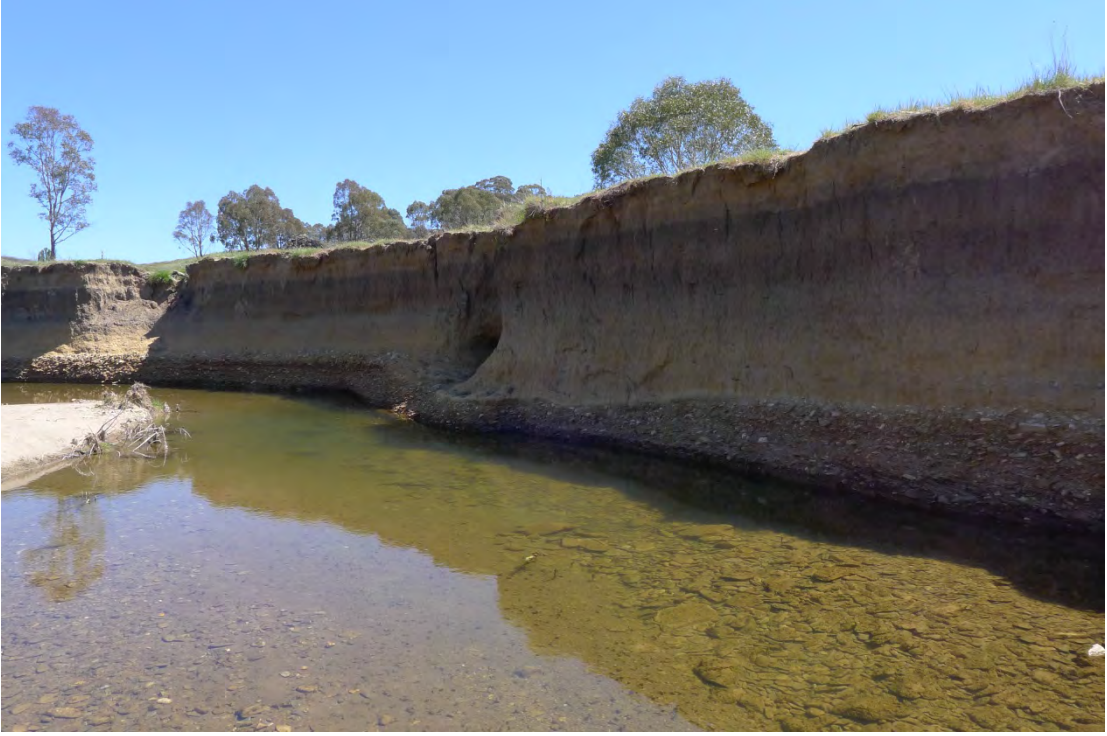
<p data-bbox="183 1816 609 1848">Photo 55 - BUR2C 30/10/2013</p>	<ul style="list-style-type: none"> <li>- Significant section of embankment scoured after Sept event</li> </ul>

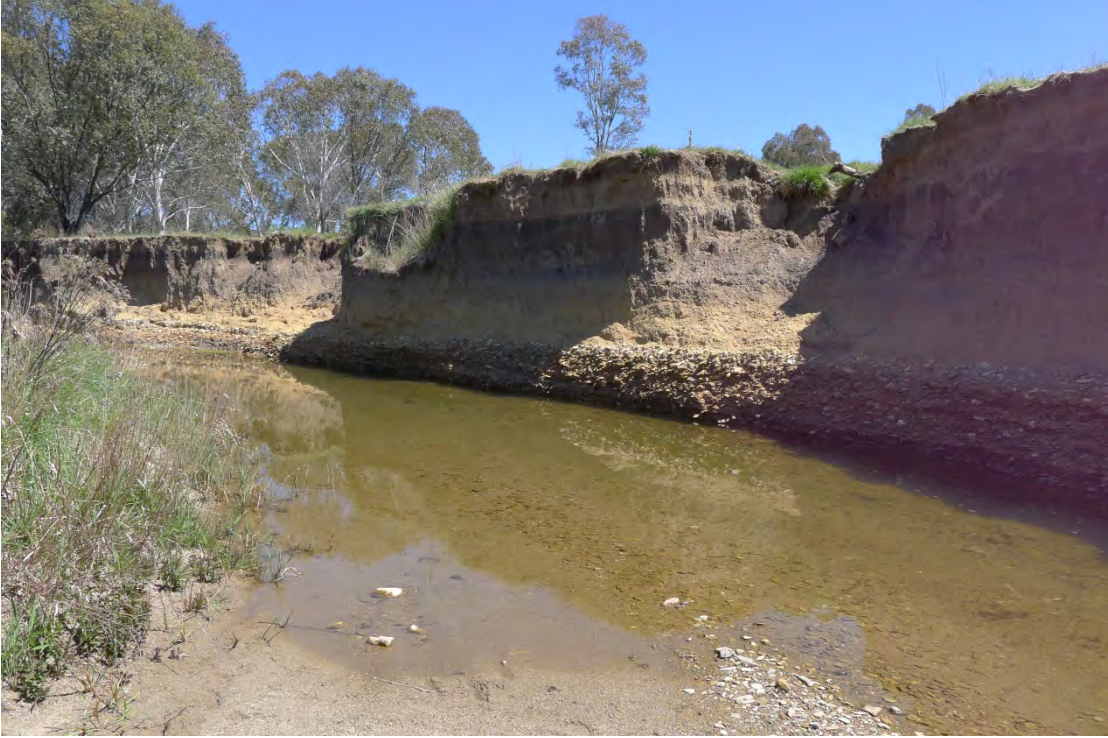
<p data-bbox="181 887 609 918">Photo 56 - BUR2C 30/10/2013</p>	<ul style="list-style-type: none"> <li>- slumping of embankment sections following Sept 2013 storm event</li> </ul>

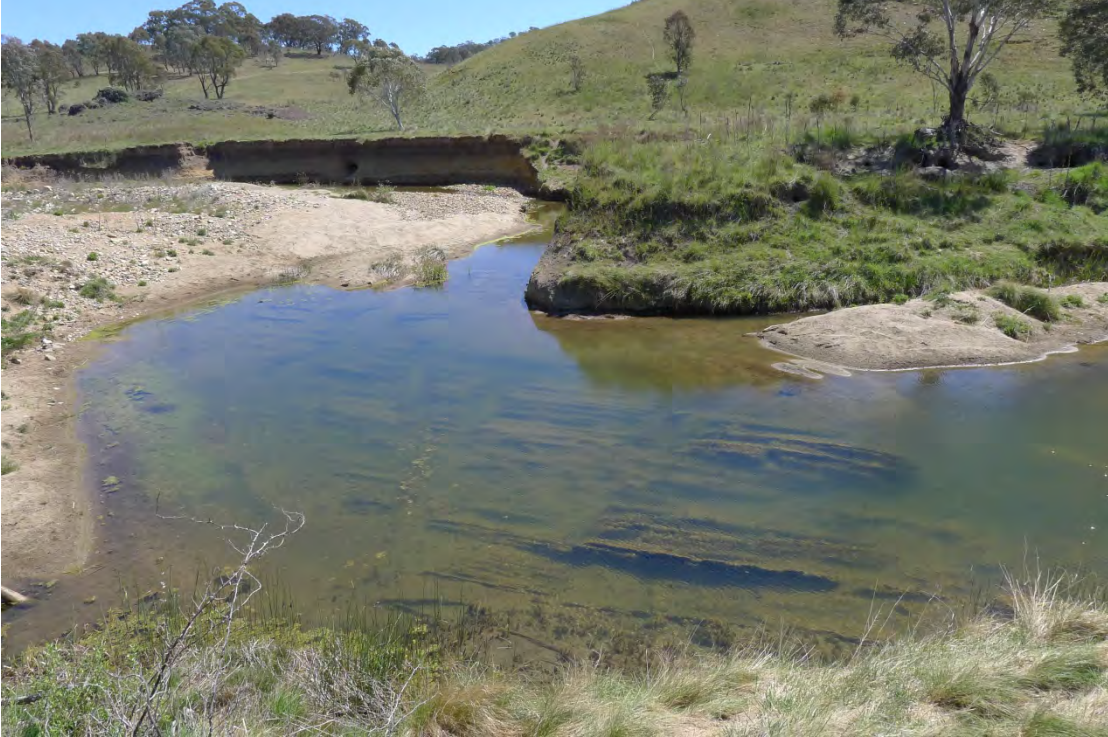
<p data-bbox="181 1686 609 1718">Photo 57 - BUR2C 30/10/2013</p>	<ul style="list-style-type: none"> <li>- Bank Scour from Sept event</li> <li>- Reforming of point bar from the event.</li> <li>- Mid and outer bend scoured to bedrock</li> </ul>

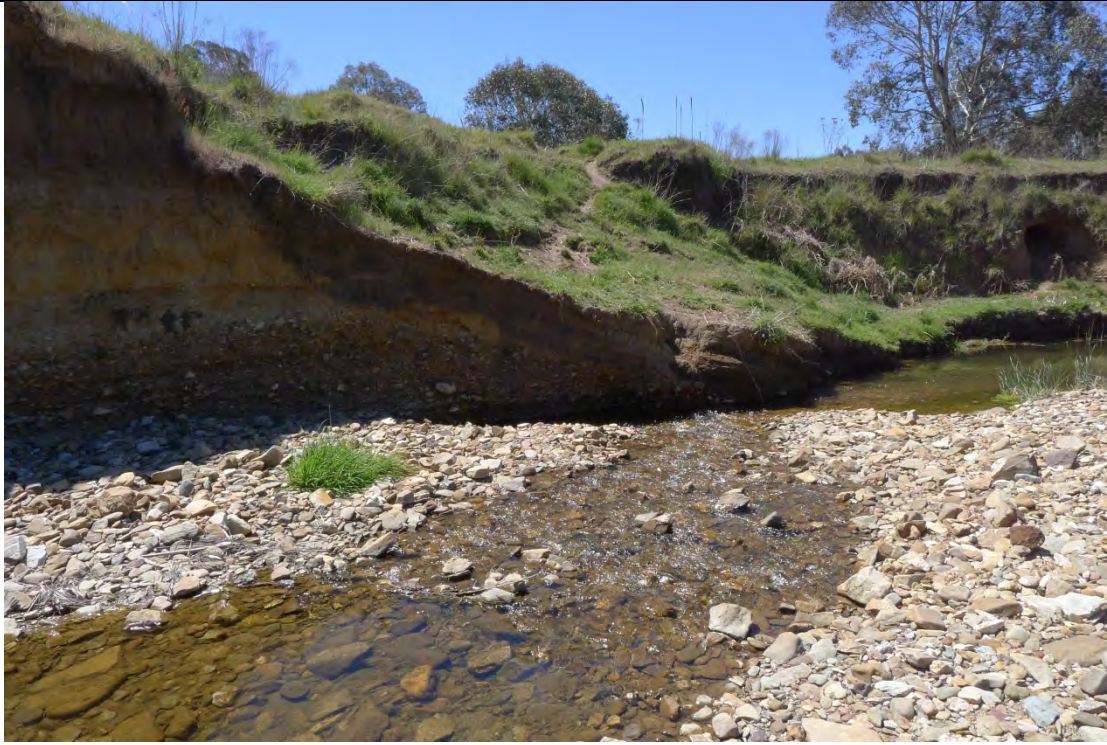
Photo 58 - BUR2C 30/10/2013

- Movable gravel bed control for Pool 5

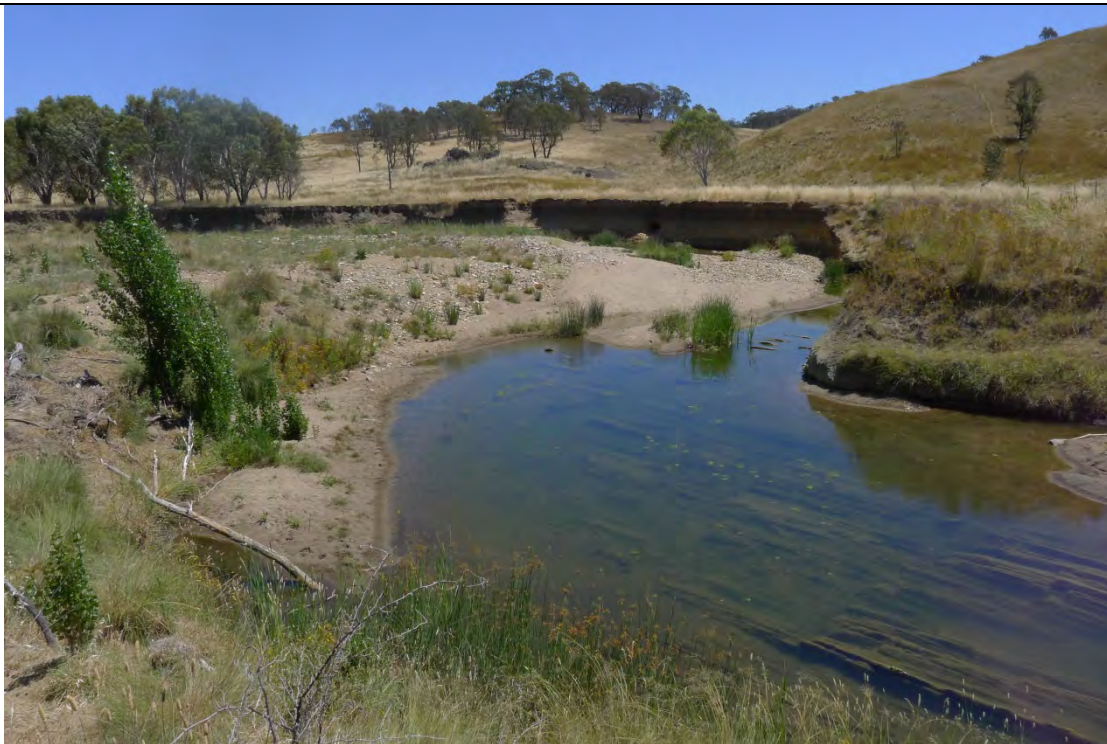
Photo 59 - BUR2C 13/1/2014

- Shallow pool over bedrock with no shading riparian vegetation allows for ready growth of filamentous algae

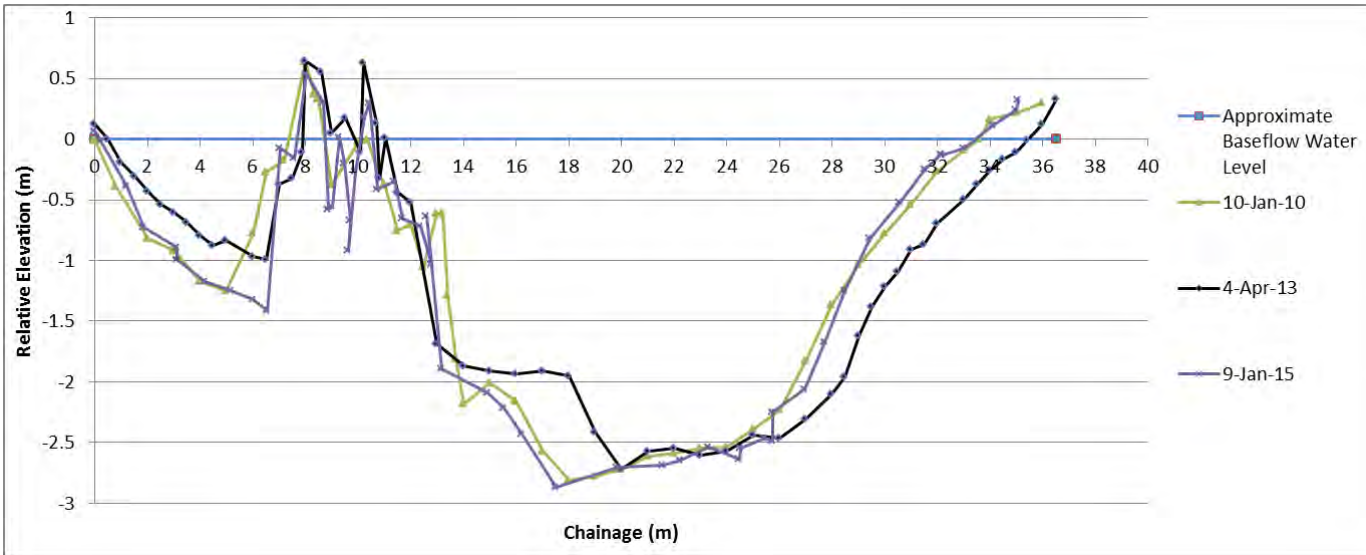
Figure 52 - Angle Crossing U/S 2010 - XS 1

- Differences due to taking a slightly different line through the rock outcrop
- 2015 section follows closely with line of 2010 survey, river bed in central channel is bedrock.

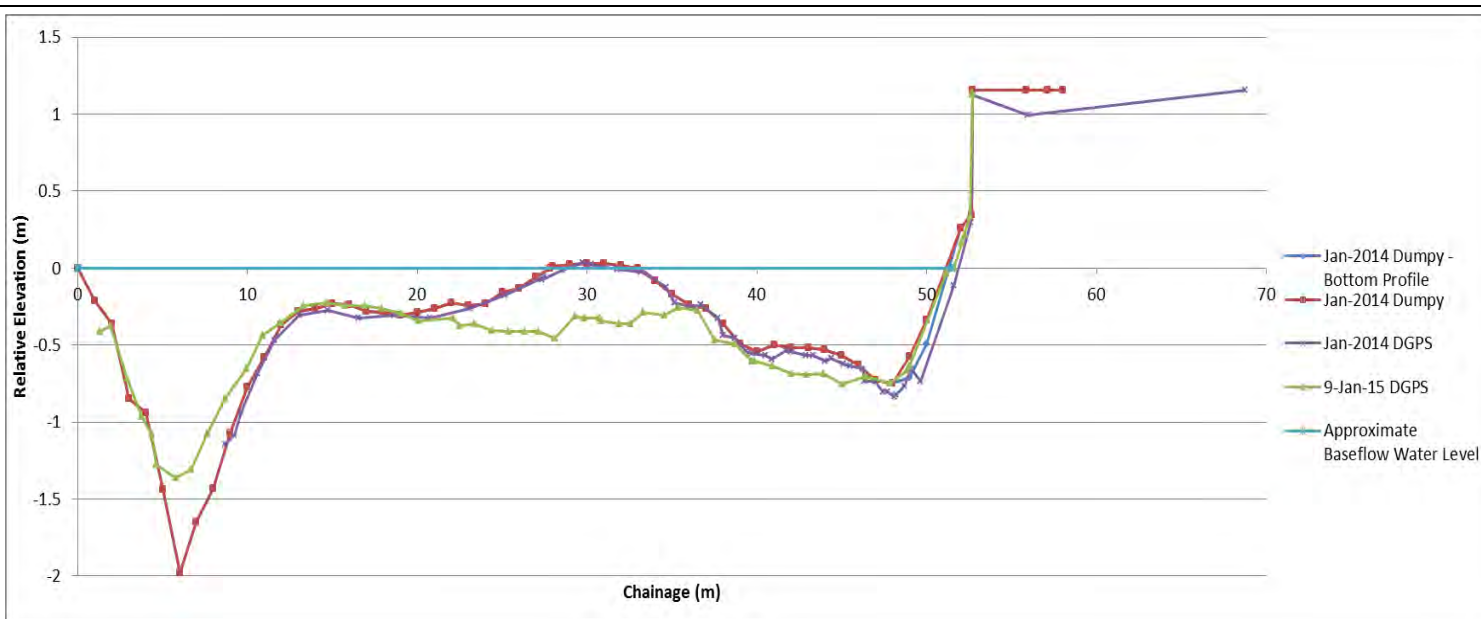
Figure 54 - Angle Crossing Cross Section at U/S Corner of Inlet Structure

- 2014 and 2015 cross sections do not quite match on slope of inlet grate due to differences in RTK adjustment and slight error induced by whether previous GPS survey on or beside concrete edge.
- All sections have been aligned to top corner of intake structure
- 2015 sections shows that the sand bar in the river has shifted, becoming flatter in the centre, and slightly deeper adjacent to the intake ~Ch.43m.
- Deep channel on left hand side has had ~0.6 m of sand deposited since 2014 survey.

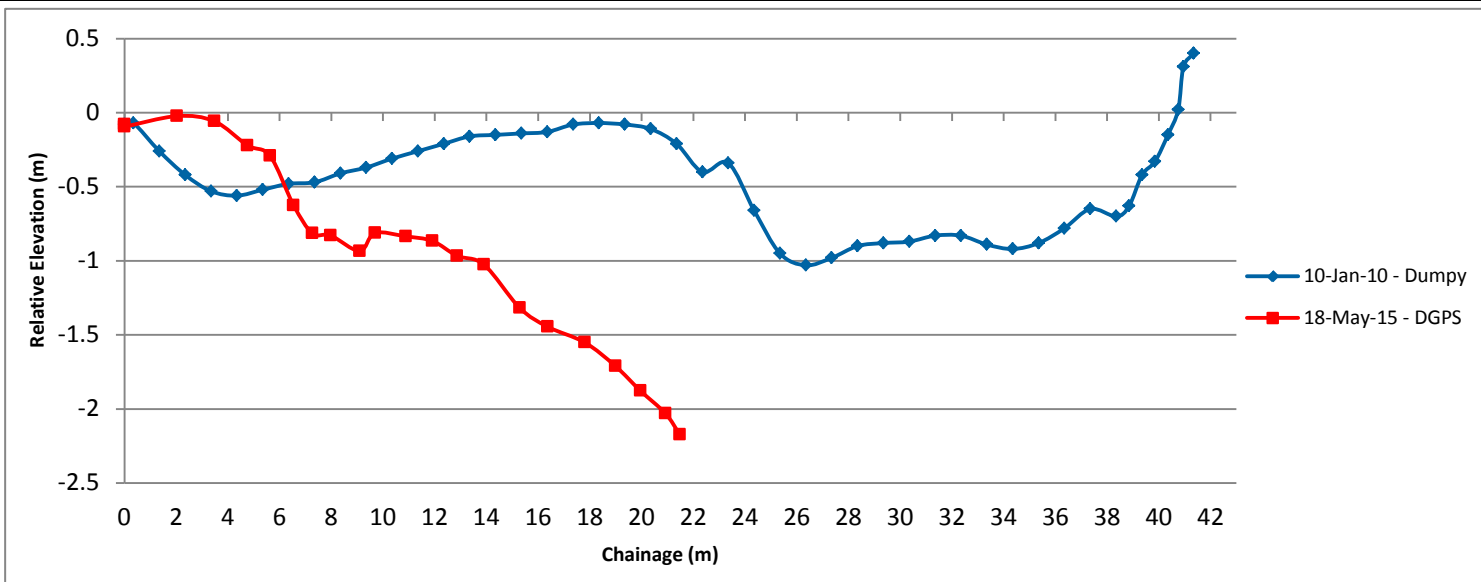
Figure 55 - Angle Crossing D/S - XS 3

- Cross sections were aligned to left hand side (looking downstream) GPS point. Original marker lost.
- Sections adjusted to level at left hand side end point to show relative change in elevation.
- Significant removal of sediment bar in main channel resulting in deep cross-section.
- 2015 cross-section was not completed due to depth and water velocity now present at section. Boat survey required to complete section.

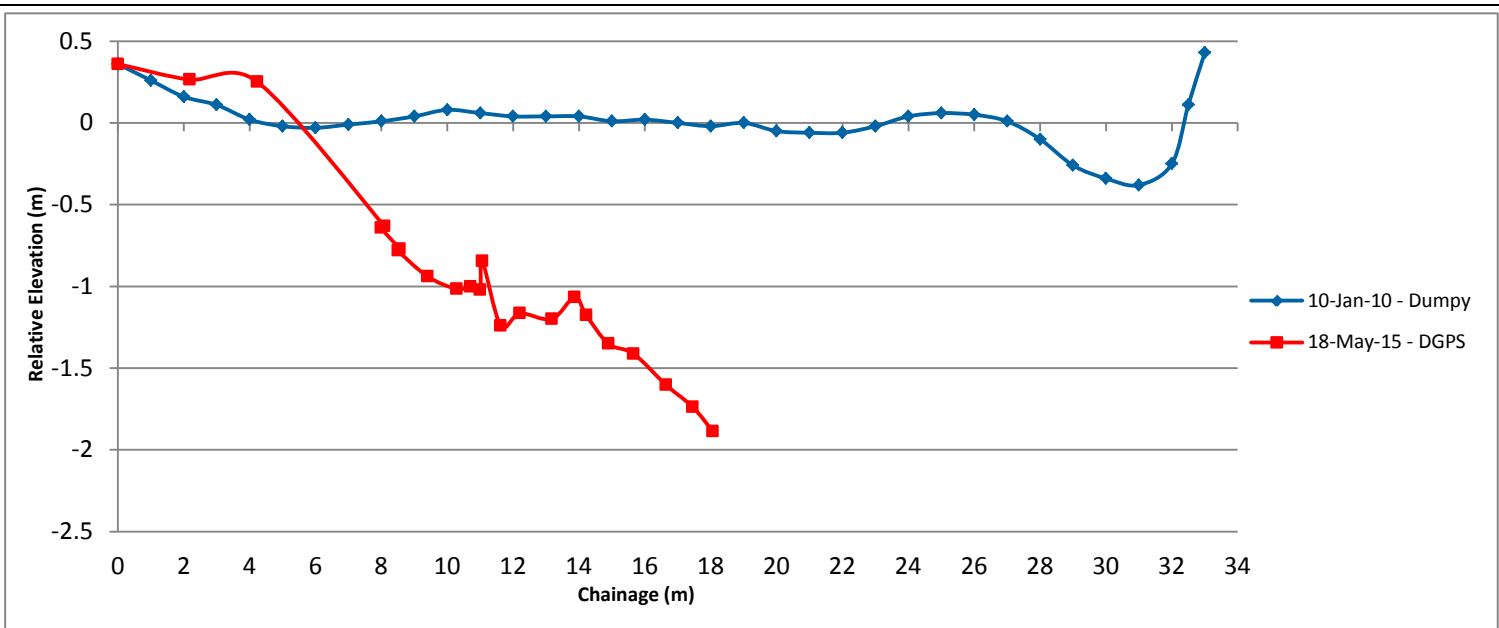
Figure 56 - Angle Crossing D/S - XS 4

- Cross sections were aligned to left hand side (looking downstream) GPS point.
- Sections adjusted to level at left hand side end point to show relative change in elevation.
- Significant removal of sediment bar in channel resulting in deep cross-section.
- 2015 cross-section was not completed due to depth and water velocity now present at section. Boat survey required to complete section.

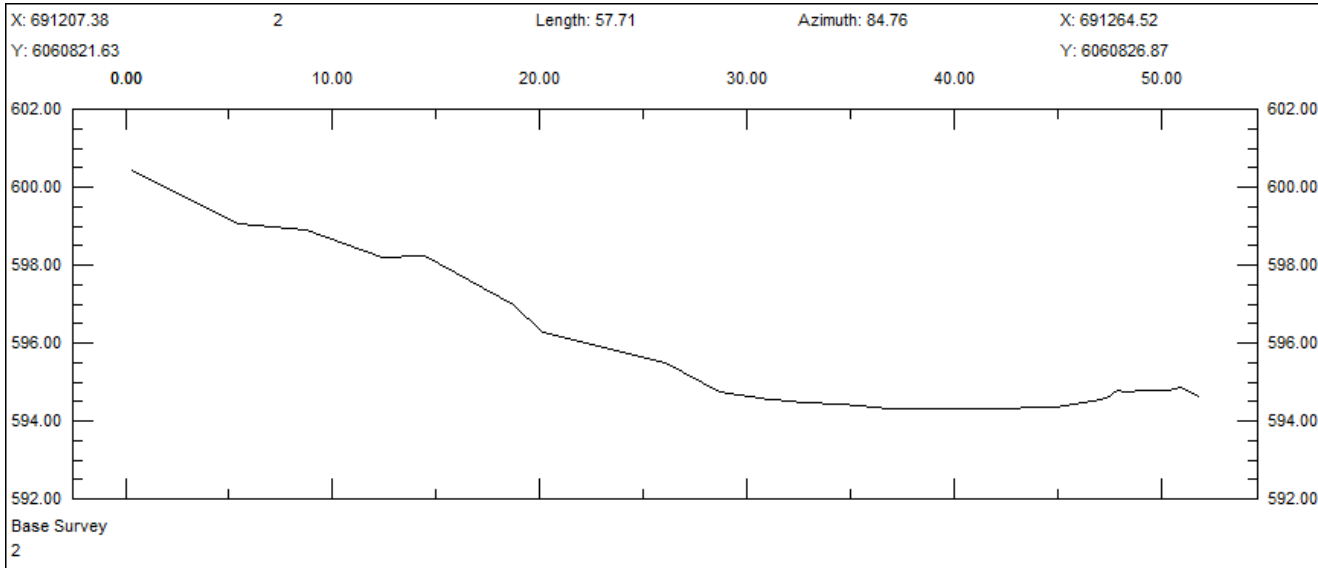
Figure 58 - Angle Crossing D/S 3D GPS XS-2, Jan 2013

- DGPS cross section ends in-stream due to water level and vegetation not allowing access to opposite bank at time of survey
