DRAFT M2G Planting (Tree & Shrub) Monitoring Report

Construction Corridor (Spring 2015)

Prepared for
Icon Water

2 December 2015

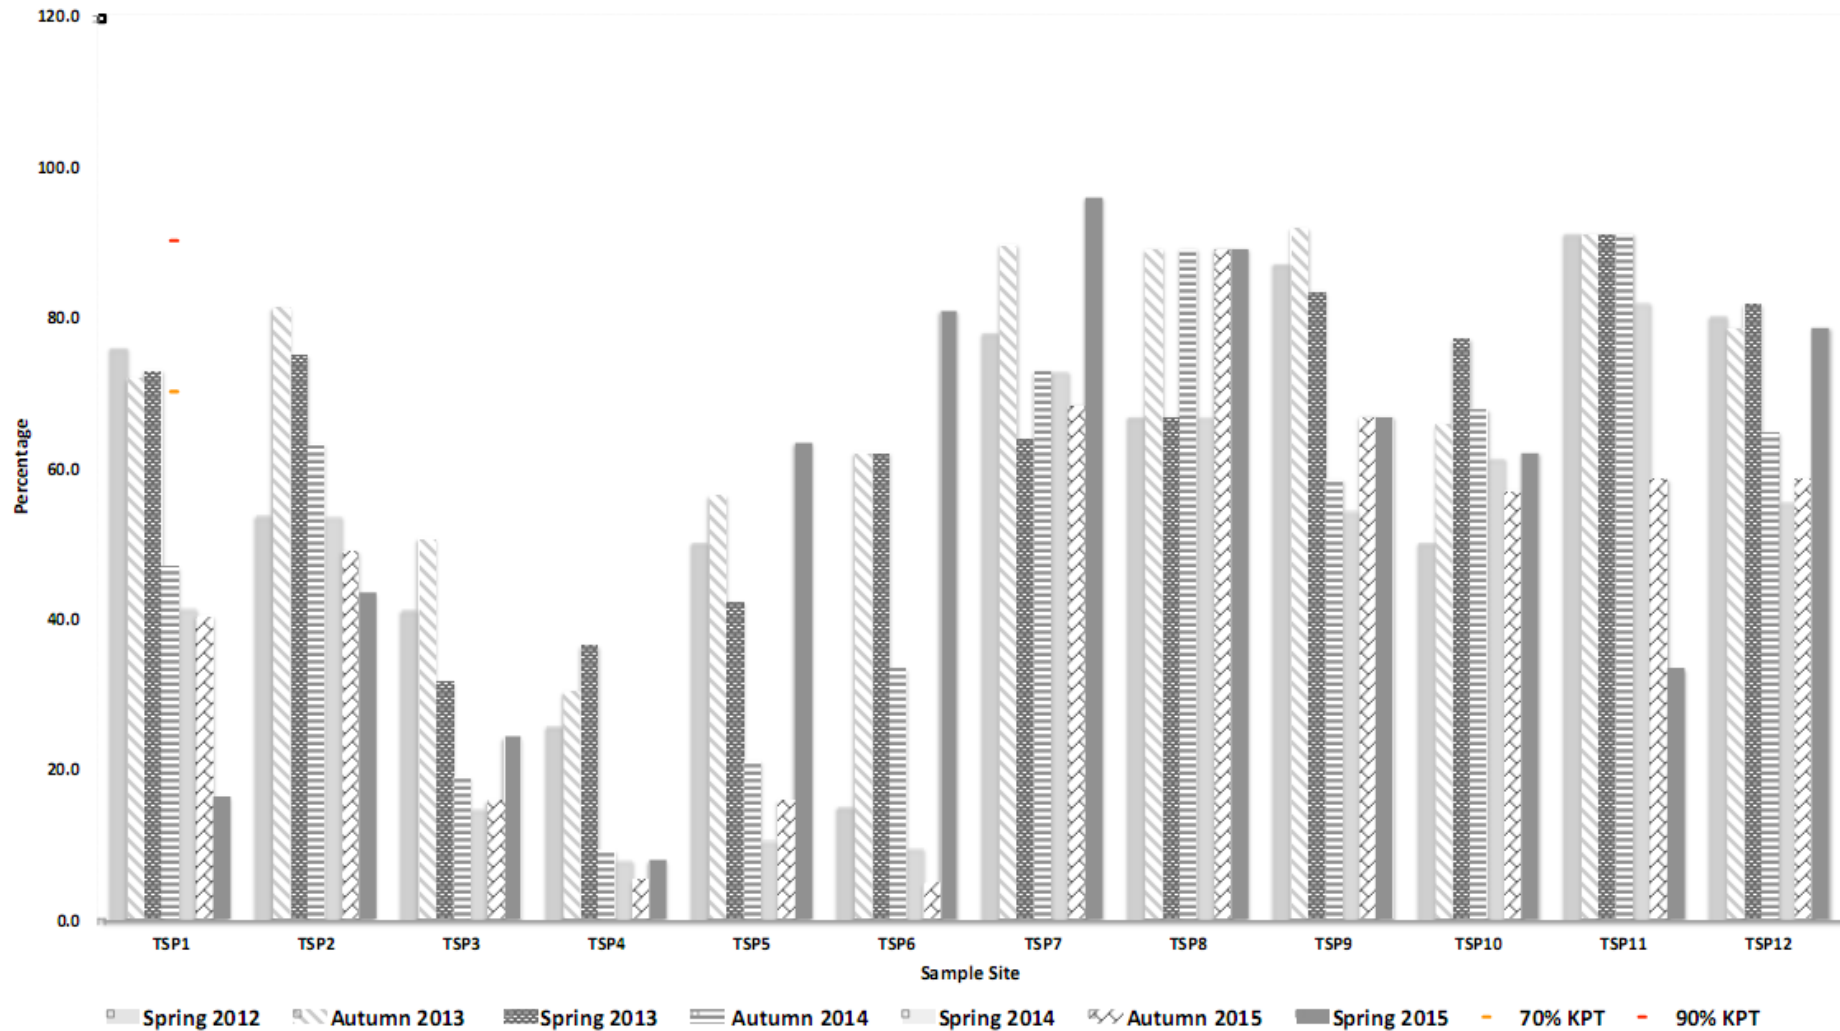
Chart 1: Proportion of plantings in good health at each site during all monitoring periods. ACT sites = TSP 1-6 and NSW sites = TSP 7-12.

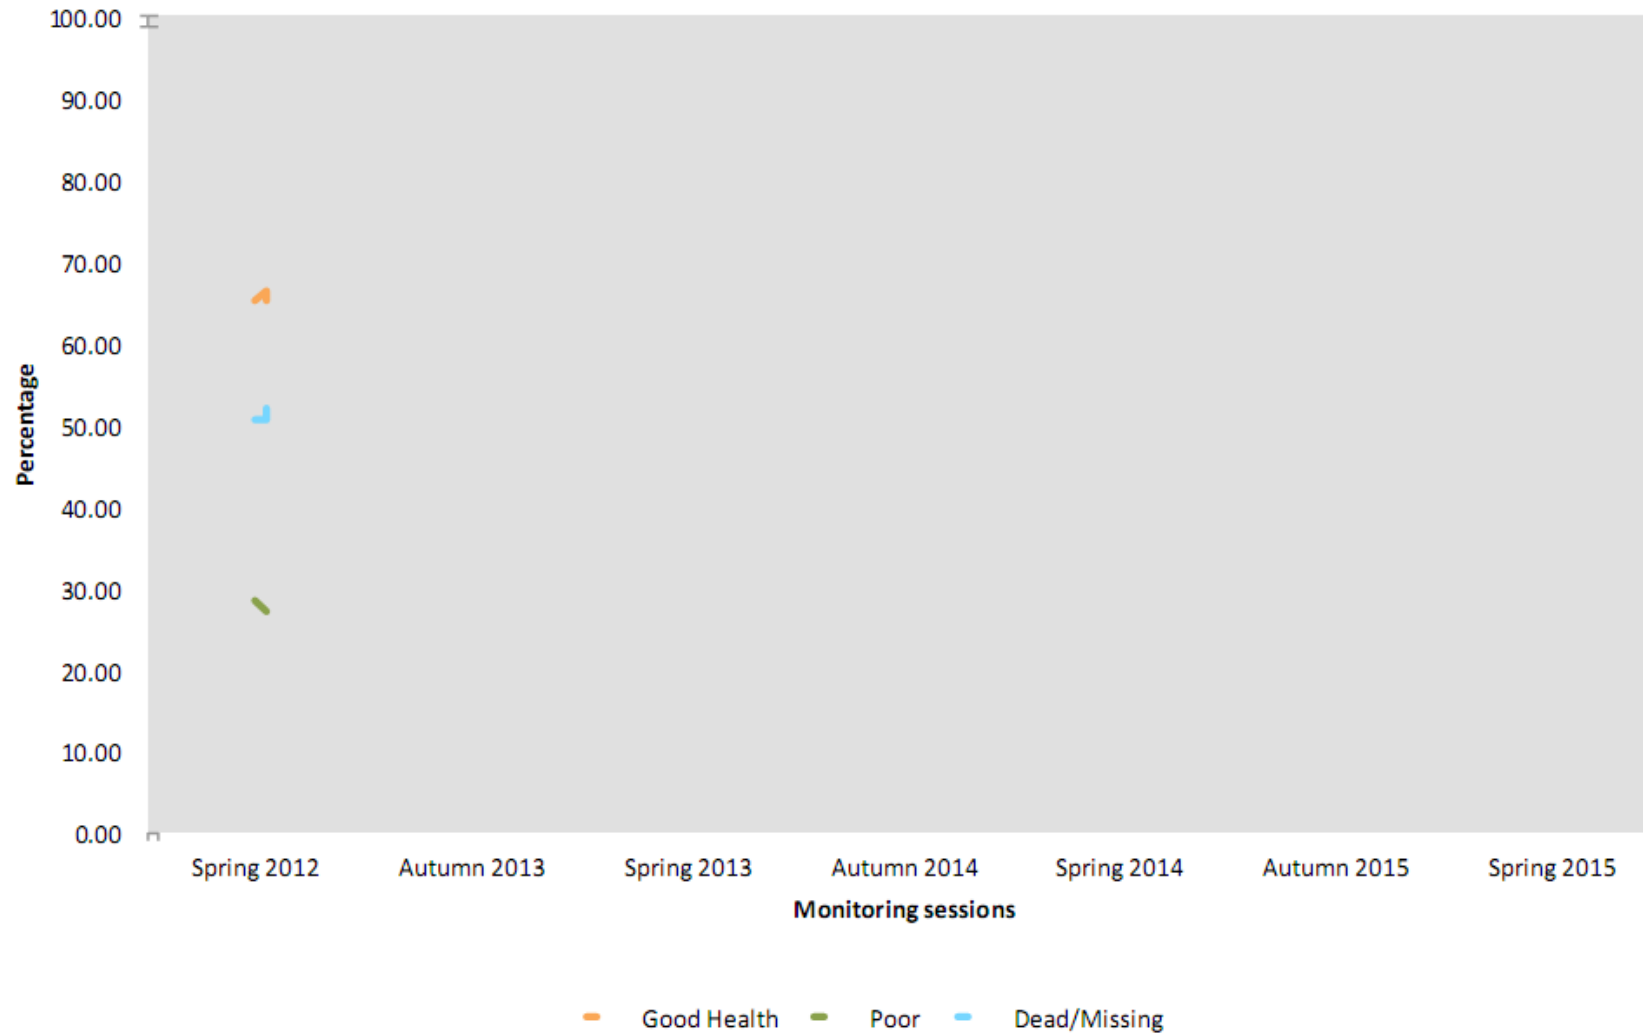
Overall **344 (46.6%)** specimens were in good health, **105 (14.2%)** in poor health and **289 (39.2%)** either dead or missing (**Table 3**). The proportion of specimens in good health increased by **5.9%** compared to the previous autumn 2015 results and those either dead or missing declined by **12.7%** over the same period.

Chart 2: Total planting health across all monitoring periods.
