**ACTEWAGL DISTRIBUTION**  
**MURRUMBIDGEE ECOLOGICAL MONITORING**  
**PROGRAM**  
**FIELD OBSERVATION REPORT: AUTUMN 2012**

**Client:** ActewAGL Distribution  
**Project Title:** Murrumbidgee Ecological Monitoring Program  
**Report Title:** **Field observation report: autumn 2012**  
**Document No:** 211063-12-R9  
**Document Status:** **Draft for client review**  
**Date of Issue:** **17/05/2012**

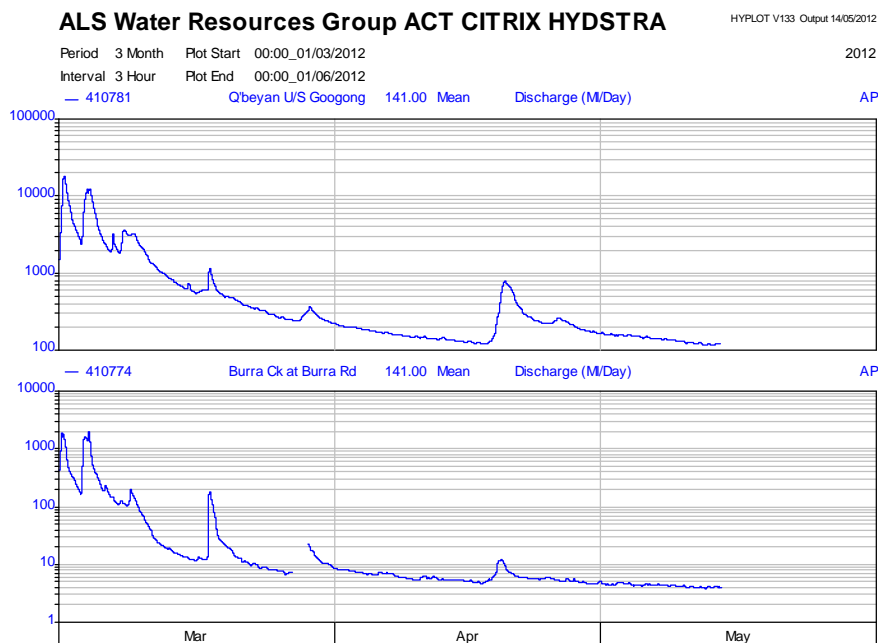
**Figure 1.** Queanbeyan River (top) and Burra Creek hydrograph for March and April and including the sampling period in early May 2012

Sites BUR 3 and QBYN 2 remain inundated by water backing up from Googong reservoir (Plate 1) and consequently BUR 2c was sampled as a replacement for BUR 3; however, there are no appropriate alternatives for QBYN 2. Flows in the Queanbeyan River were still dropping after a small event in mid-April and flows in Burra Creek were stable (Figure 1).

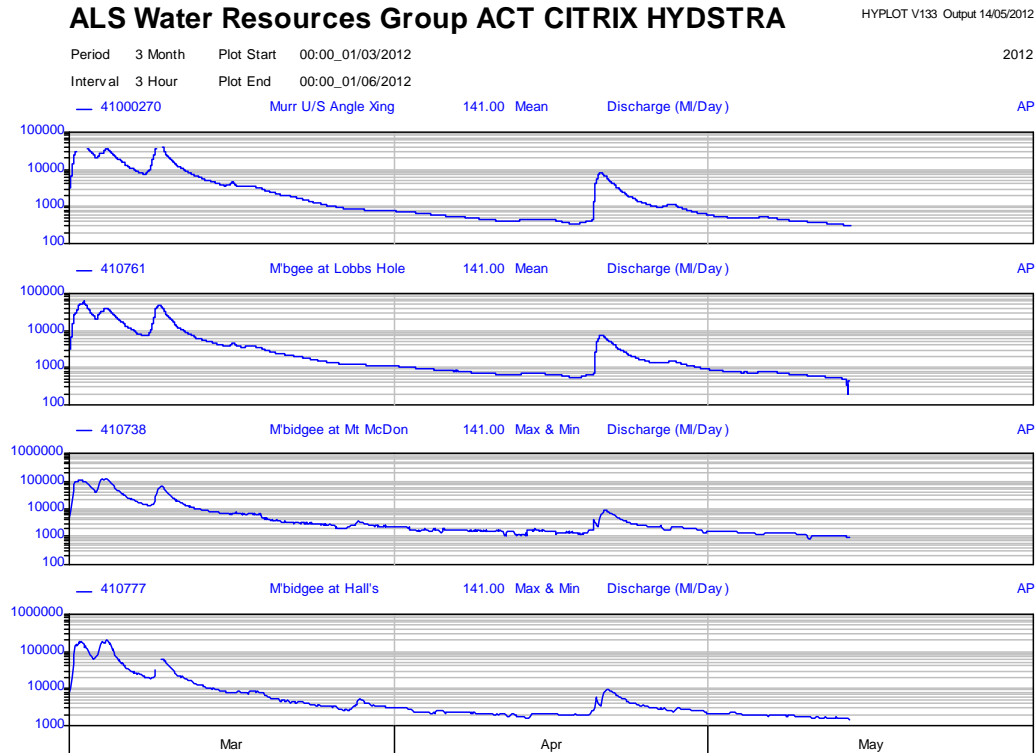
**Figure 2.** Hydrograph for March, April and including the sampling period in early May 2012 for the key sites on the Murrumbidgee River

Flows in the Murrumbidgee were up to four times the volume compared to the same period last year (Figure 2). March, according to the Bureau of Meteorology ([www.bom.gov.au](http://www.bom.gov.au)), was the third wettest on record and subsequently most of the upper catchment was saturated during this period of high rainfall, resulting in higher base flows throughout the autumn.
