ACTEW Water
Murrumbidgee Ecological Monitoring Program
Burra Creek geomorphology and vegetation assessment

March 2014

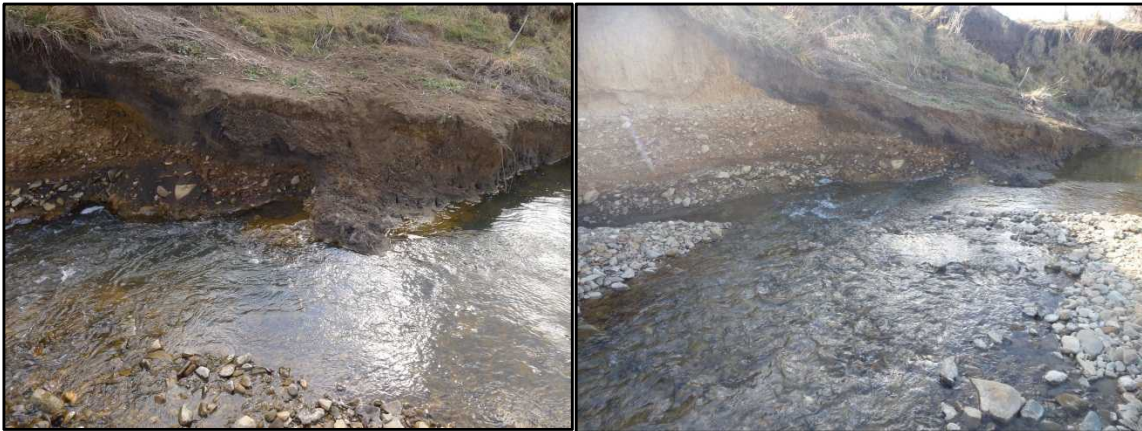
Photo 1 - High erosion potential area downstream of Pool 5 during July (left) and August (right) 2012

The bank area which was assessed as having the highest potential for substantial erosion was a section of steep bank just downstream of Pool 5, immediately upstream of the BUR2C

macroinvertebrate sampling site. This bank area has been made vulnerable by the high flow events which have scoured the bank and undercut sections over time. Photos of the bank in 2012 are shown in Photo 1 and Photo 2, indicating erosion potential along the bottom of the bank which will increase the undercutting of the bank, resulting in bank collapse into the creek.

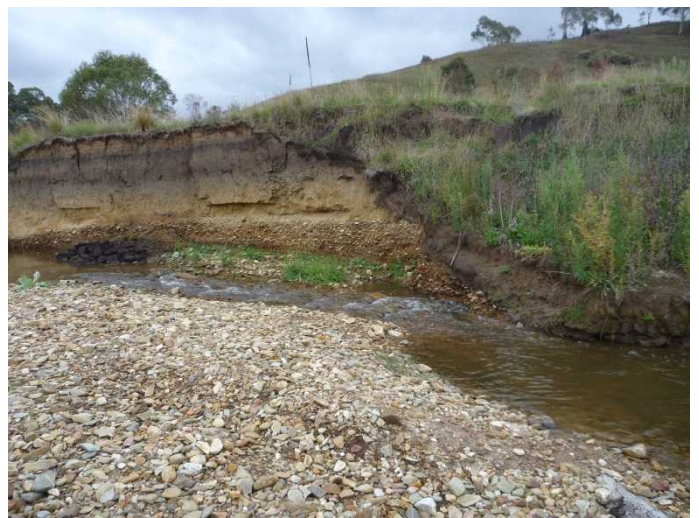
Bend U/S BUR2C Riffle

There was no visually detectable change at sites except for the embankment at bend U/S BUR2C riffle where erosion had occurred.

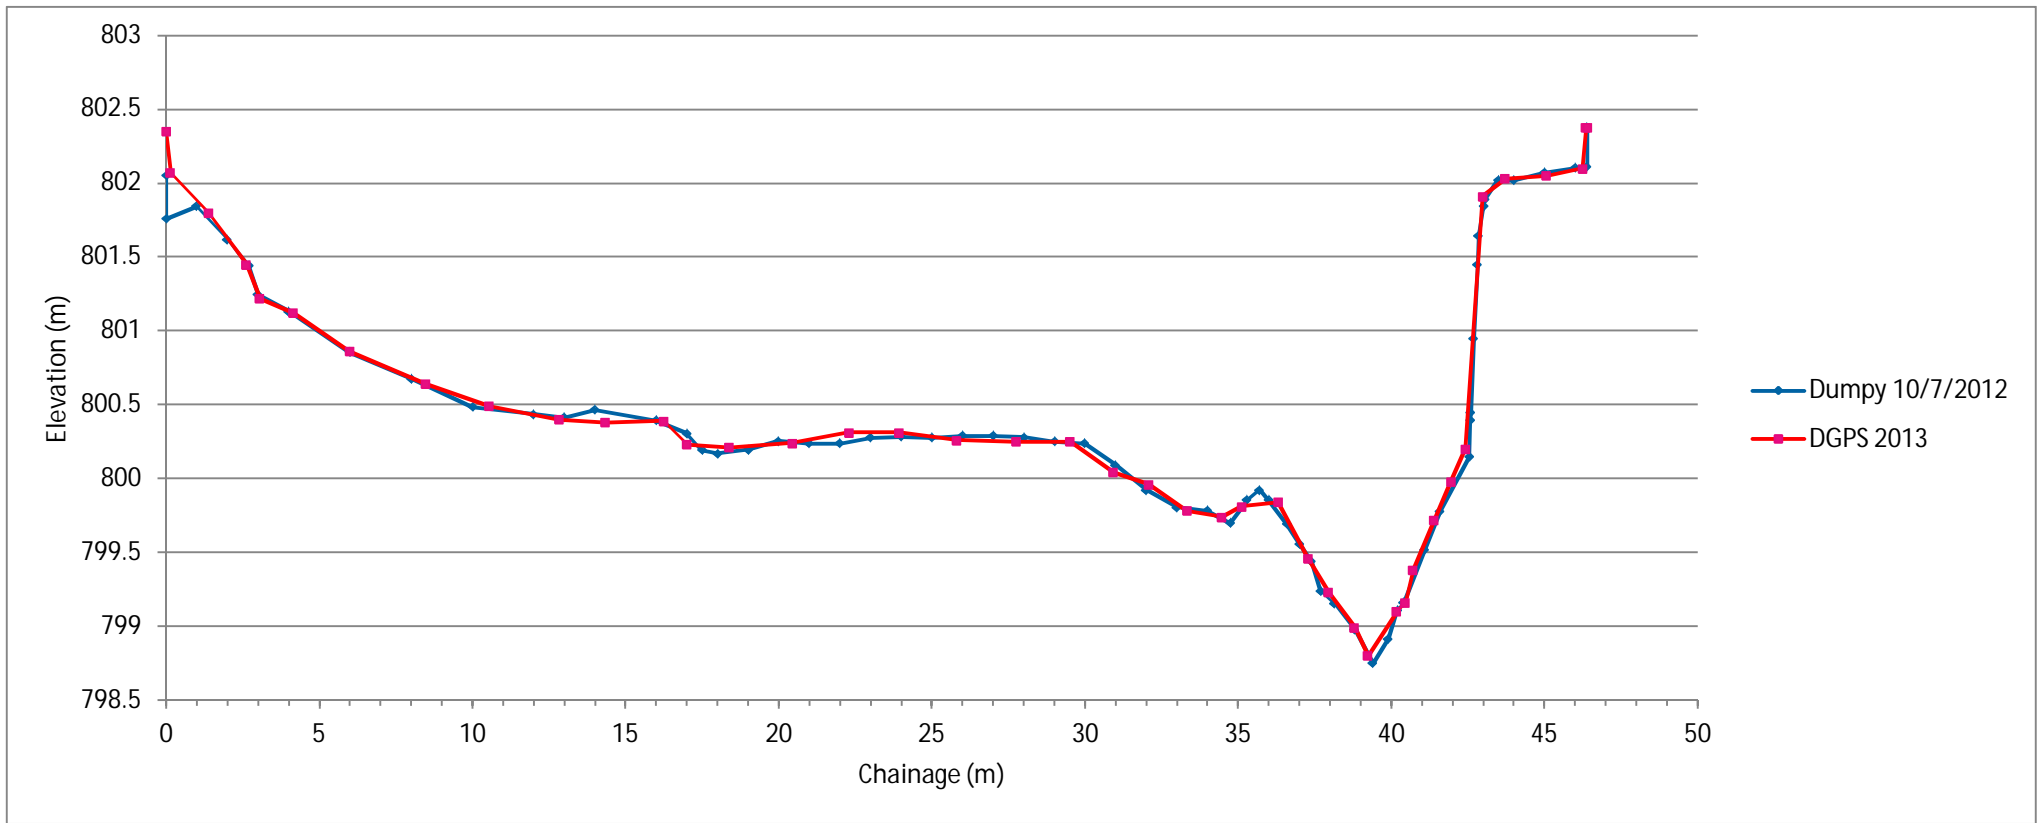
Figure 12 - BUR1 XS-1

- The cross section taken using a DGPS unit (Red) closely matches the cross section recorded by dumpy (Blue)

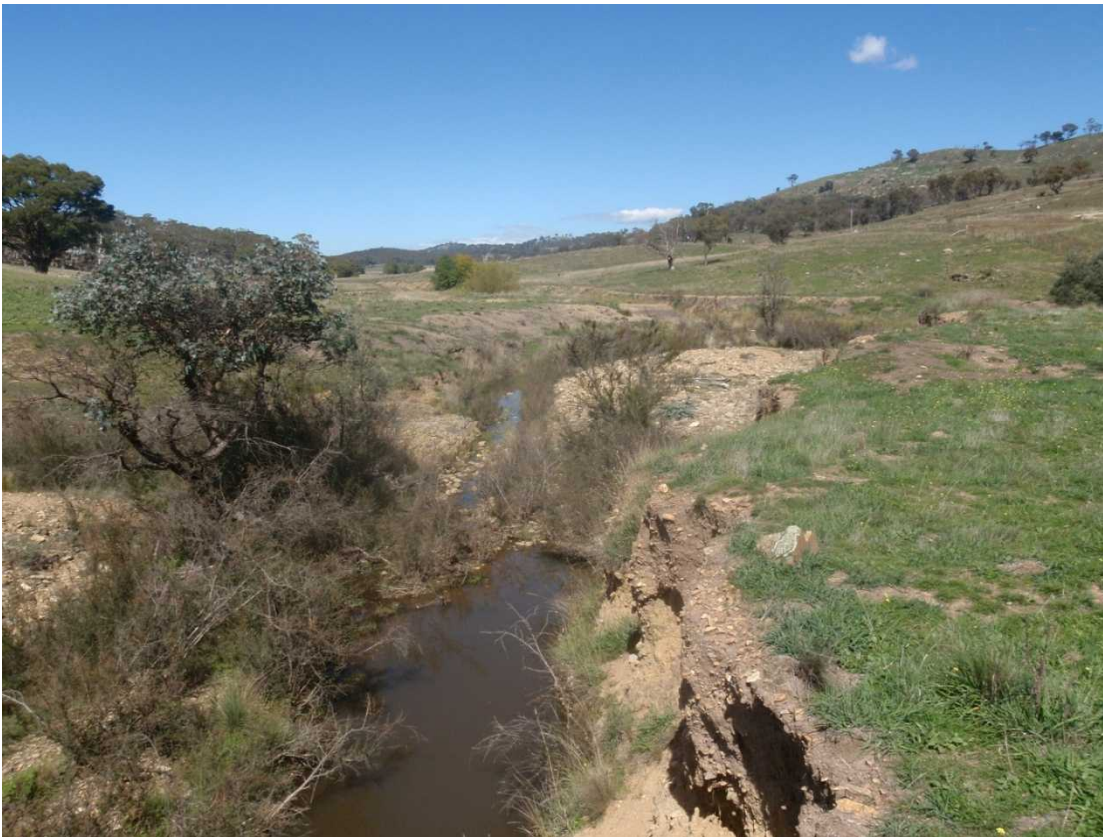
Photo 4 - BUR1 17/3/2010

- Water flow present in centre channel.

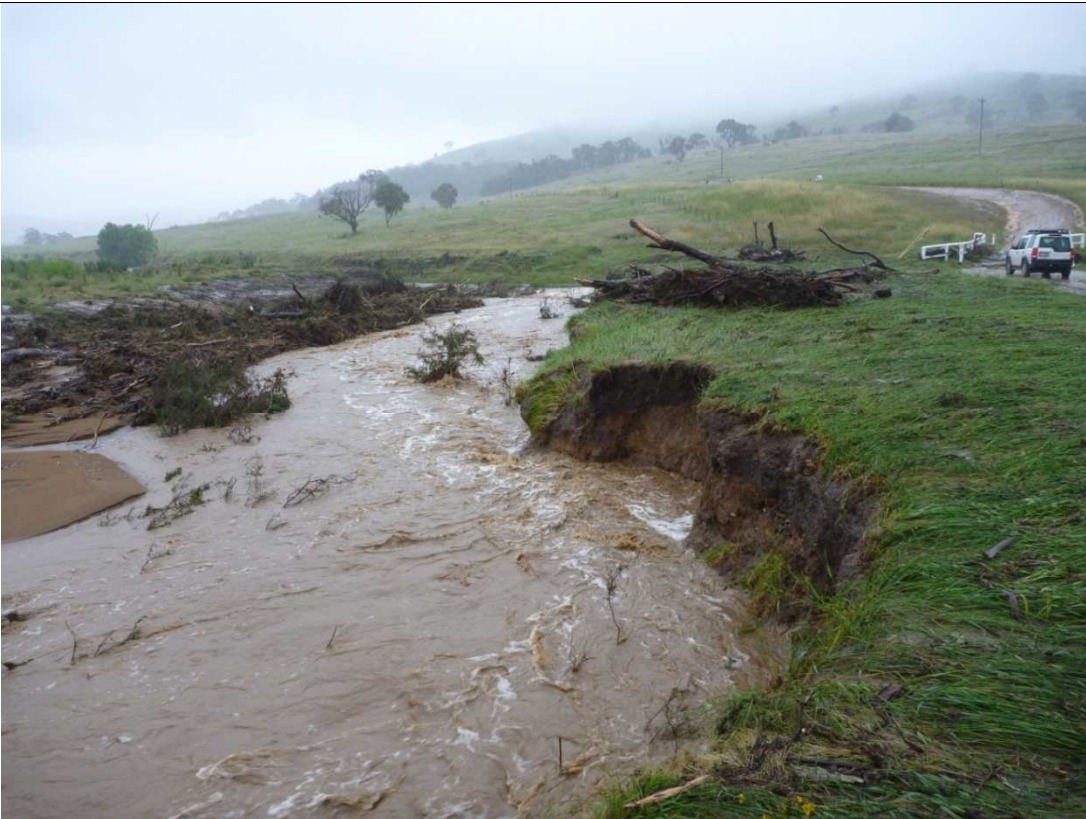
Photo 8 - BUR1 9/12/2010

- Tail end of severe flood event. Peak of event went over the RHS bank.
- Scouring of banks and channel
- Vegetation removal
- Highly turbid water indicates significant sediment transport.
- Heavy debris load deposited by flood waters including tree on RHS bank.

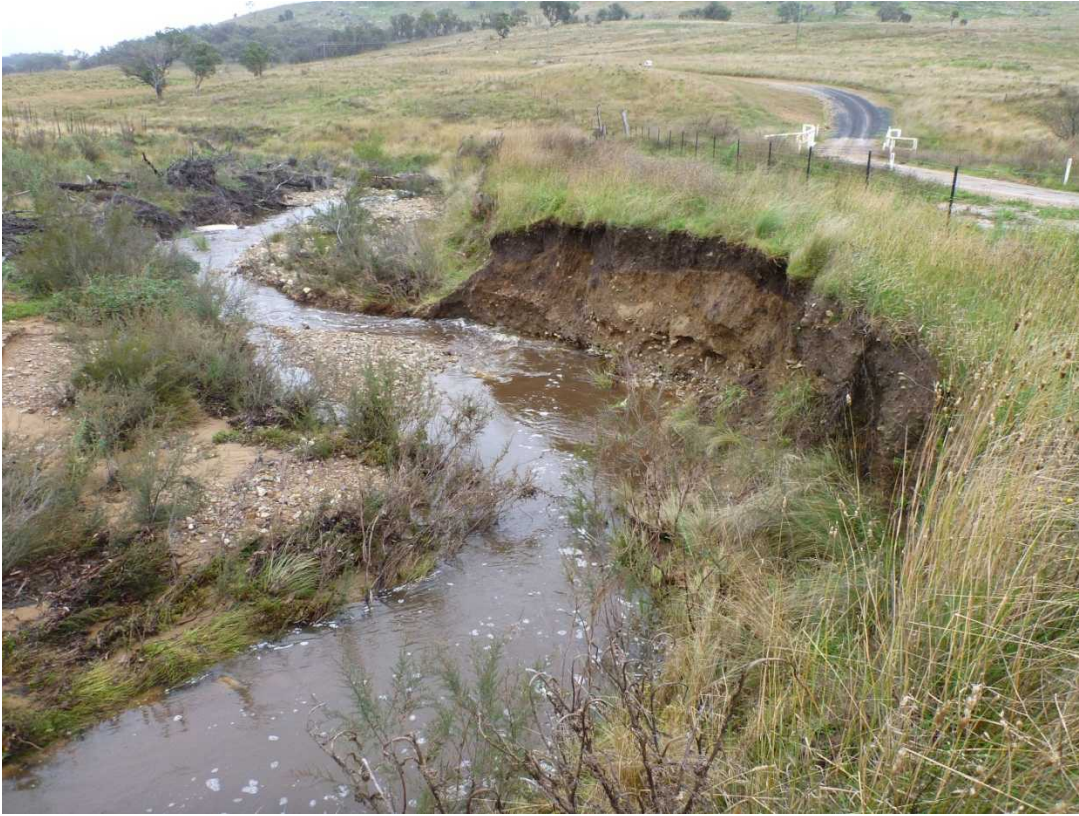
Photo 17 - BUR1 8/3/2012

- Evidence of additional bank erosion on outside of bend
- Bankside grass vegetation on LHS flattened by previous flow.

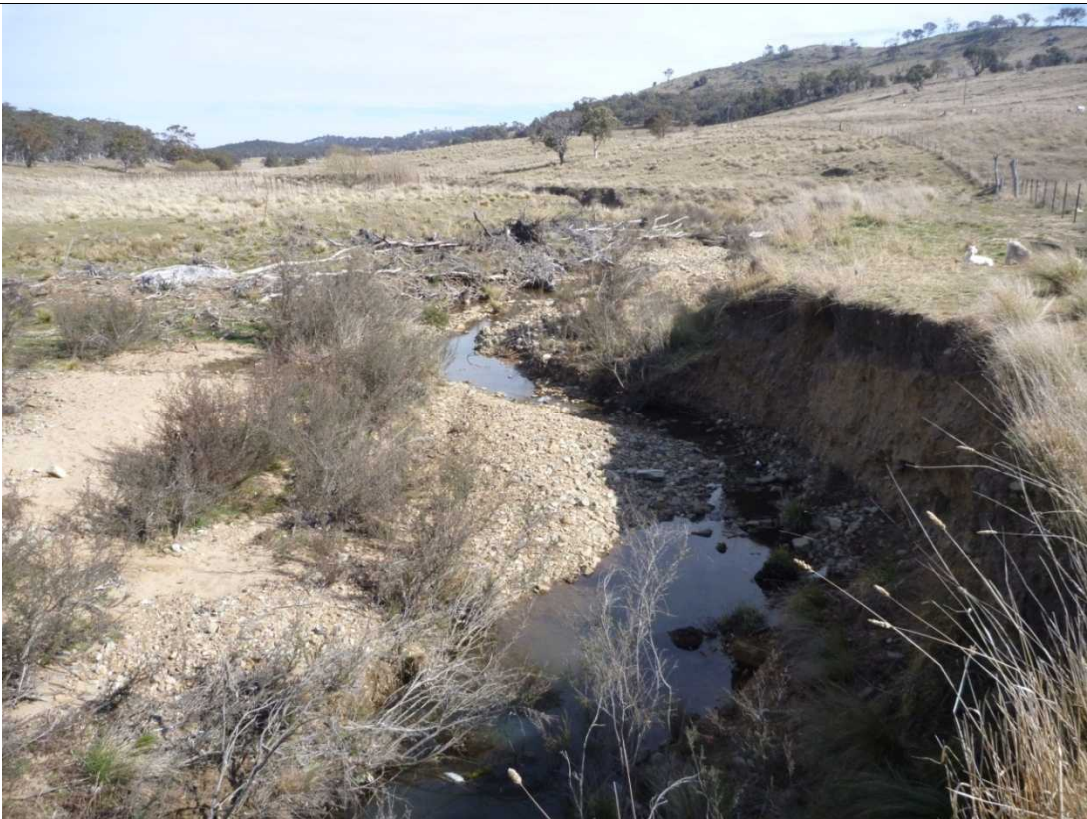
Photo 21 - BUR1 3/8/2012

- End of winter photo

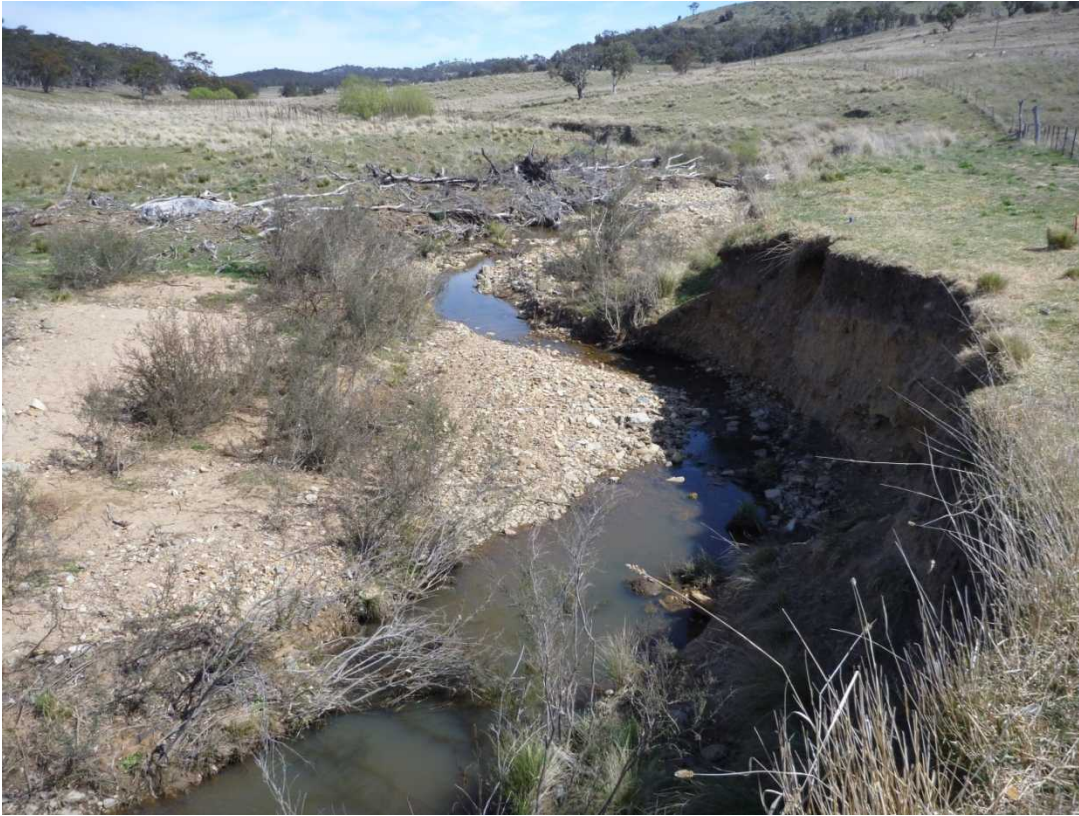
Photo 22 - BUR1 10/9/2012

- Vegetation just commencing spring growth
- baseflow maintained through winter

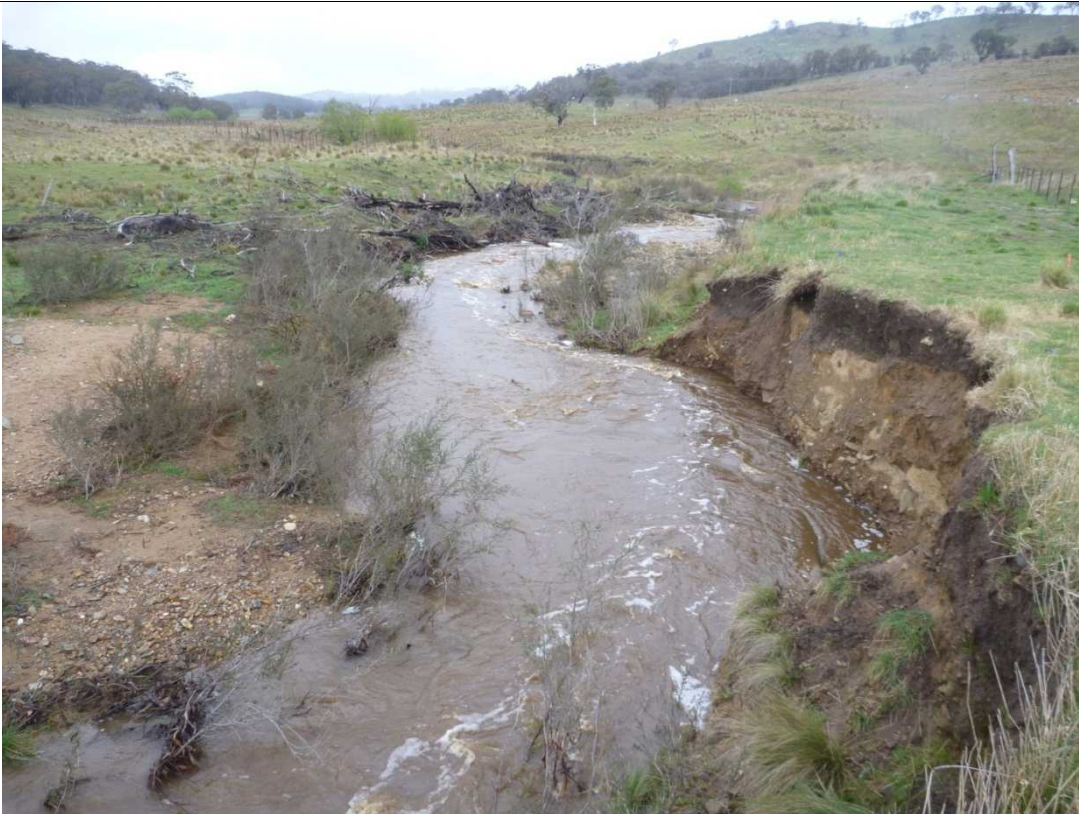
Photo 24 - BUR1 12/10/2012

- Medium flow event
- Spring vegetation growth apparent

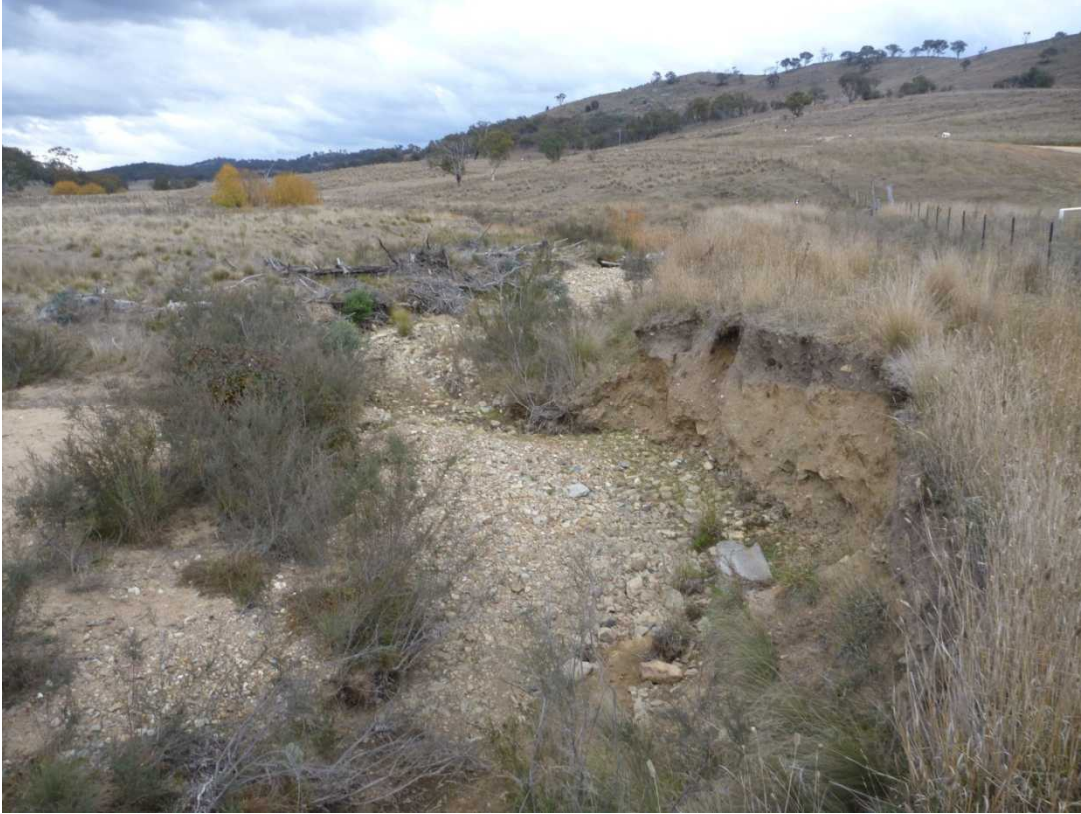
Photo 27 – BUR1 29/4/2013

- Lack of autumn rainfall means creek still not flowing
- Vegetation encroachment into central channel

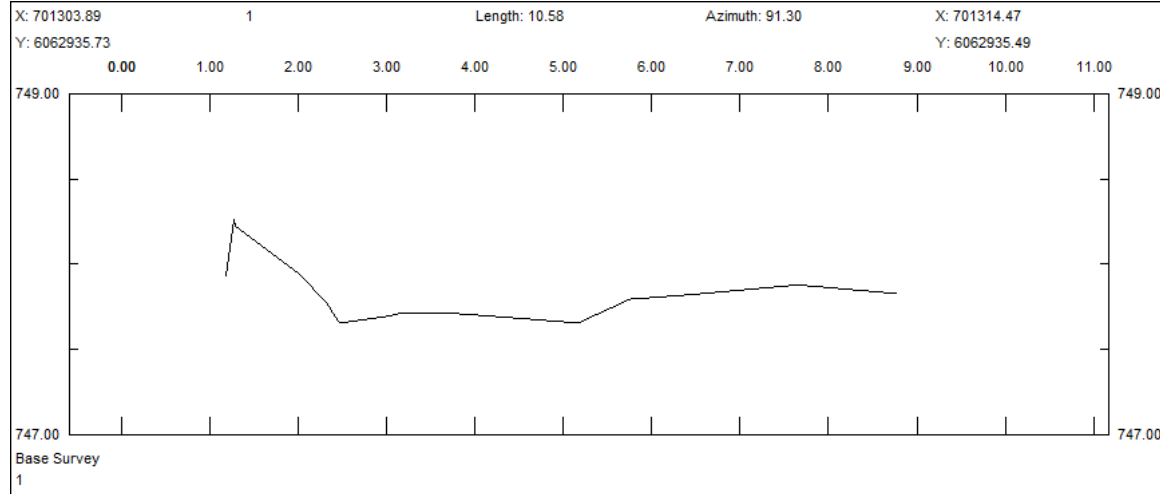
Figure 16 - BUR1C 3D GPS XS-1

DGPS Survey equipment experiencing signal difficulties at this site, resulting in DGPS cross-sections not matching dumpy sections.

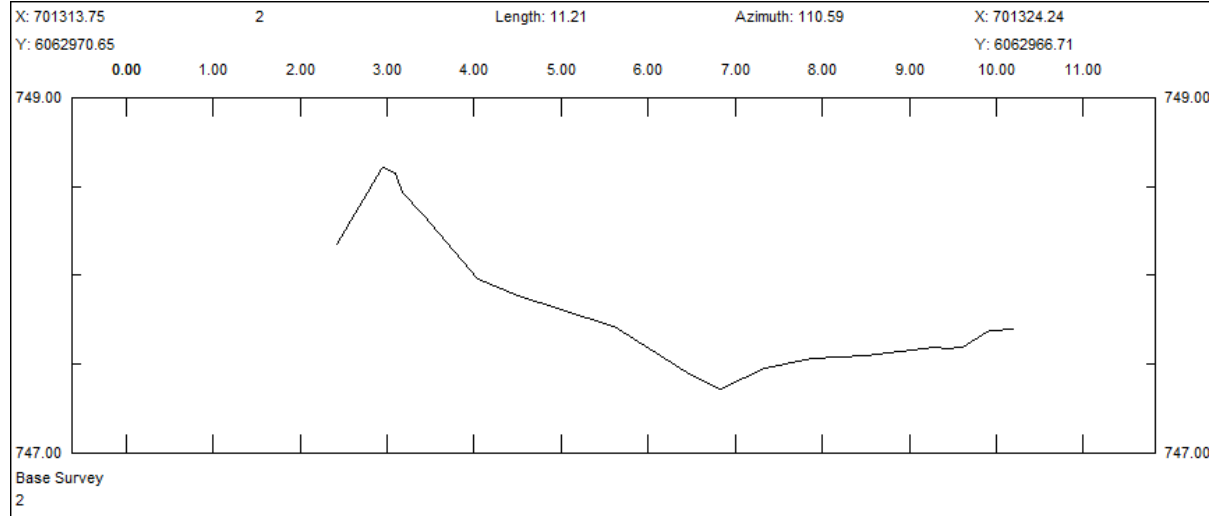
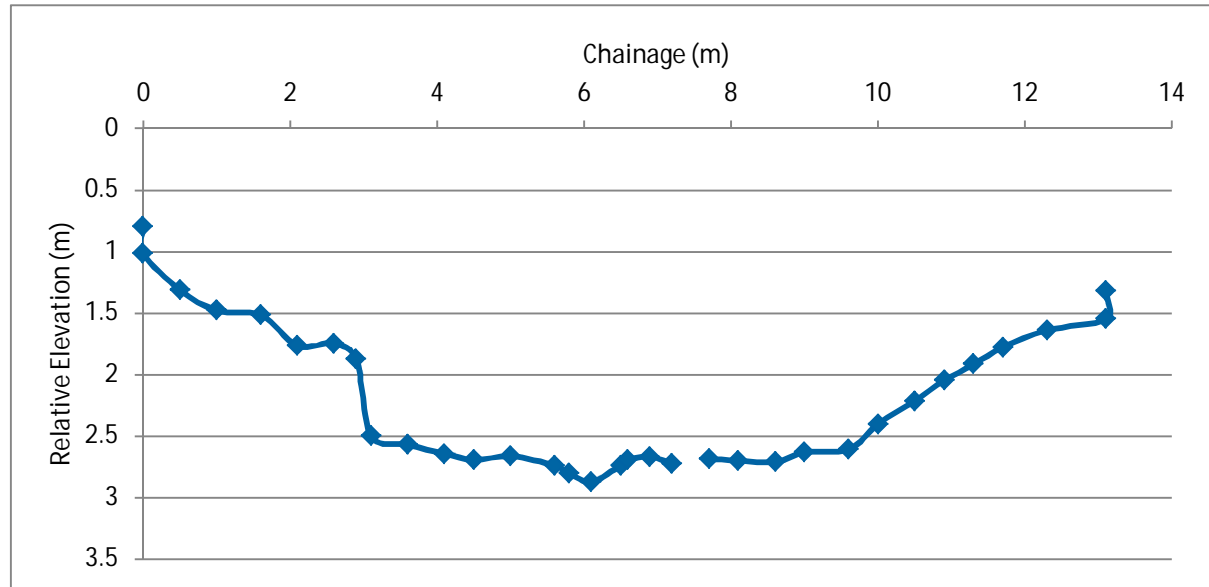
Figure 19 - BUR1C 3D GPS XS-2

- Requires post commission survey for accurate comparison, no change noted during commissioning flow site inspections
- Resurvey of actual cross section with DGPS required to complete/append to DGPS model

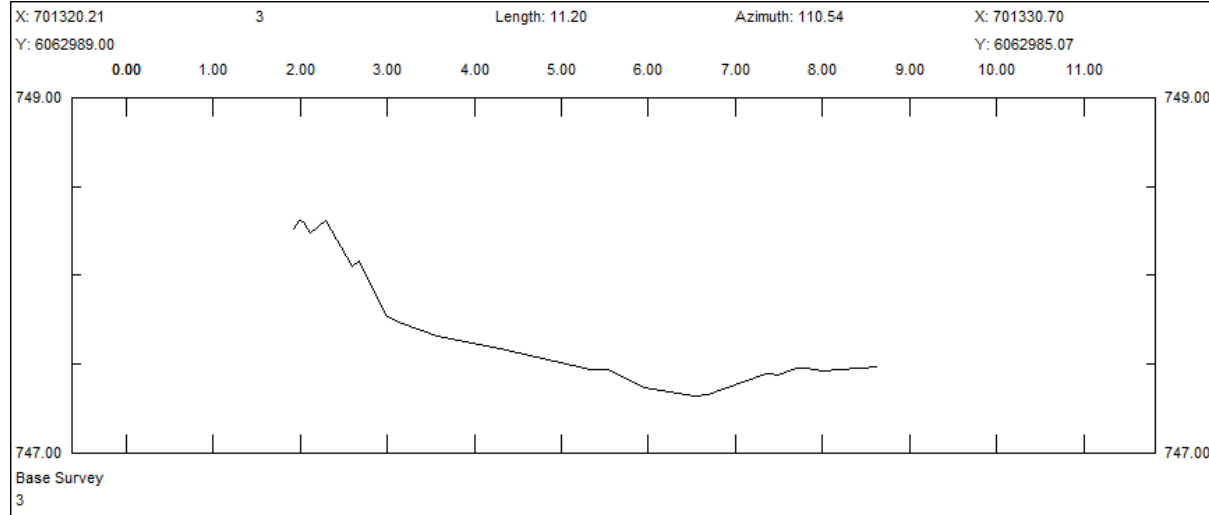
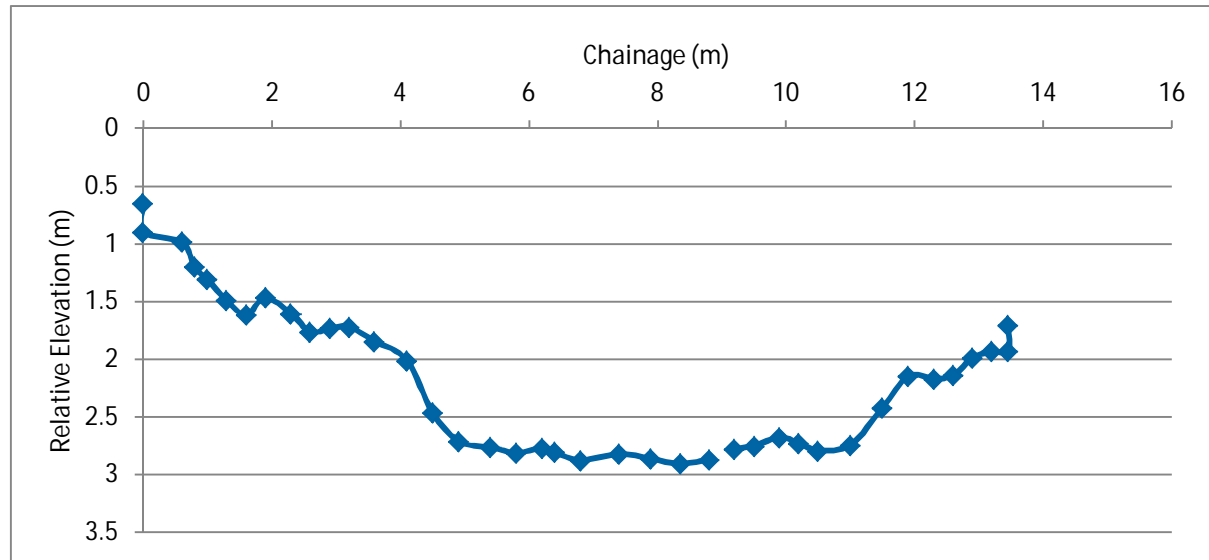
Figure 21 - BUR1C 3D GPS XS-3

- Requires post commission survey for accurate comparison, no change noted during commissioning flow site inspections
- Resurvey of actual cross section with DGPS required to complete/append to DGPS model

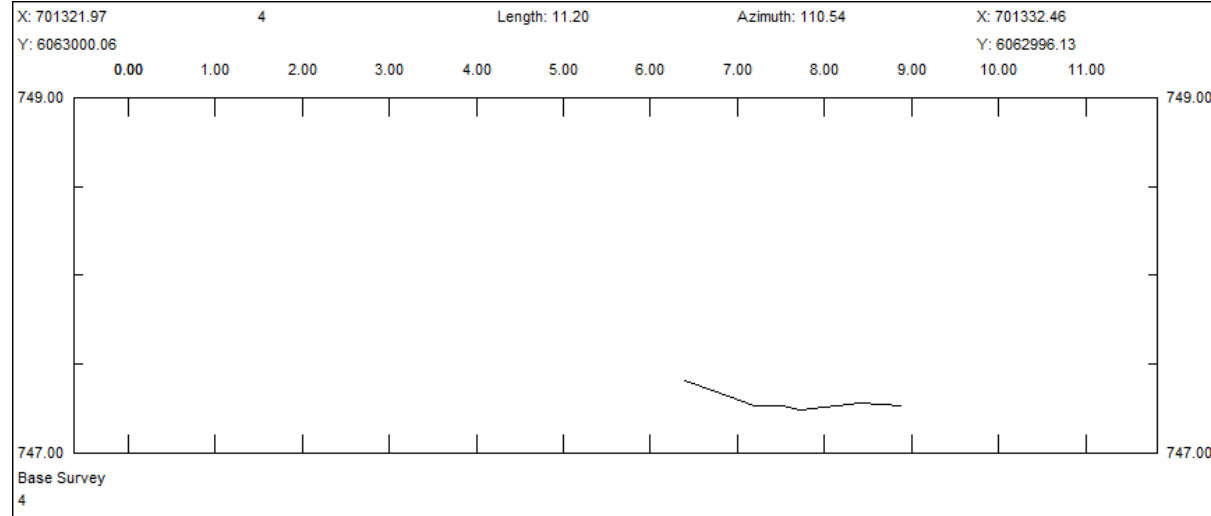
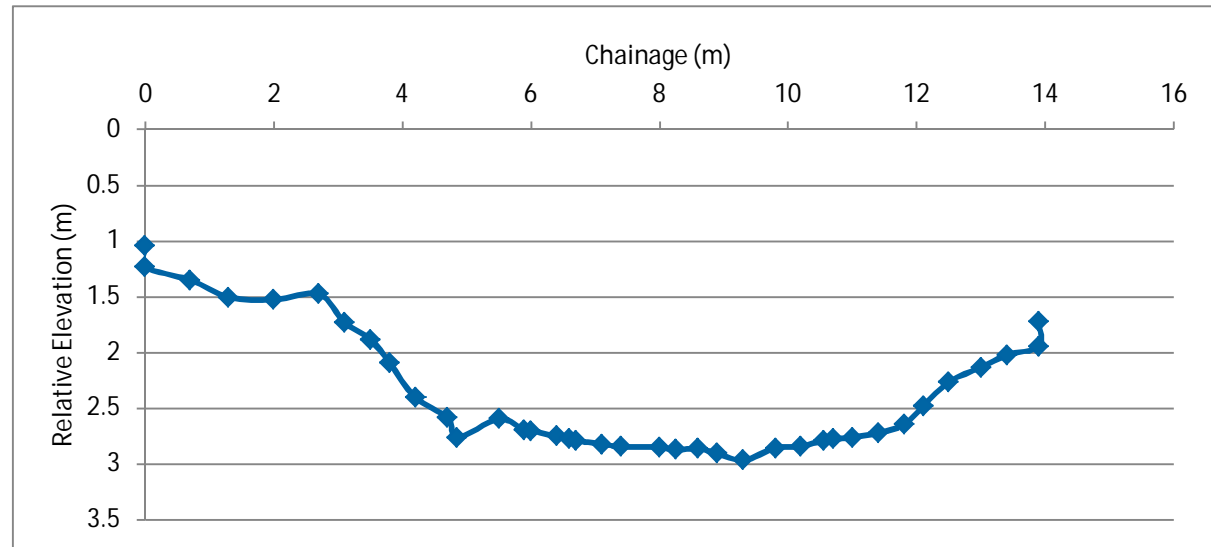
Figure 23 - BUR1C 3D GPS XS-4

- Requires post commission survey for accurate comparison, no change noted during commissioning flow site inspections
- Resurvey of actual cross section with DGPS required to complete/append to DGPS model

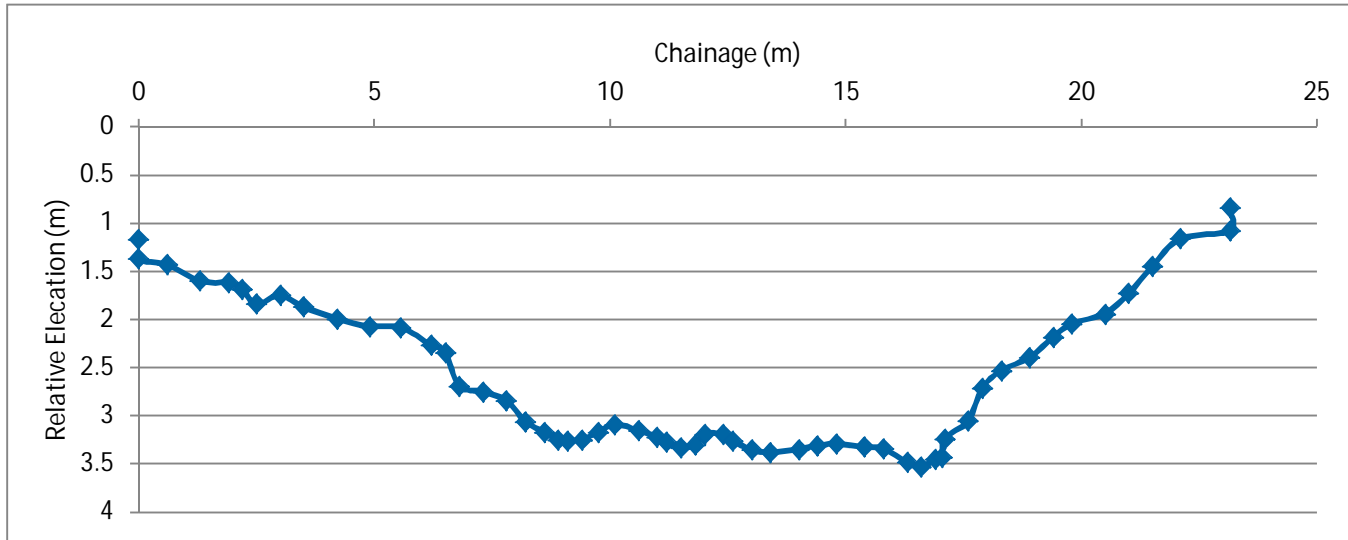
Figure 31 - BUR2A XS-1 _ 2012

- Requires post commission survey for accurate comparison, no change noted during commissioning flow site inspections

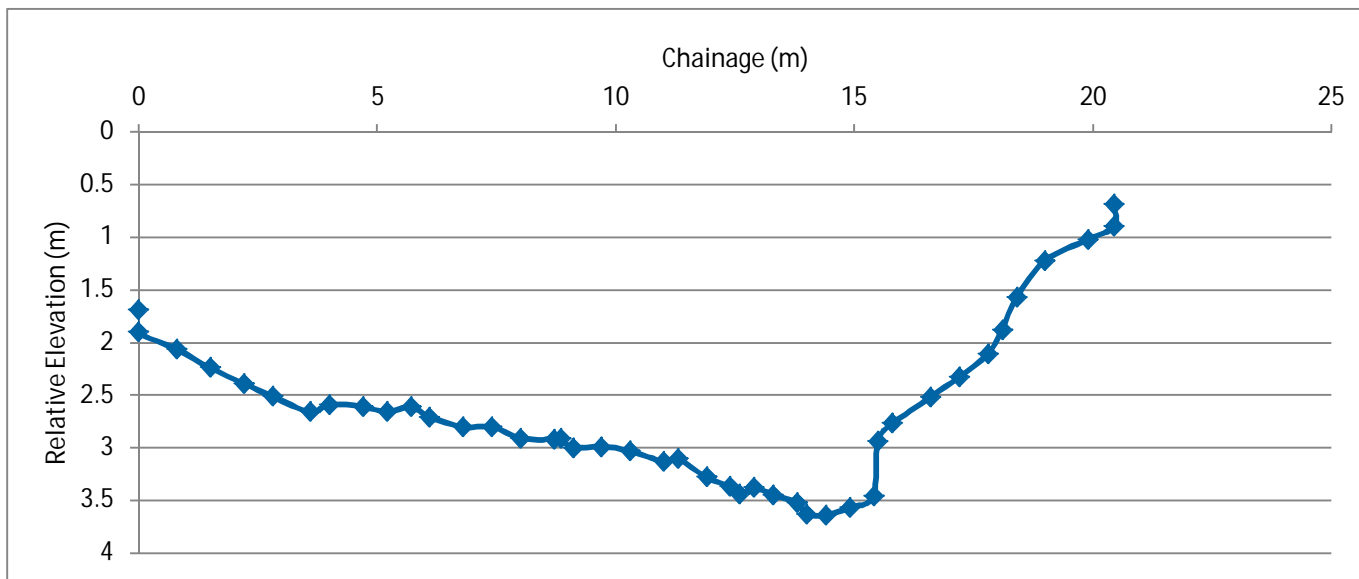
Figure 32 - BUR2A XS-2 _ 2012

- Requires post commission survey for accurate comparison, no change noted during commissioning flow site inspections

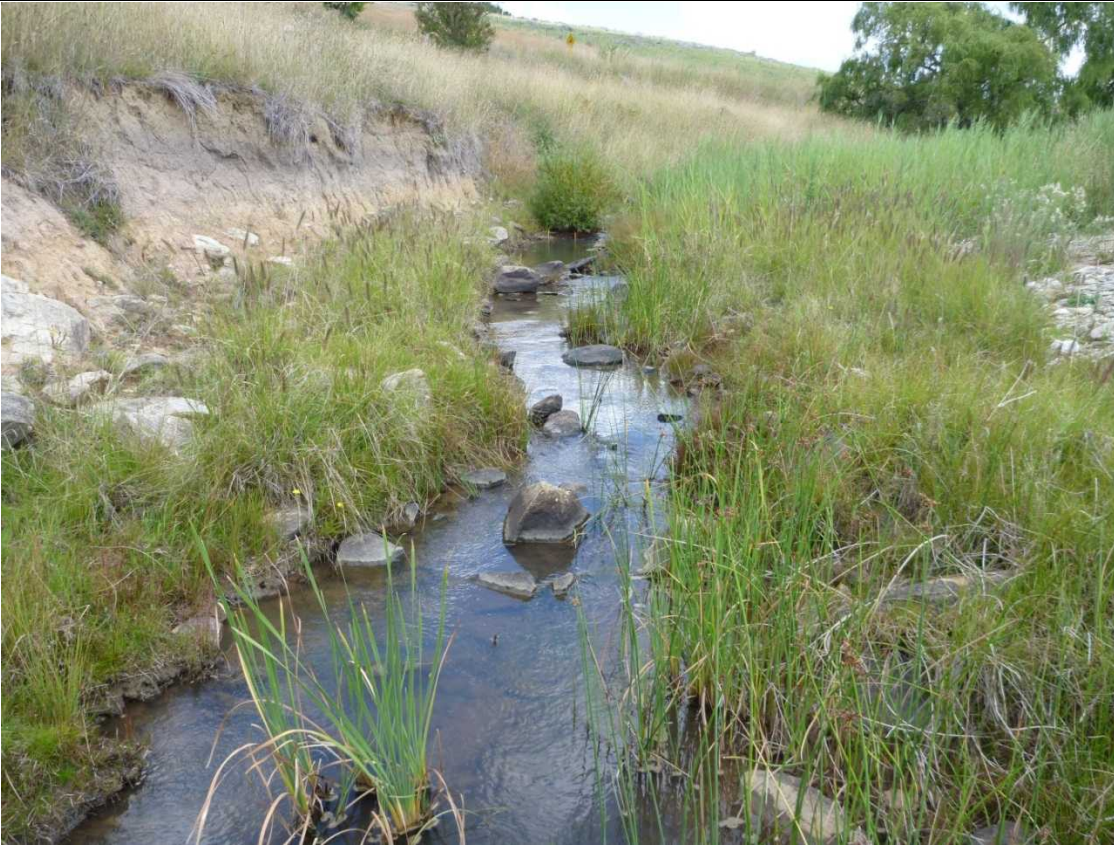
Photo 28 - BUR2A 14/2/2012

- Looking upstream
- Stable riparian vegetation present

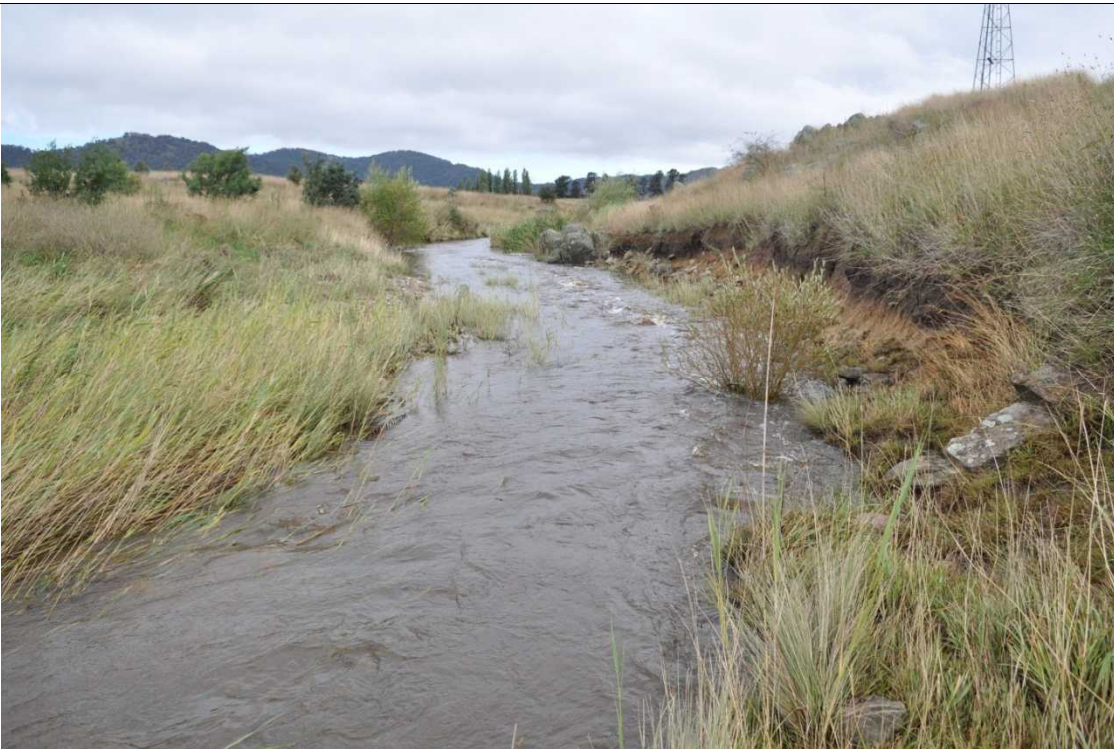
Photo 29 - BUR2A 8/3/2012

- Flow event ~ 100 ML/d
- Evidence of higher waters pushing vegetation over
- No evidence of erosion

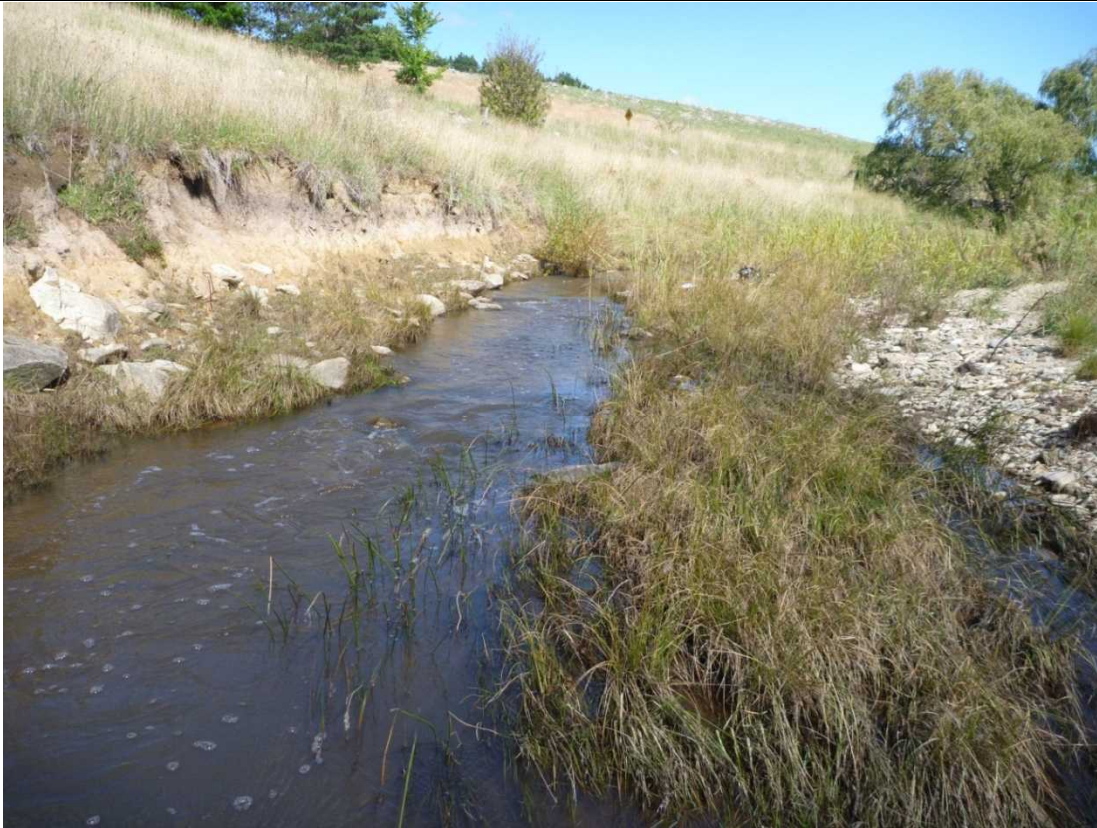
Photo 30 - BUR2A 20/3/2012

- Continued elevated flows
- Vegetation still showing signs of being pushed over by higher flows.

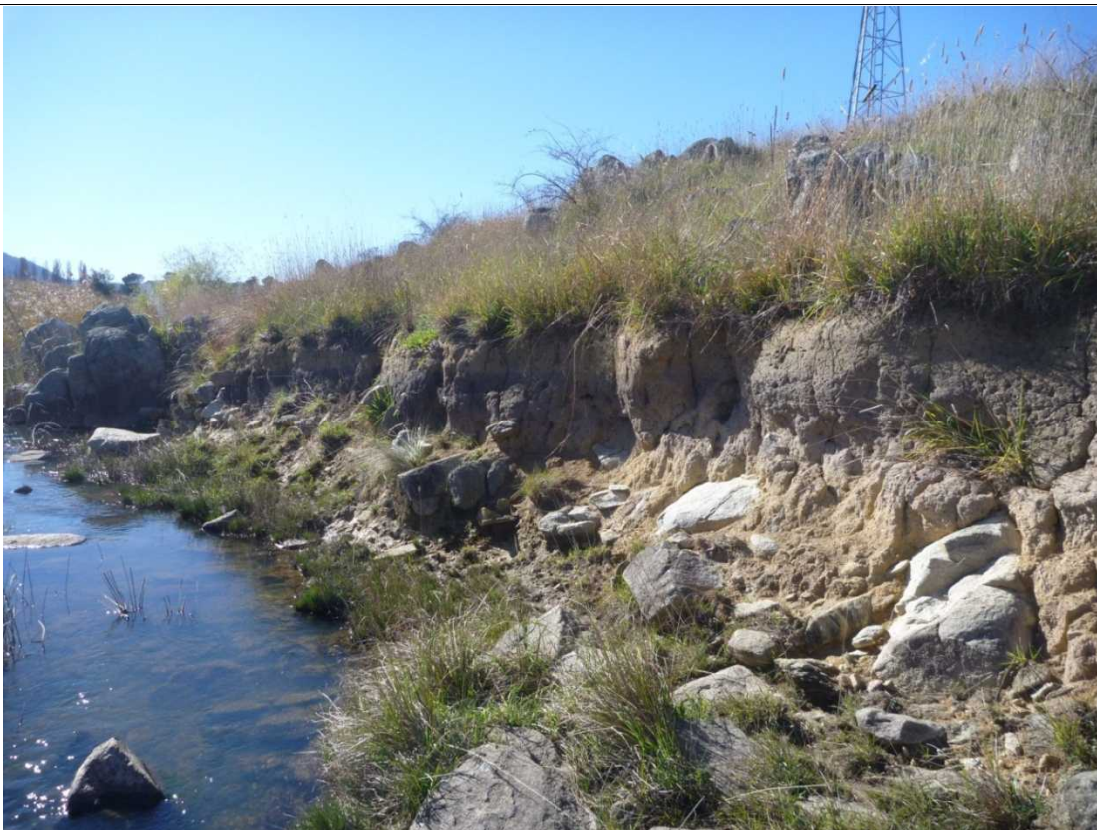
Photo 31 - BUR2A 4/5/2012

- Normal water levels
- Low turbidity
- Increased clarity and available nutrients allow algal and periphyton growth on substrate

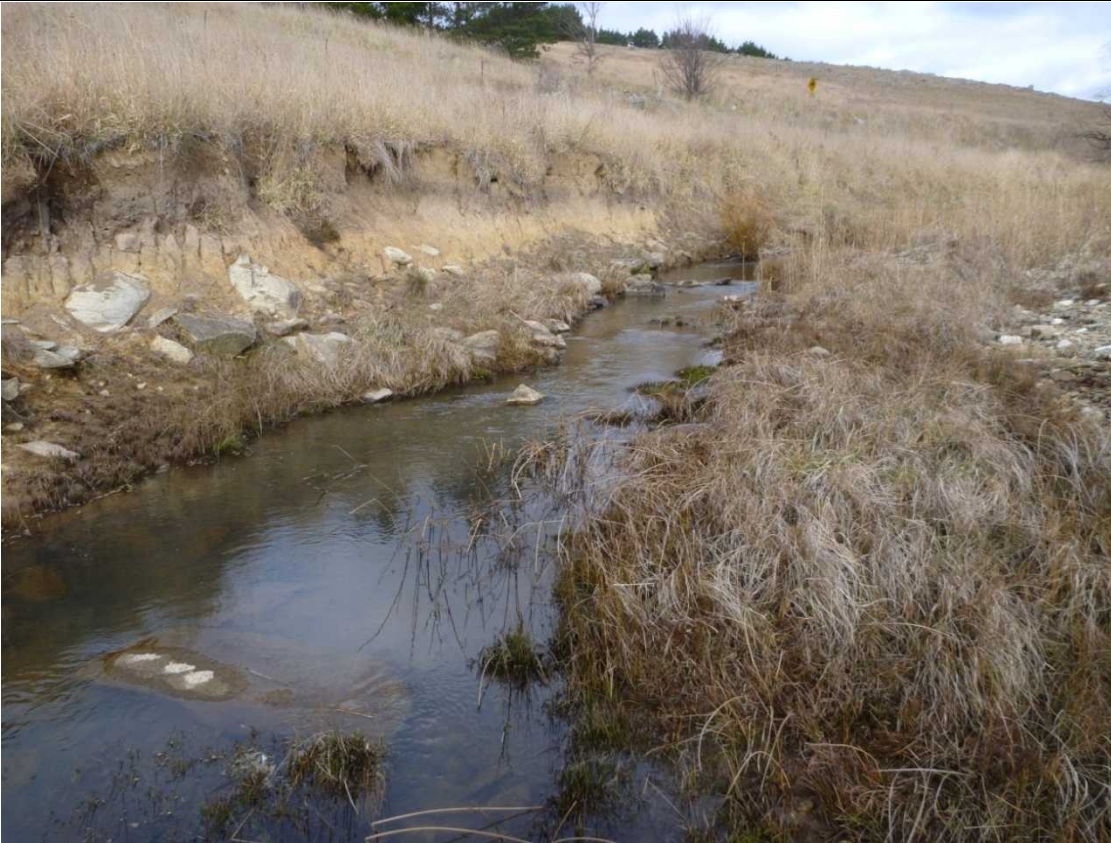
Photo 32 - BUR2A 5/7/2012

- Normal water levels
- Evidence of vegetation die off during winter months for emergent macrophytes

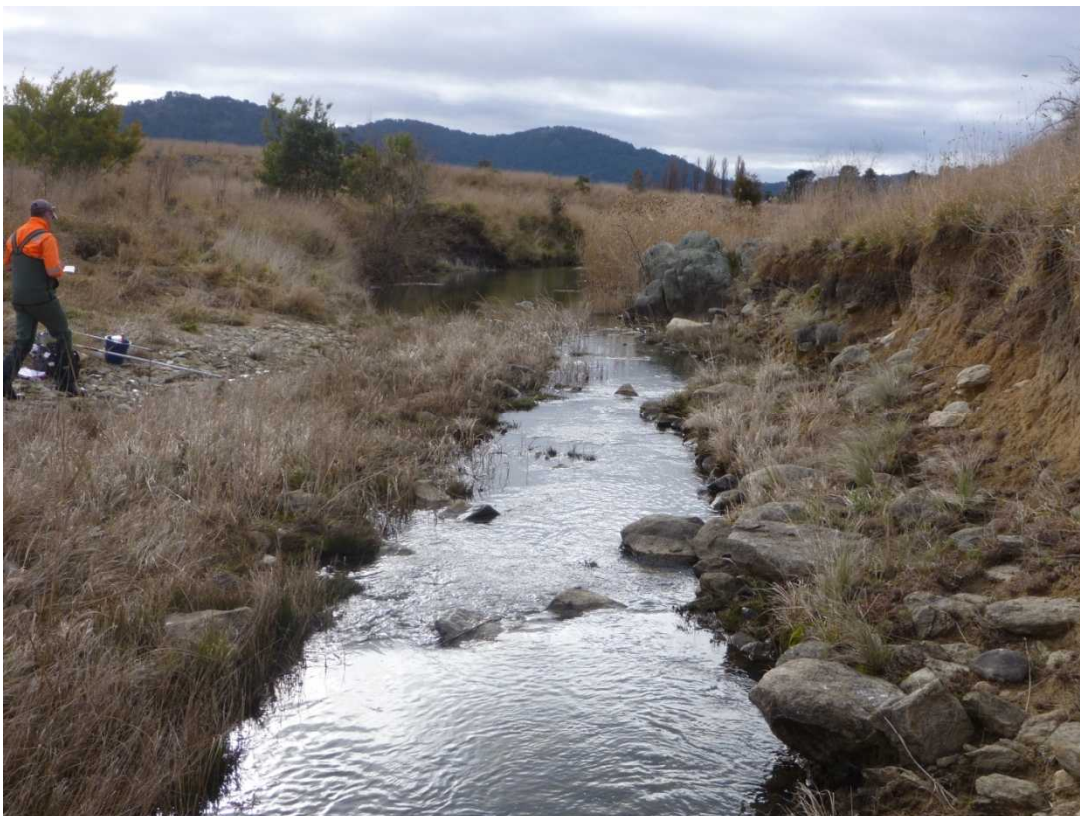
Photo 33 - BUR2A 5/7/2012

- Stream condition at time of 2012 winter sampling

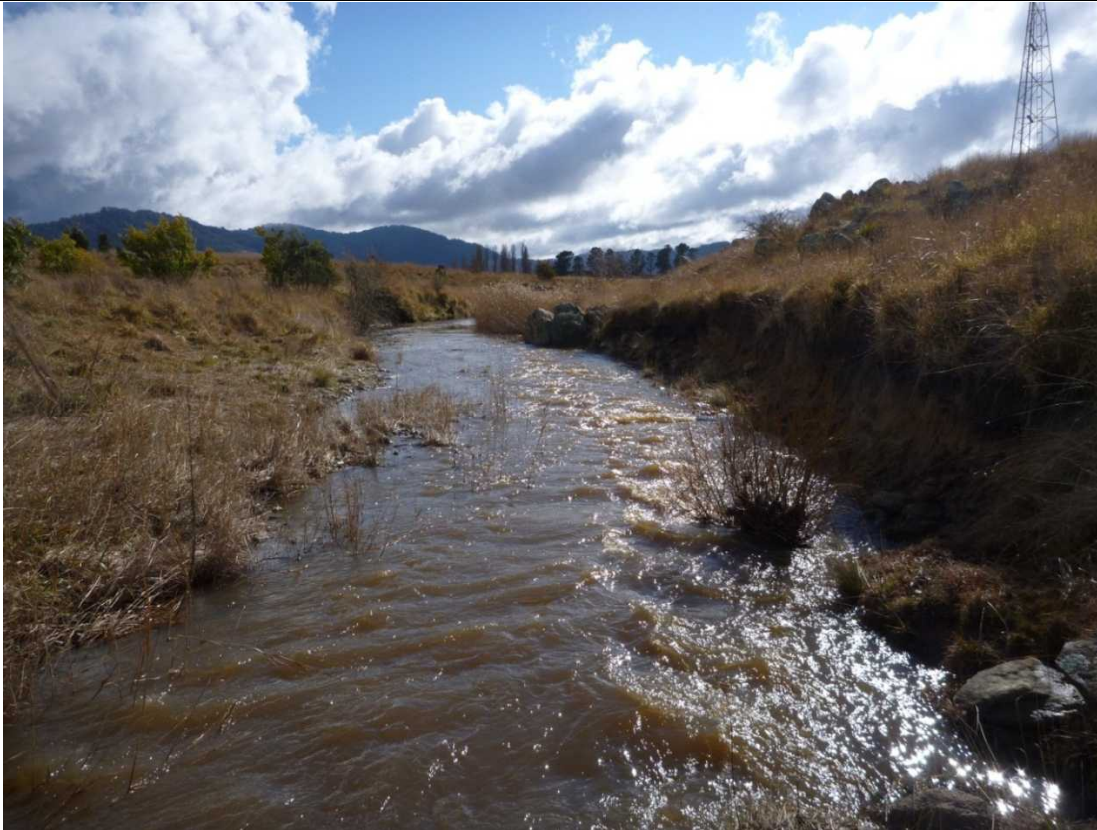
Photo 34 - BUR2A 13/7/2012

- Med flow event - ~110ML/d

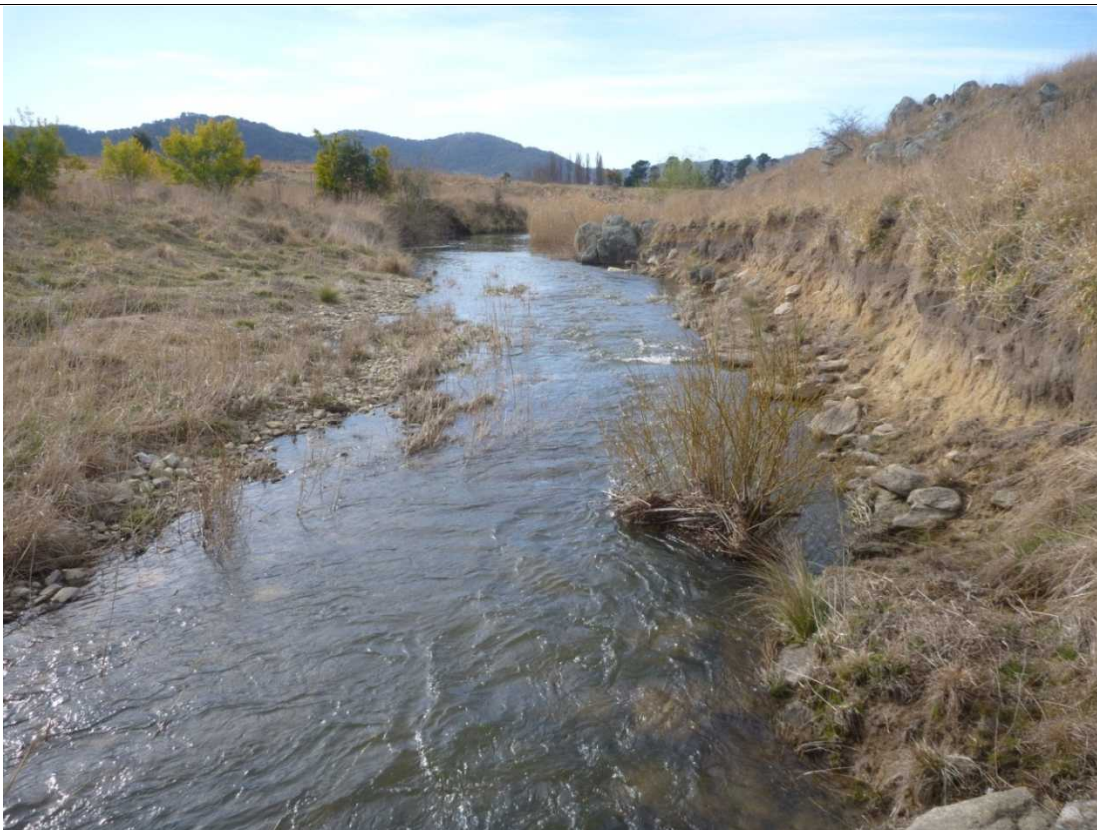
Photo 35 - BUR2A 10/9/2012

- Med flow event (This includes an M2G pump maintenance run ~20ML/d +~5ML/d baseflow)
- No evidence of new bank erosion from pumped flow
- Turbidity low
