ACTEW Water
Murrumbidgee Ecological Monitoring Program
Burra Creek geomorphology and vegetation assessment

March 2014

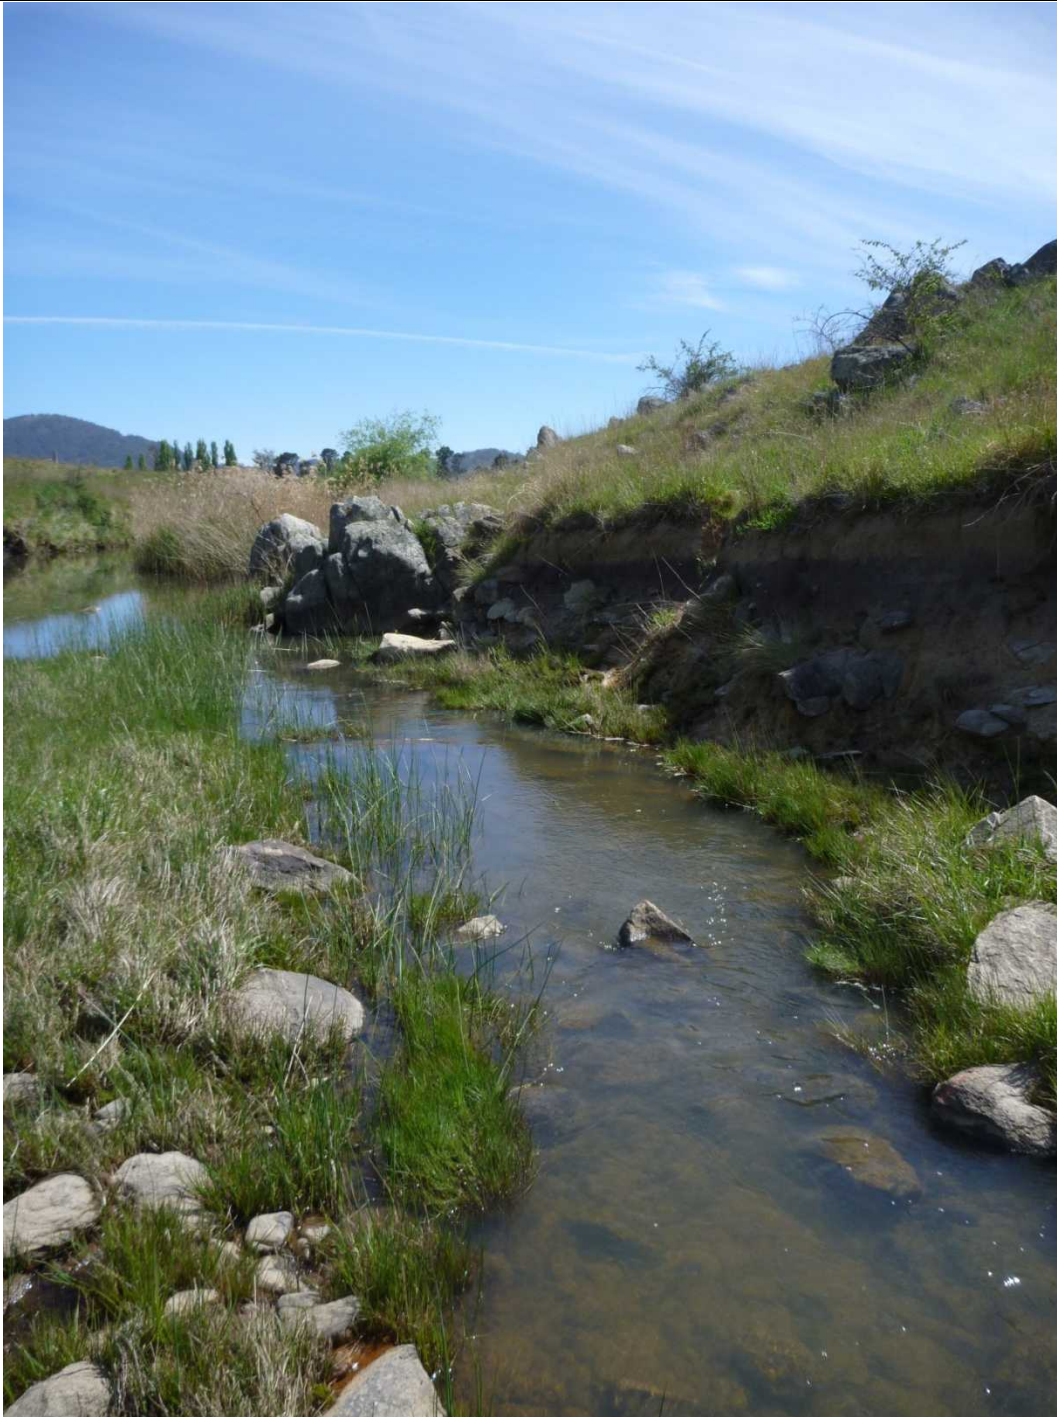
Photo 36 - BUR2A 29/10/2012

- Vegetation returning for spring
- Algal growth evident in-stream

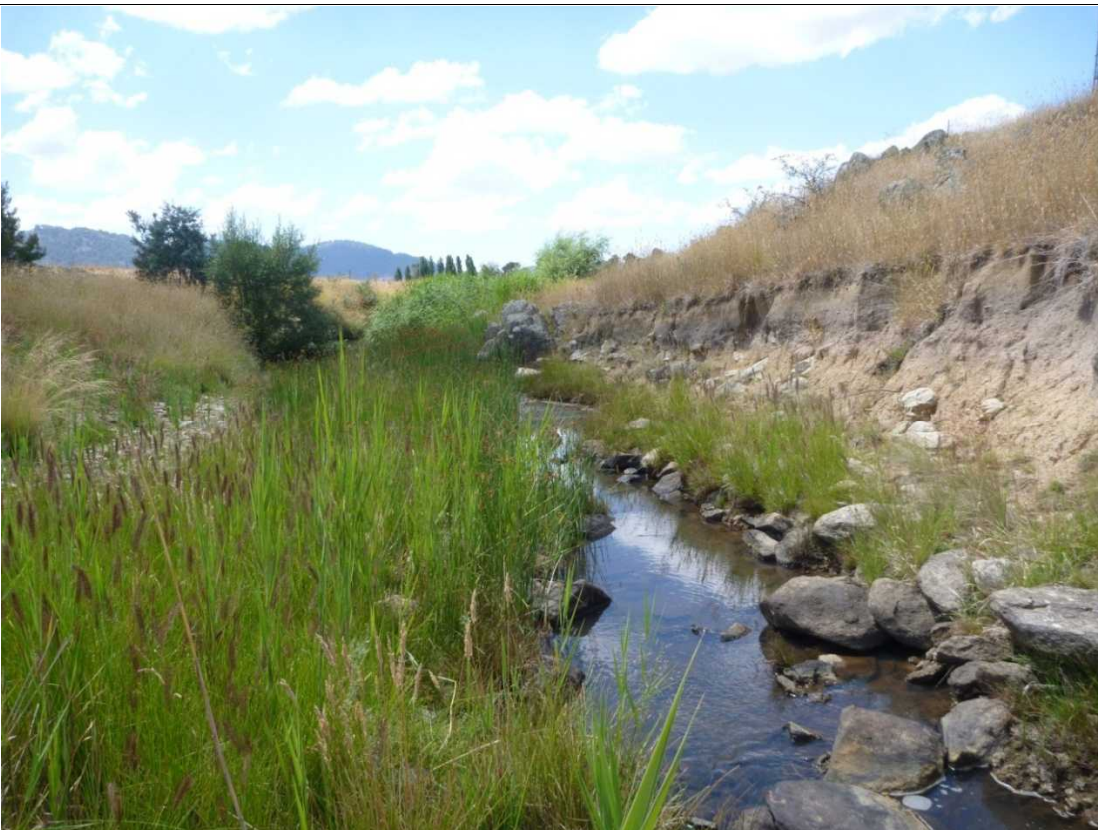
Photo 38 - BUR2A 24/1/2013

- Noticeable increase in reed growth along left side of stream

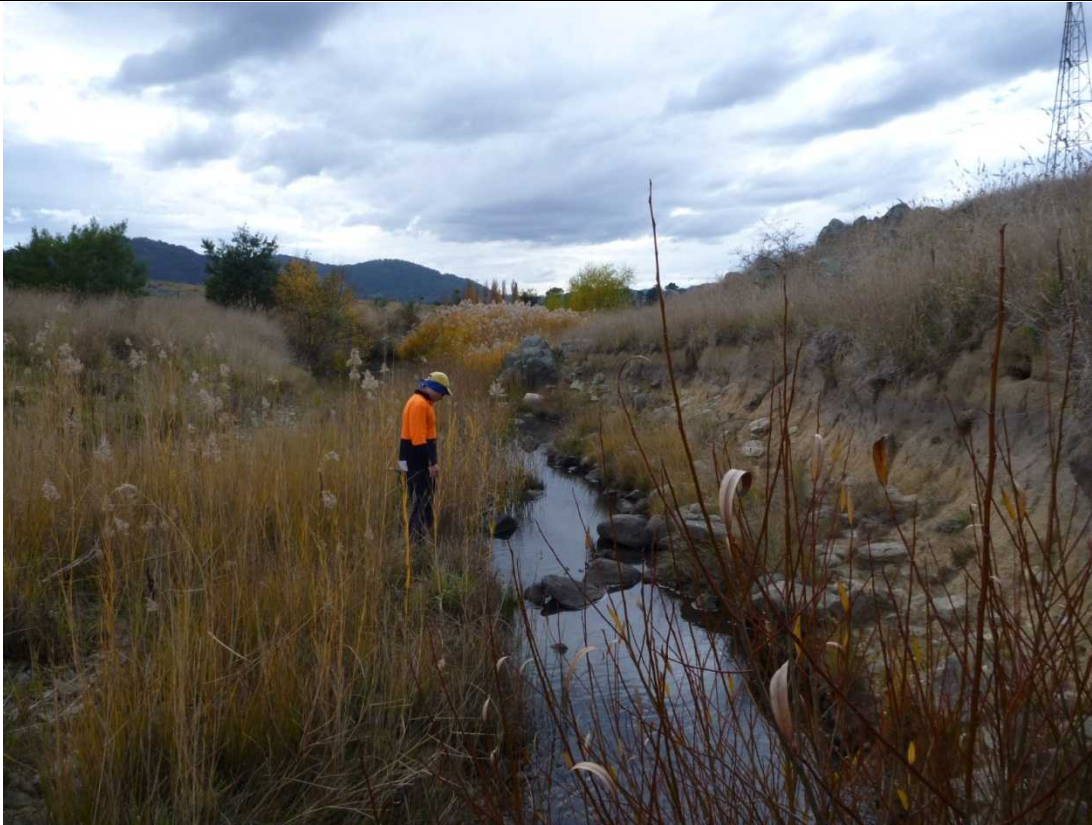
Photo 39 – BUR2A 29/4/2013

- Macrophyte die-off at onset of cold weather. Macrophytes have not fully encroached into the central channel

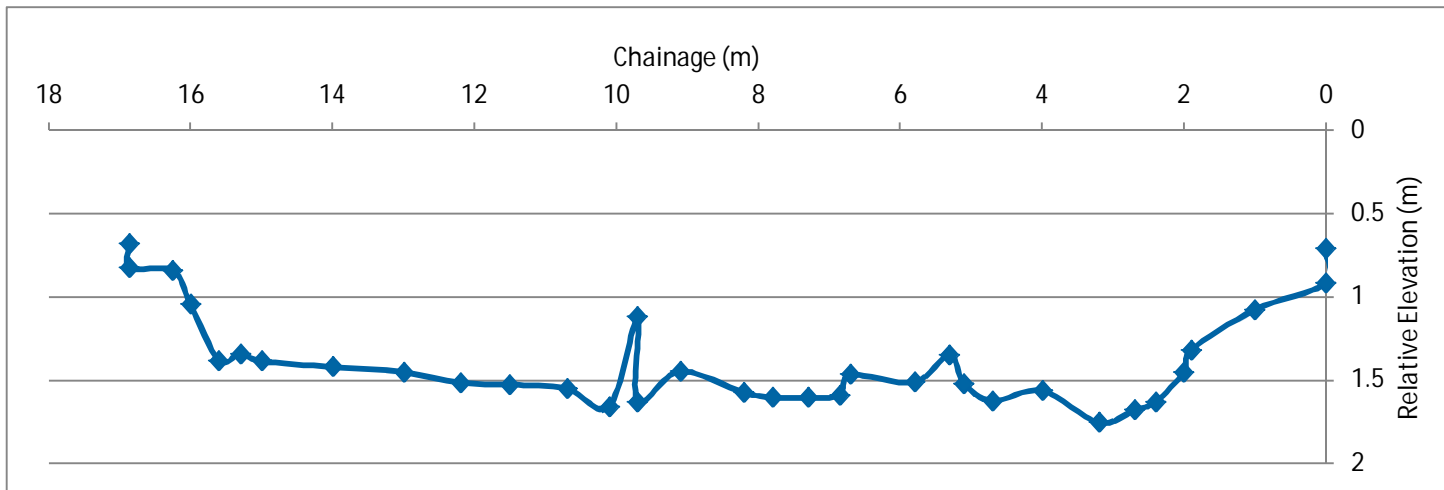
Figure 37 - BUR U/S Pool 50 XS-1 _ 2012

- DGPS survey longer than Dumpy cross section to accommodate 3D profiling
- Original survey pegs could not be found at time of 3D survey.
- Channel sections indicate similar profile, accurate survey needed to re-establish section

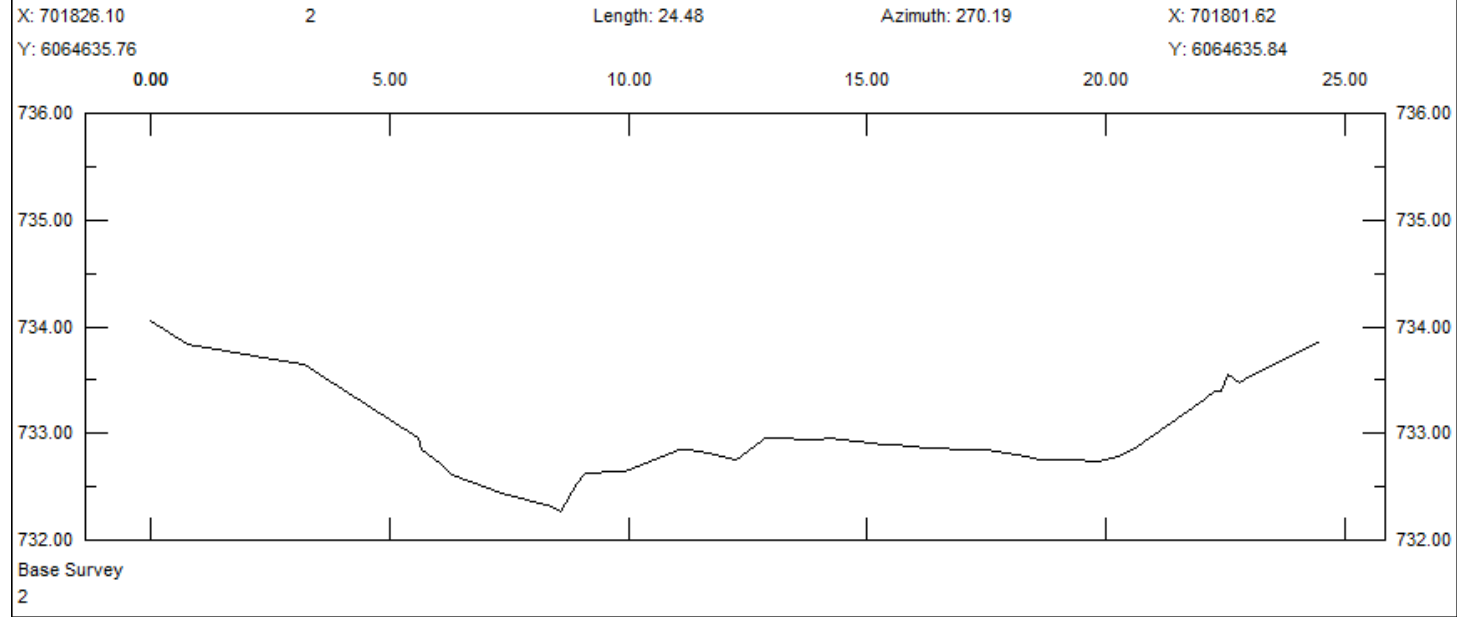
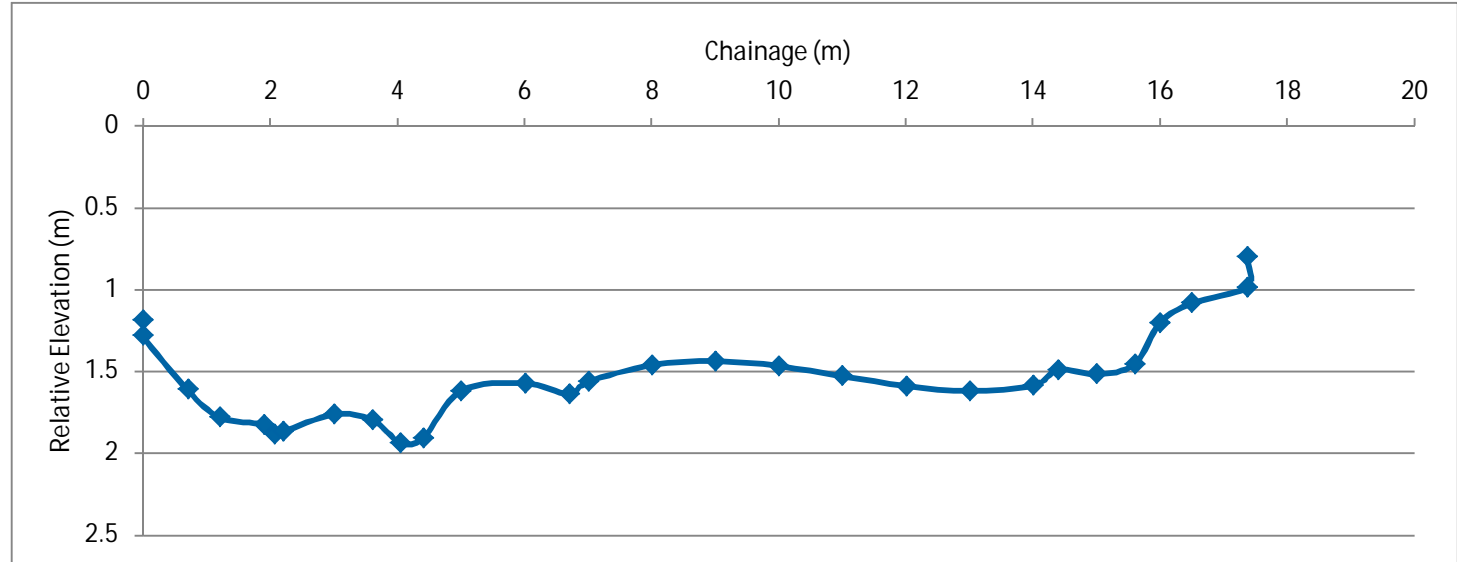
Figure 38 - BUR U/S Pool 50 3D GPS XS-2

- DGPS survey longer than Dumpy cross section to accommodate 3D profiling
- Original survey pegs could not be found at time of 3D survey.
- Channel sections indicate similar profile, accurate survey needed to re-establish section

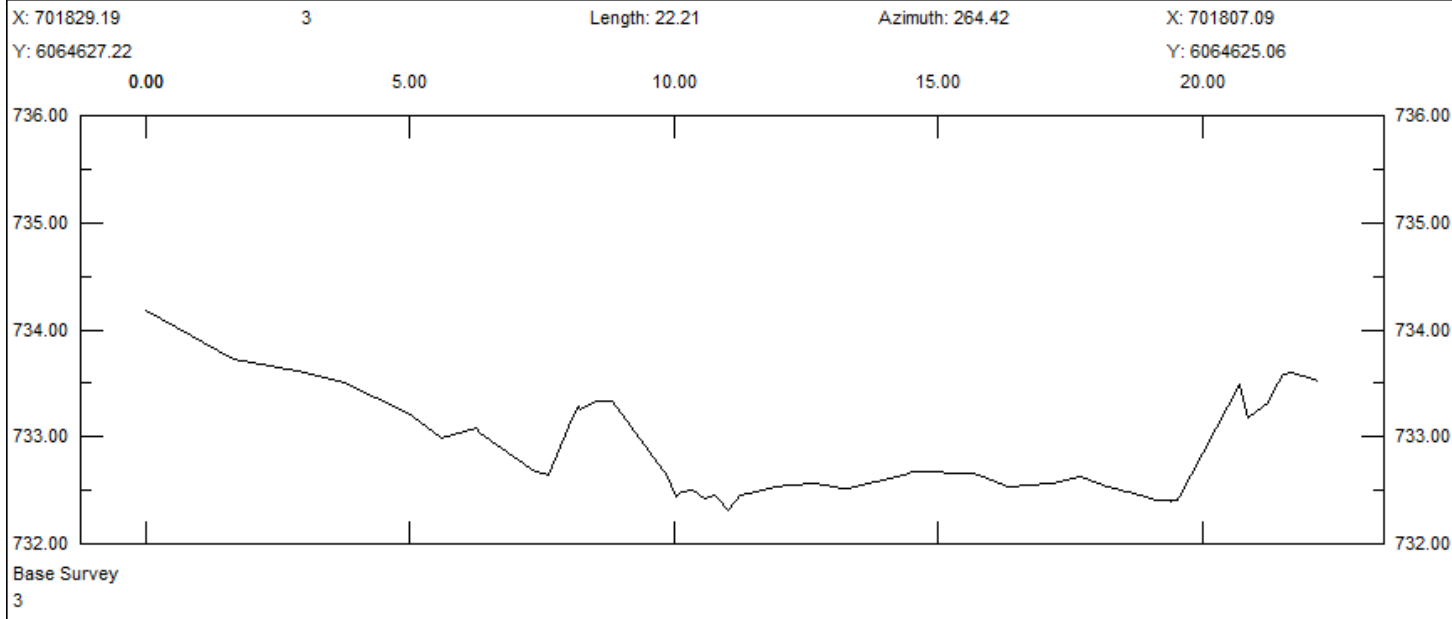
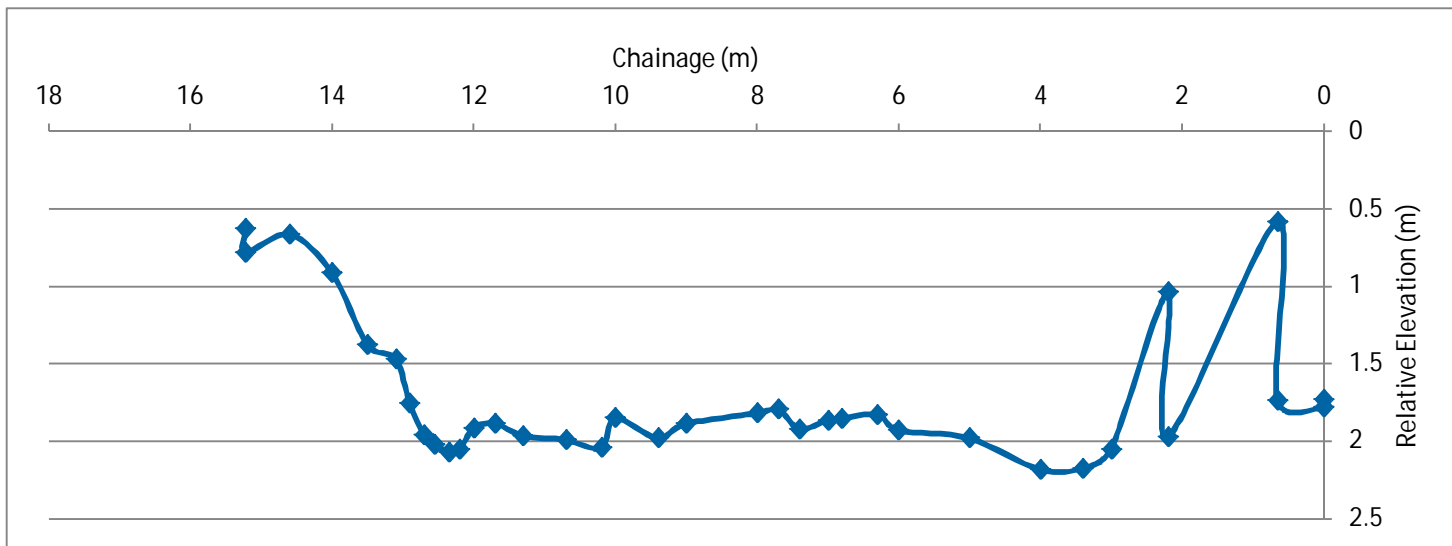
Figure 40 - BUR U/S Pool 50 3D GPS XS-3

- DGPS survey longer than Dumpy cross section to accommodate 3D profiling
- Original survey pegs could not be found at time of 3D survey.
- Channel sections indicate similar profile, accurate survey needed to re-establish section
- Differences due to rock outcrops picked up in ~1m misalignment of cross sections

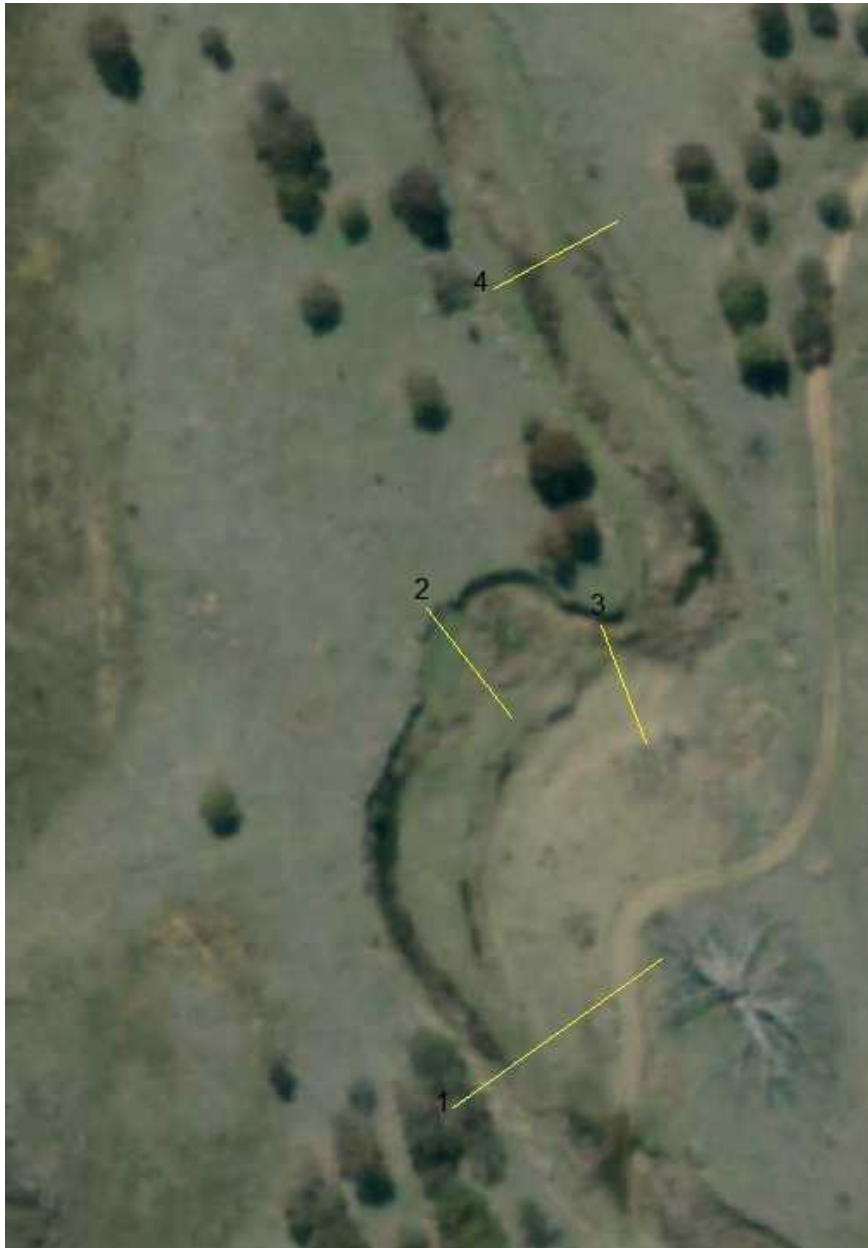
Figure 42 - BUR2C Aerial Photo (2012 NSW SIX Maps)

Some original cross-section pegs have moved due to erosion effects or earthwork impact from moving of the creek crossing.

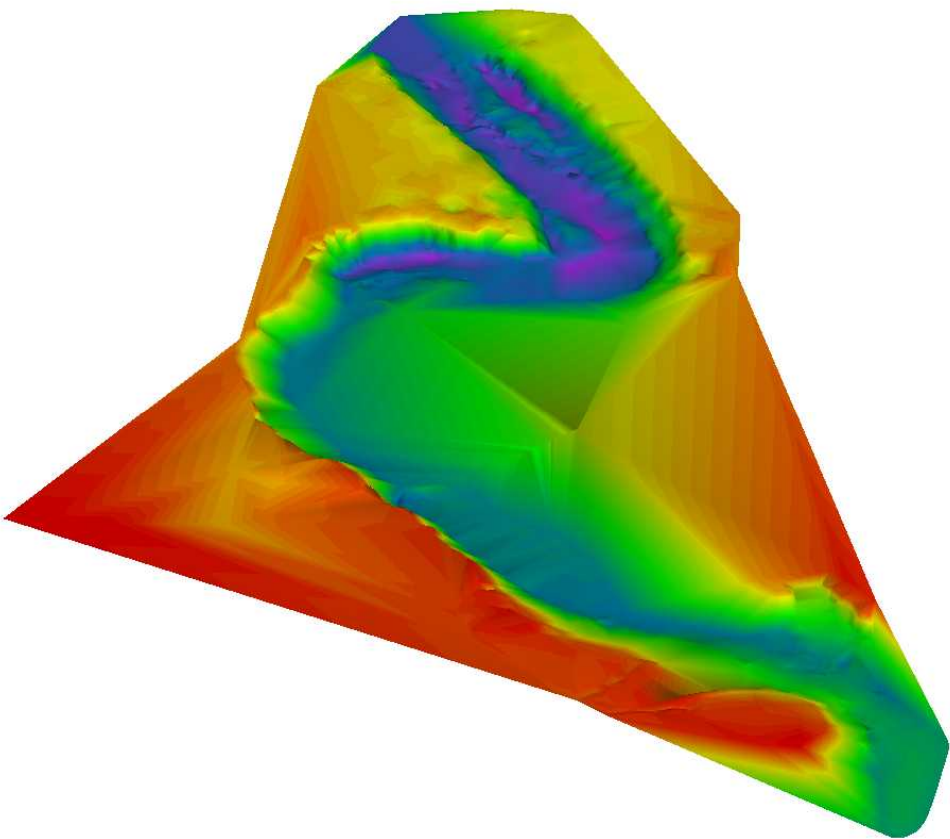
Figure 43 - BUR2C DGPS 3D Model (July 2013)

- In-stream points U/S of Riffle absent due to water level or loss of DGPS correction signal at base of embankment during survey.

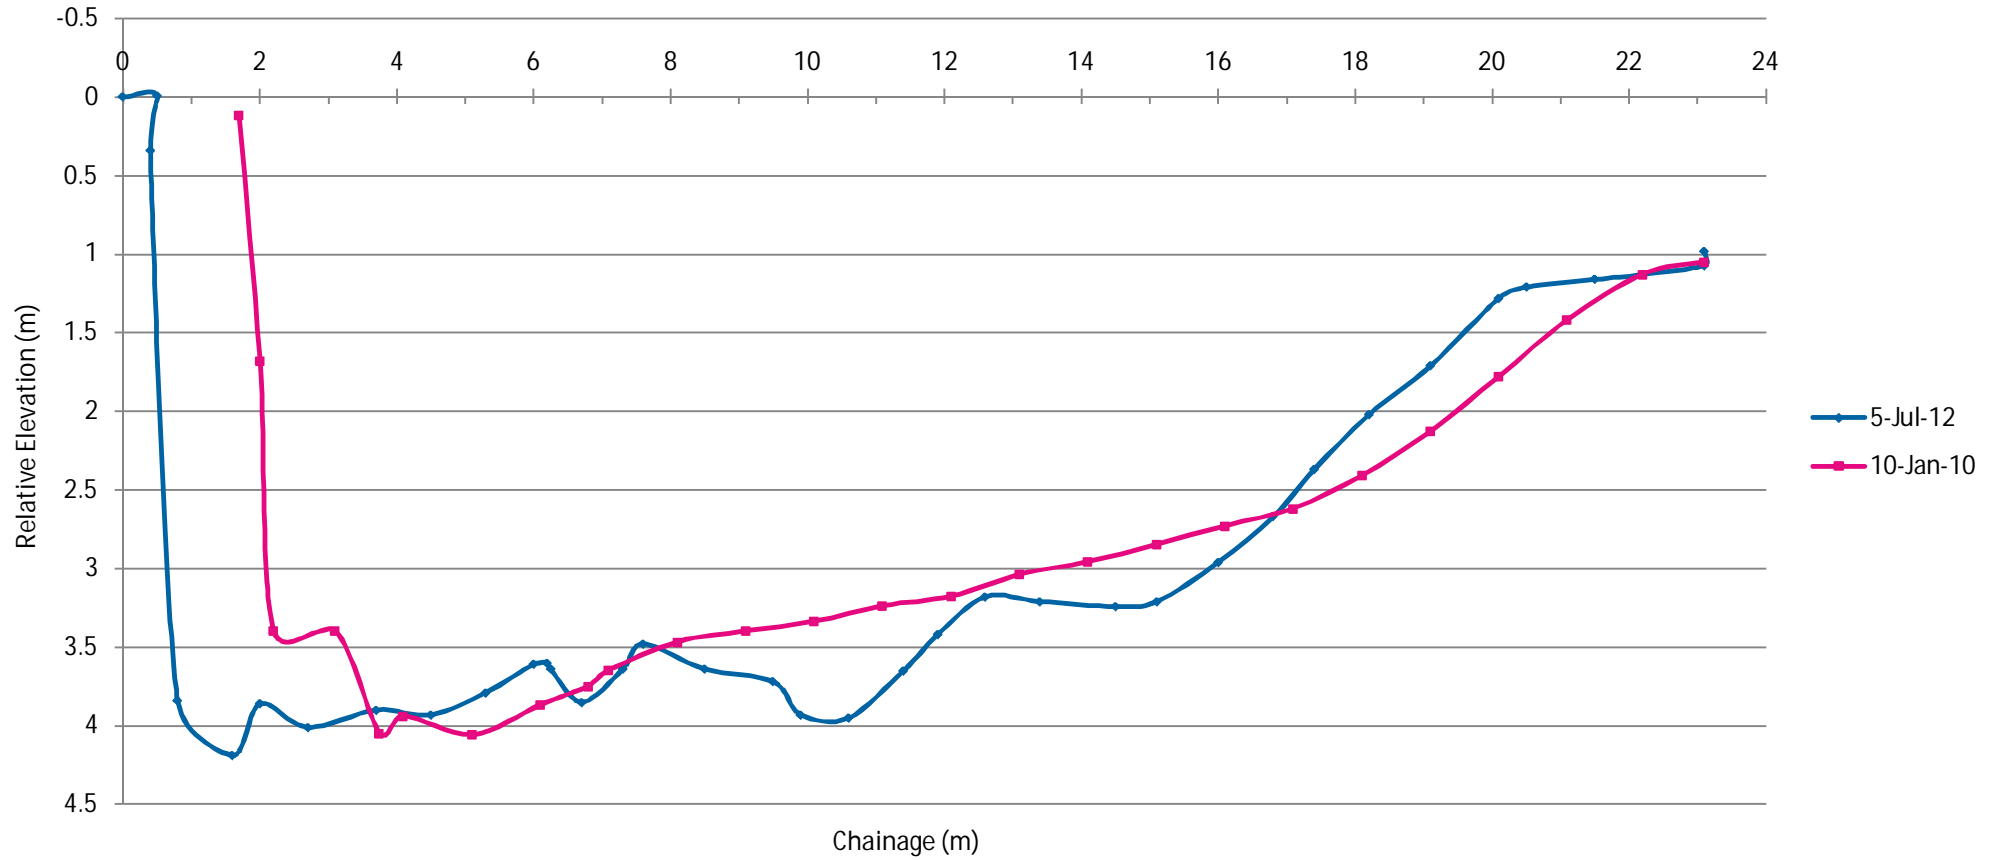
U/S 2C @ Bend XS-3

Left hand side of section shows ~1m of horizontal erosion or collapse from bank. Cross-sections were adjusted to the level of the peg on the right hand bank (right of graph) as this peg was used in both surveys. Peg on left hand bank was replaced due to loss by erosion.

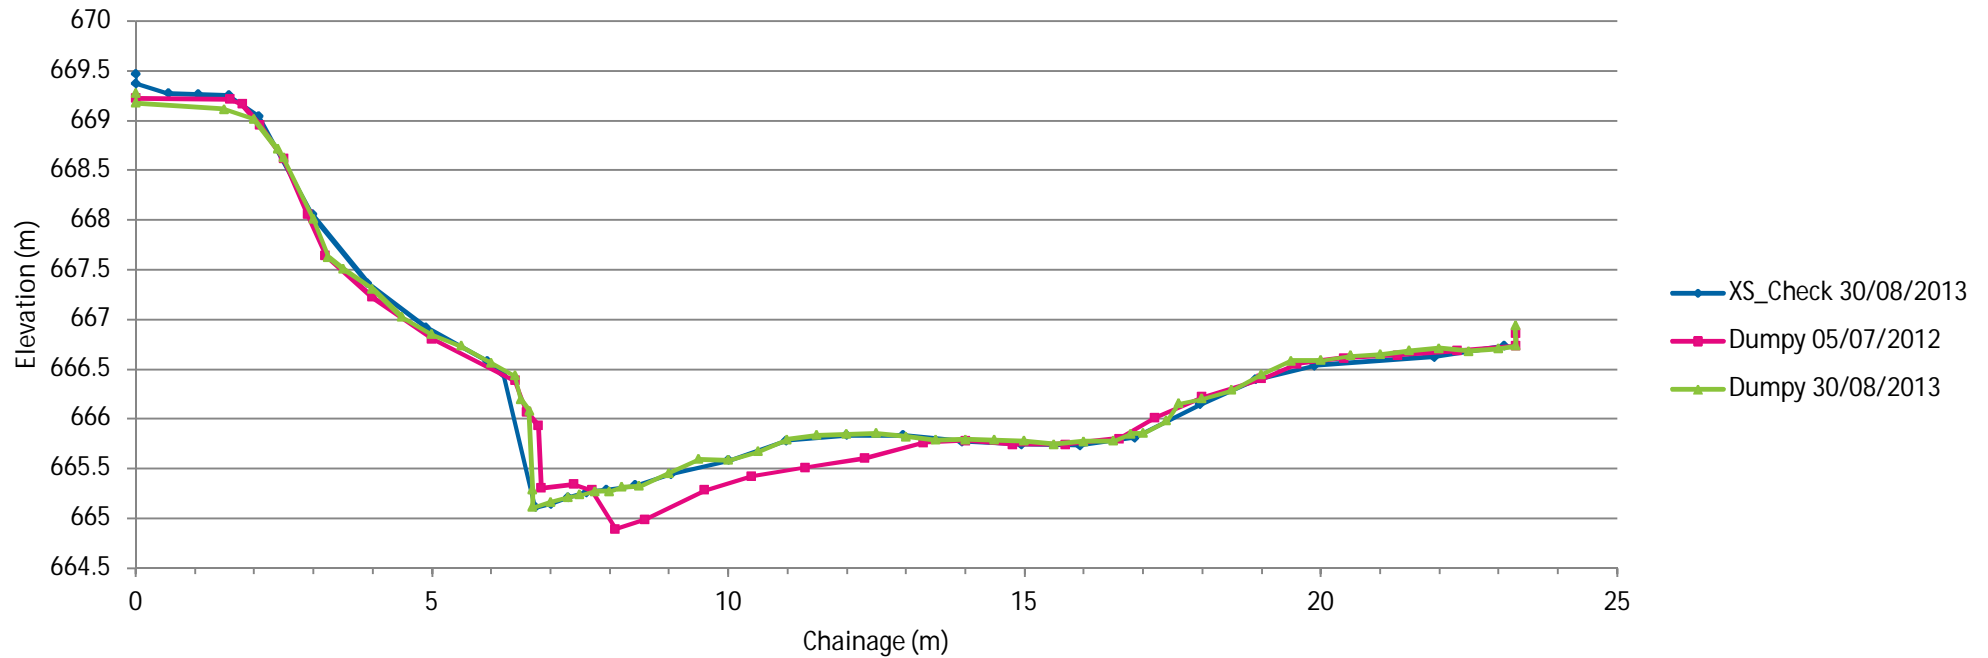
BUR2C @ Undercut Bank XS-2

Dumpy Section taken at beginning of hydrograph shown left while DGPS data taken two months after end of hydrograph. Commissioning flows follow date of Dumpy Section with a 1000 MI/d event occurring in Oct 2012. It is likely that the large event caused the changes in channel profile.

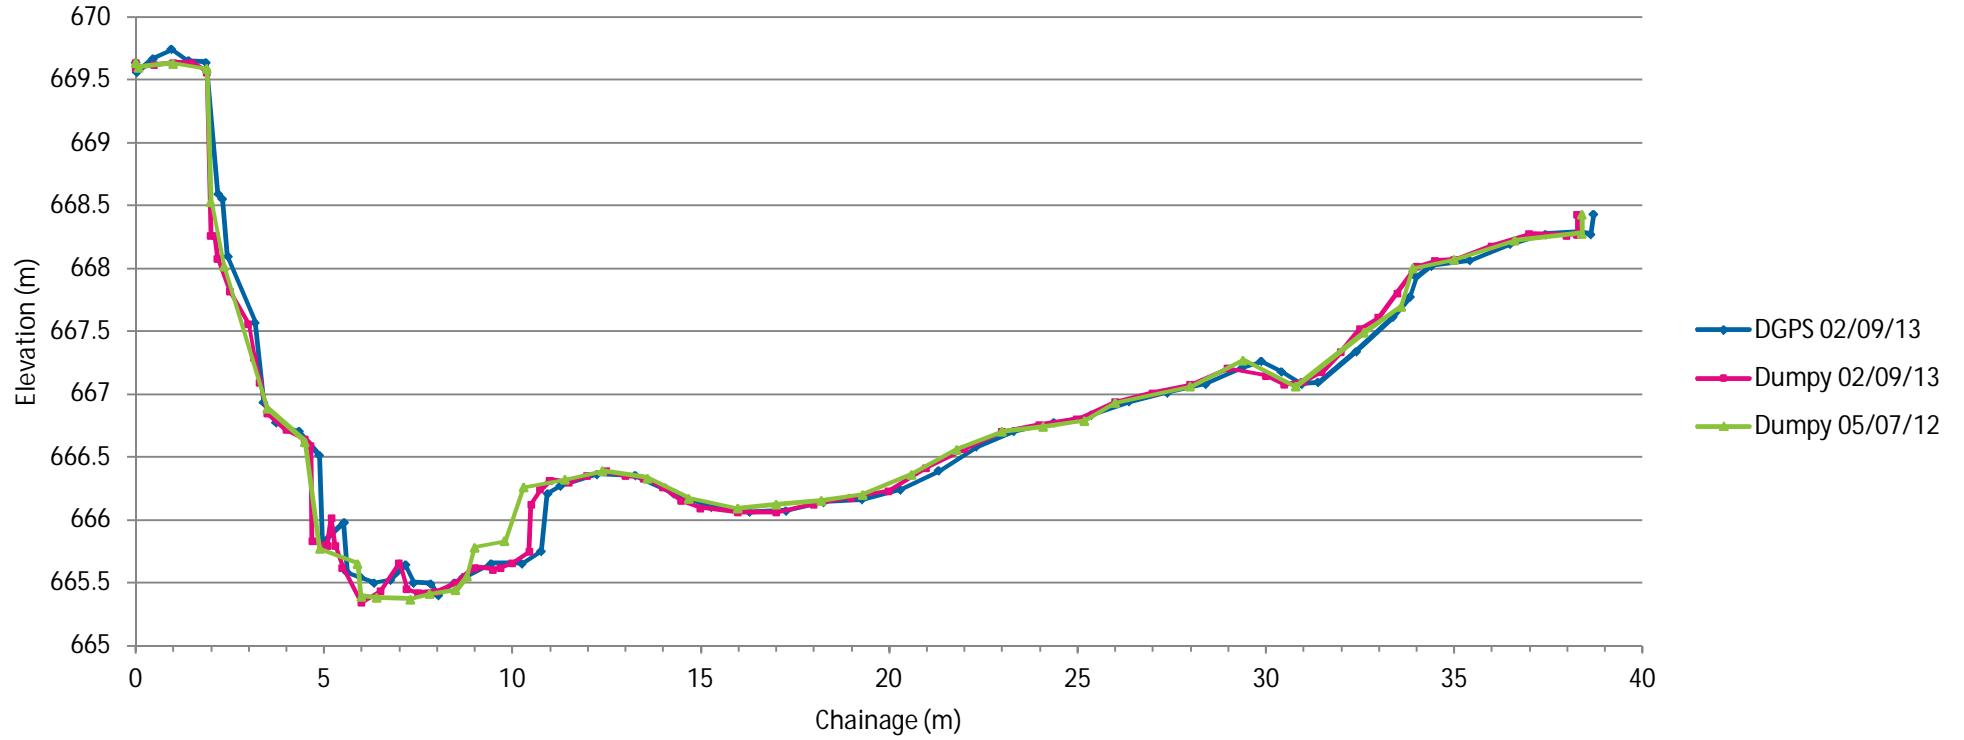
U/S @ Old Road Crossing XS-1

Erosion from right hand bank at ~CH 10m
 Some deposition in central channel
 Slump shown at ~CH 5m

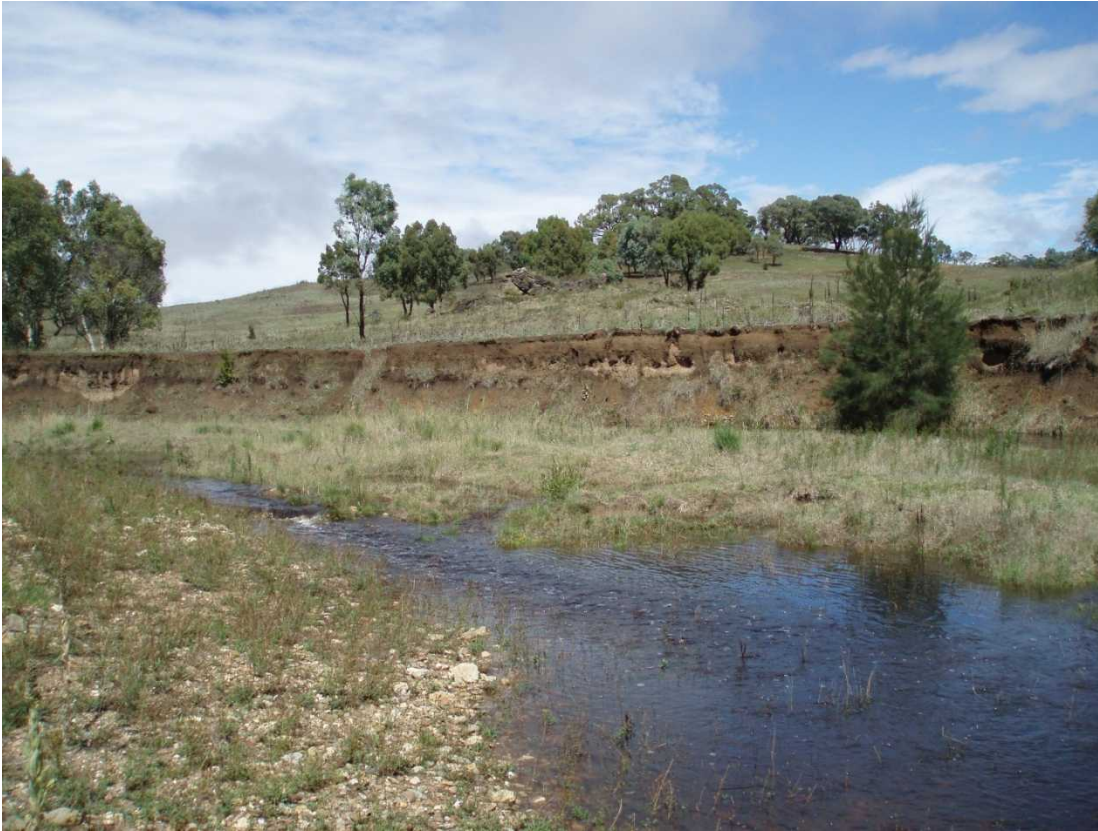
Photo 42 - BUR2C 15/2/2010

- Secondary flow on inside of bend resulting from elevated flow

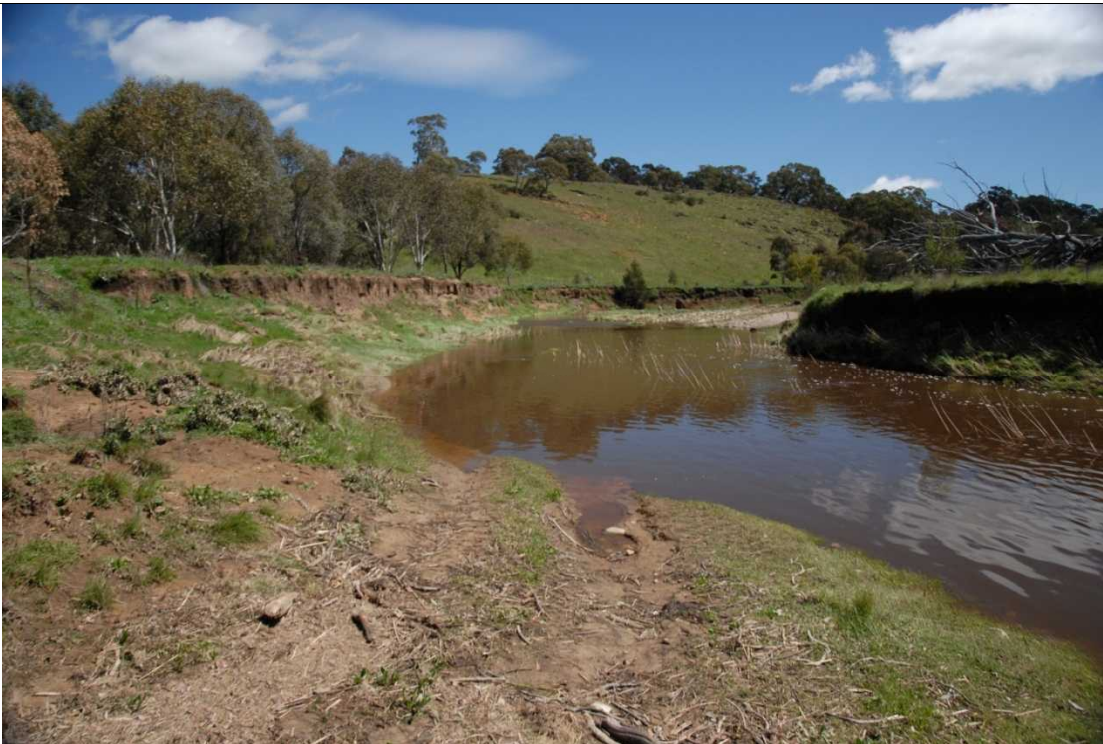
Photo 45 - BUR2C 17/10/2010

- Evidence of flood debris
- Vegetation pushed over by high flows
- Water levels still elevated

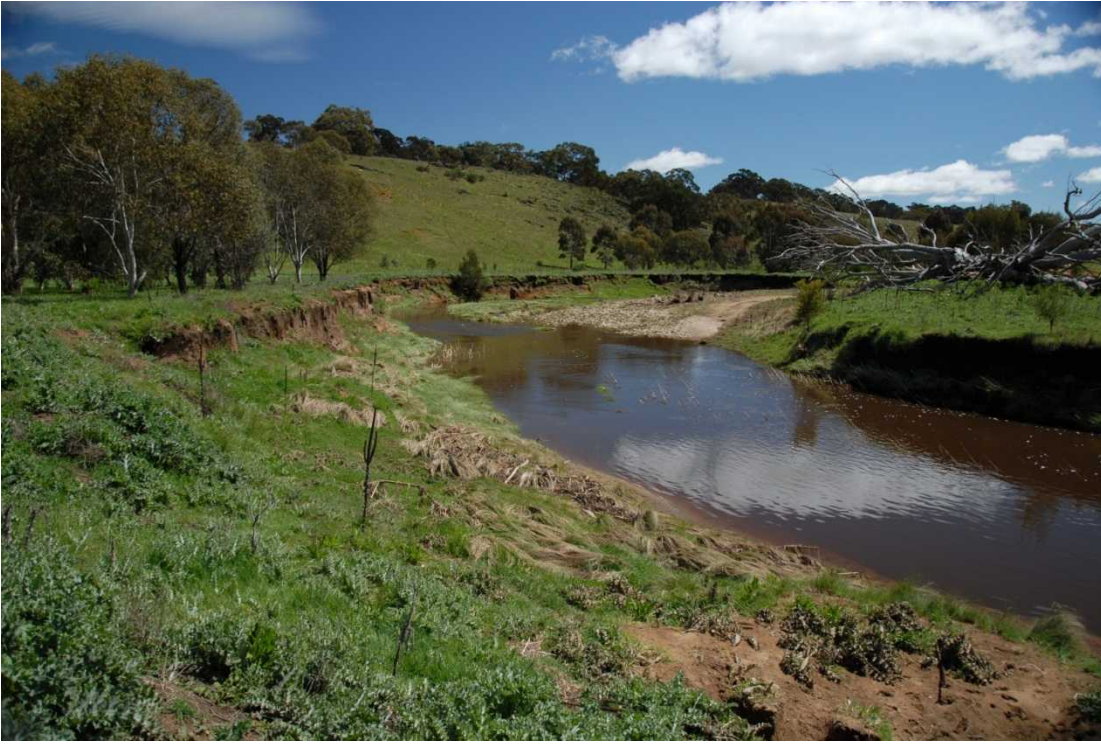
Photo 46 - BUR2C 17/10/2010

- Evidence of peak water level from debris mark on side of channel

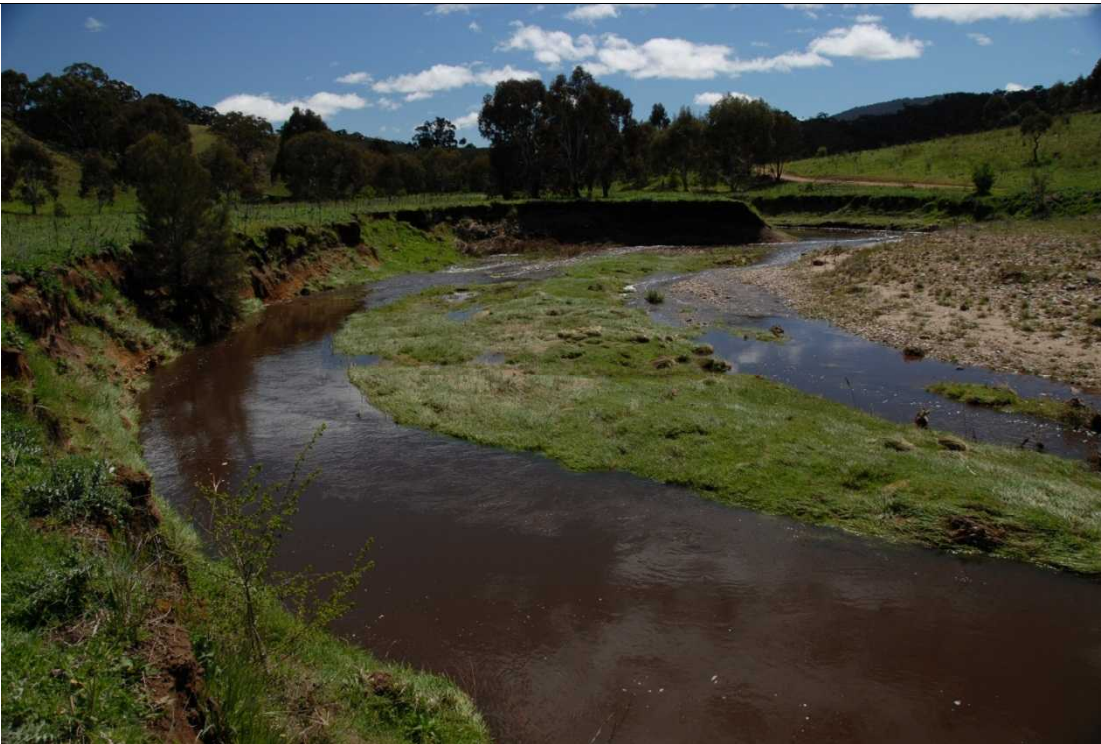
Photo 47 - BUR2C 17/10/2010

- no obvious signs of bank erosion as a result of this flood event
- new additional flow channel as a result of secondary flow on the inside bend due to the elevated water levels from the flood

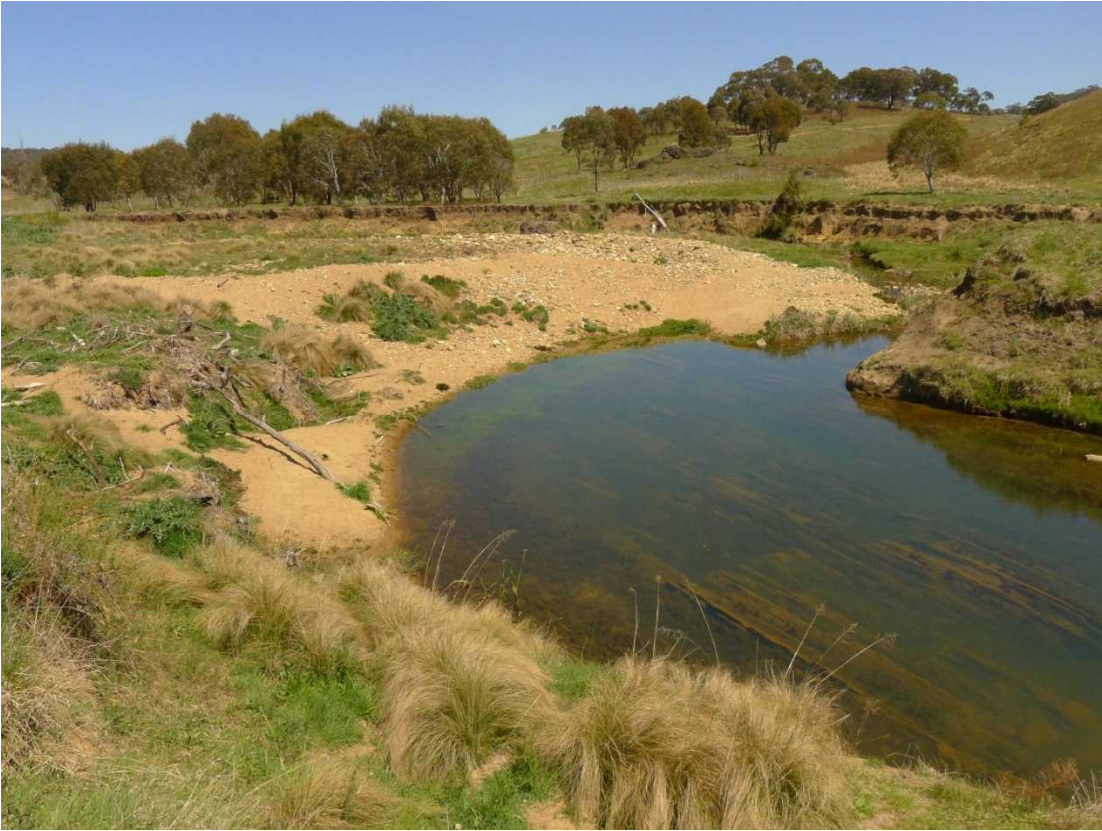
Photo 52 - BUR2C 19/10/2011

- Bed rock exposed in majority of pool

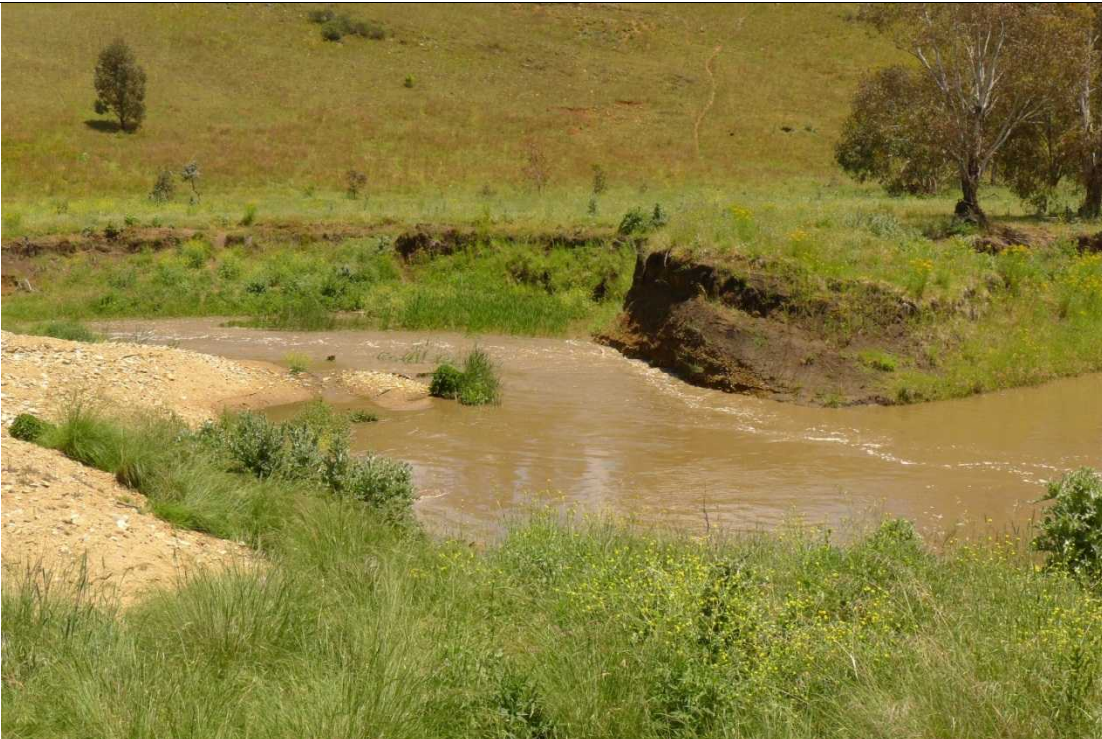
Photo 53 - BUR2C 26/11/2011

- med flow event
- Grass and reed vegetation around banks re-establishing

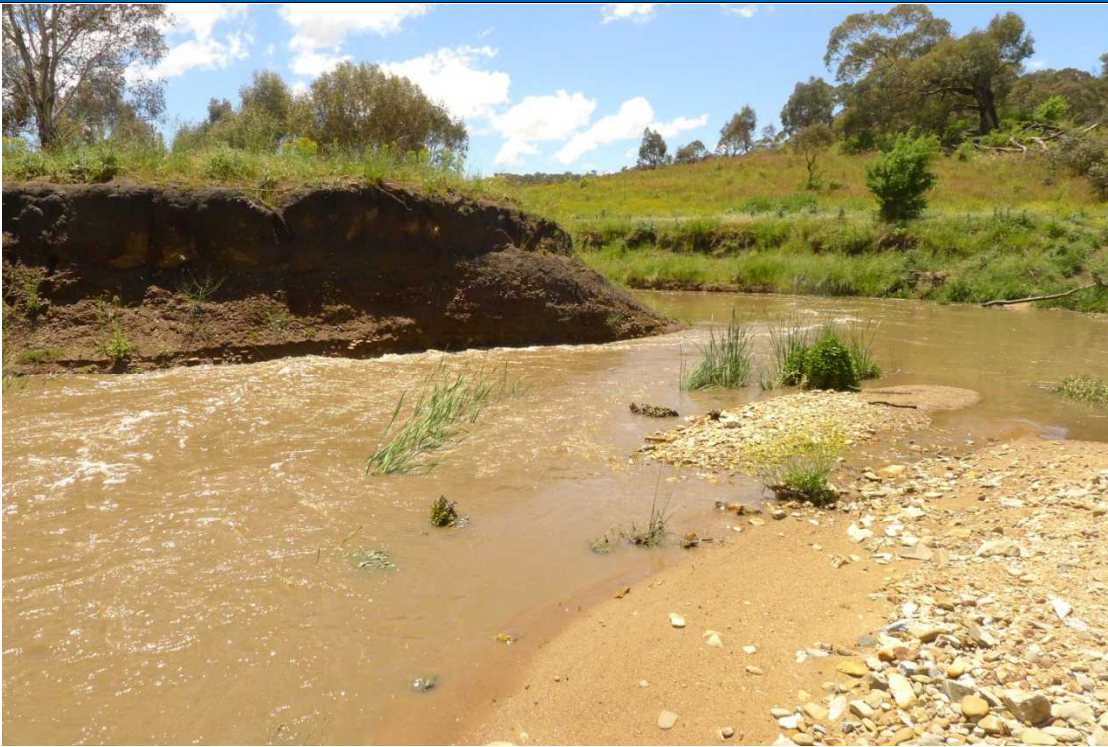
Photo 54 - BUR2C 26/11/2011

- Med flow event
- Evidence of bank undercutting and erosion
- High turbidity

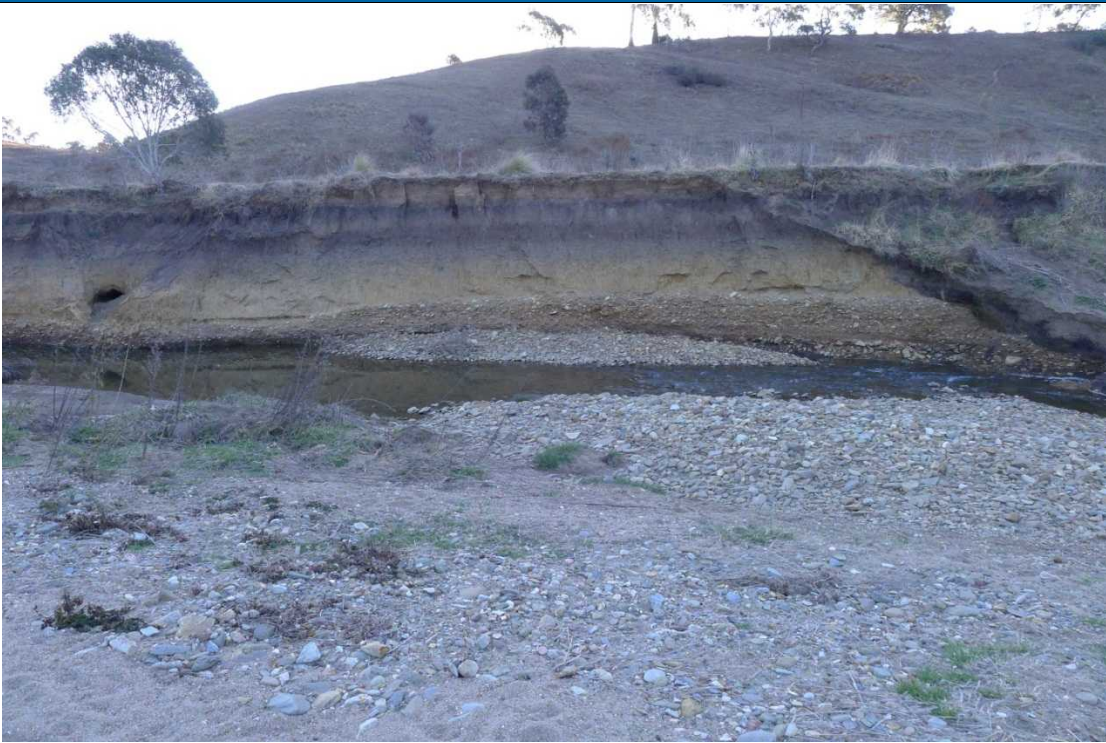
Photo 62 - BUR2C 3/9/2012

- Sediment deposition evident on outside of bend.

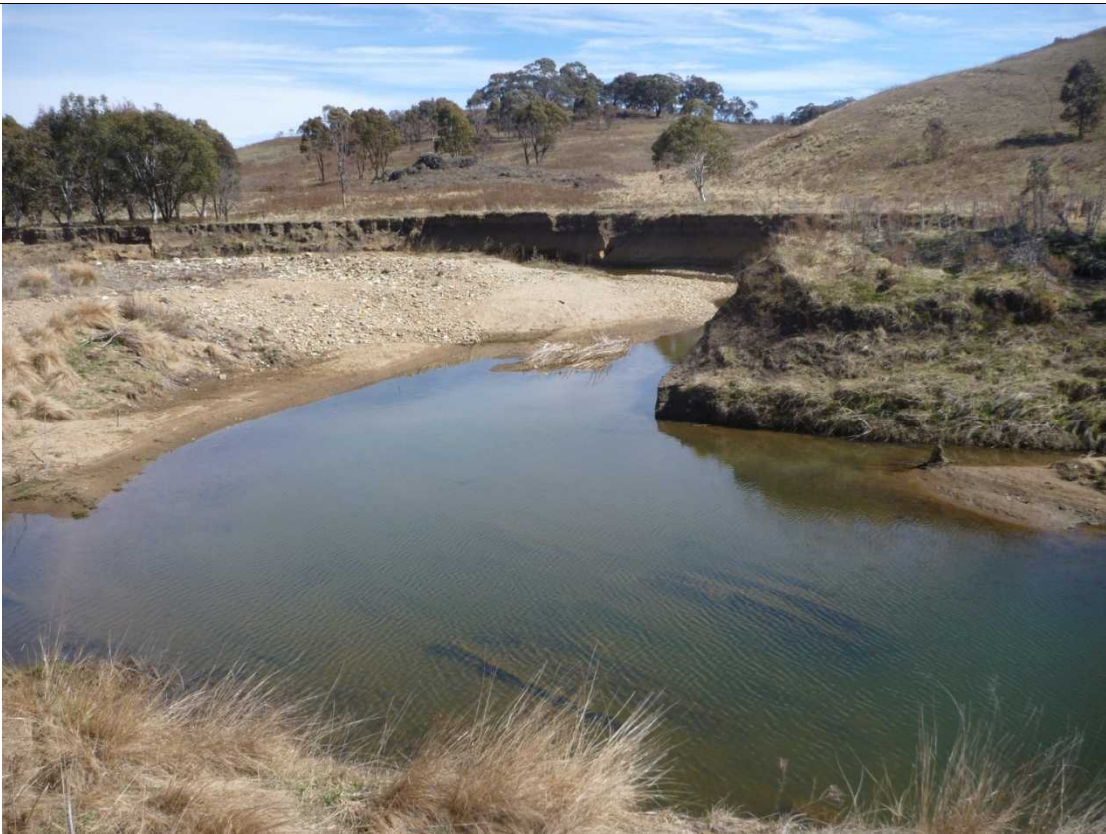
Photo 63 - BUR2C 10/9/2012

- Evidence of new sediment deposition in pool
- Algal growth continues

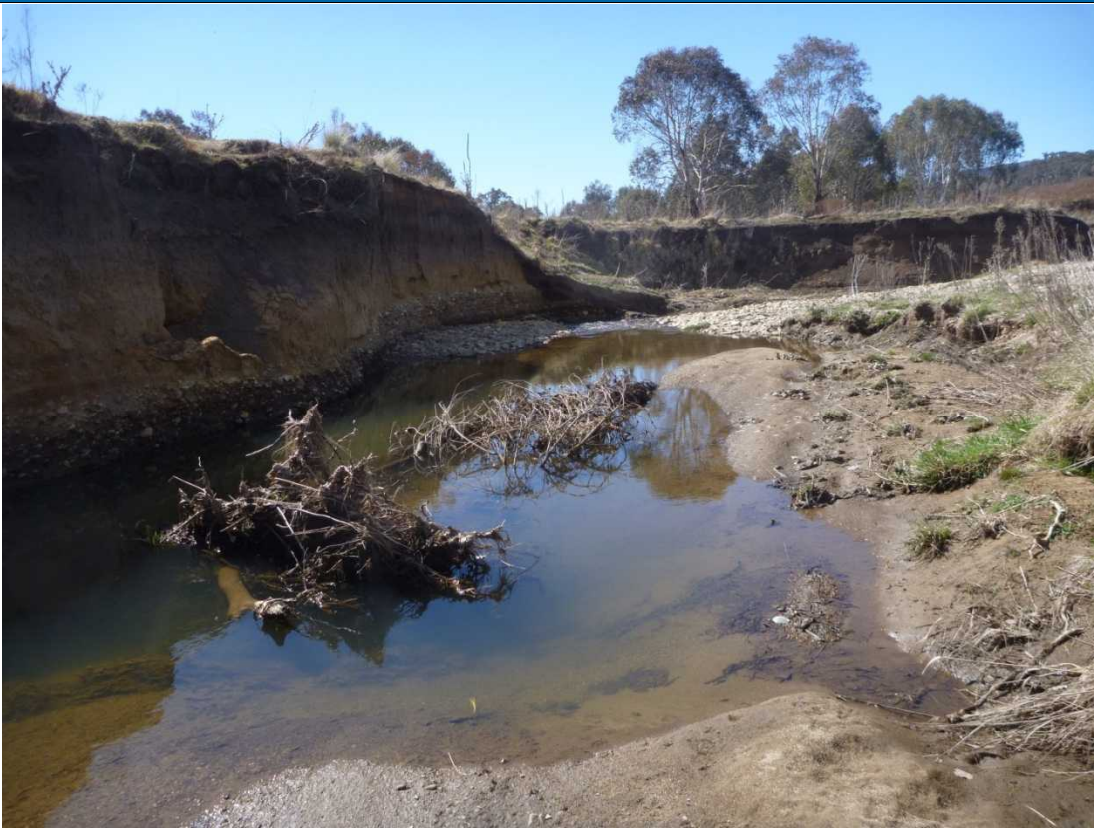
Photo 64 - BUR2C 10/9/2012

- Woody debris present in channel
- Fine Sediment deposit evident
- Eroded banks too steep to allow easy vegetation regrowth for stability
