ACTEW Water
Murrumbidgee Ecological Monitoring Program
Burra Creek geomorphology and vegetation assessment

March 2014

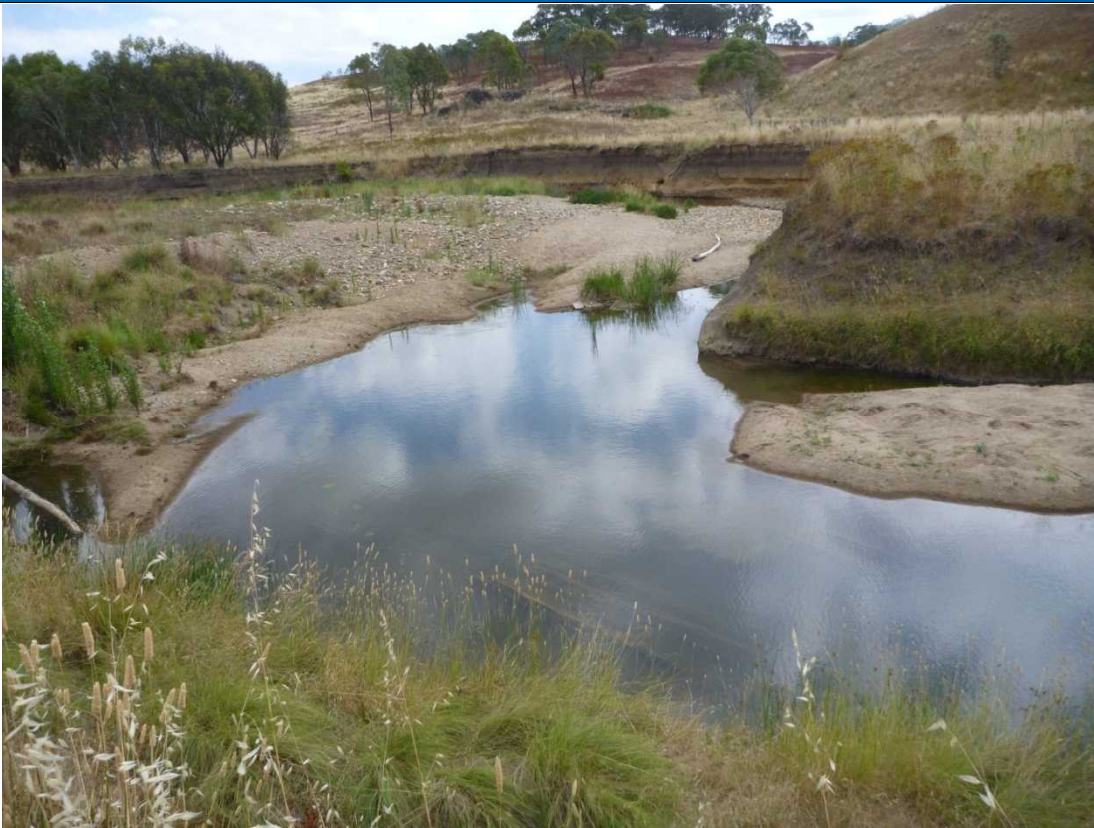
Photo 68 - BUR2C 23/1/2013

- Sloping banks show signs of vegetation recovery

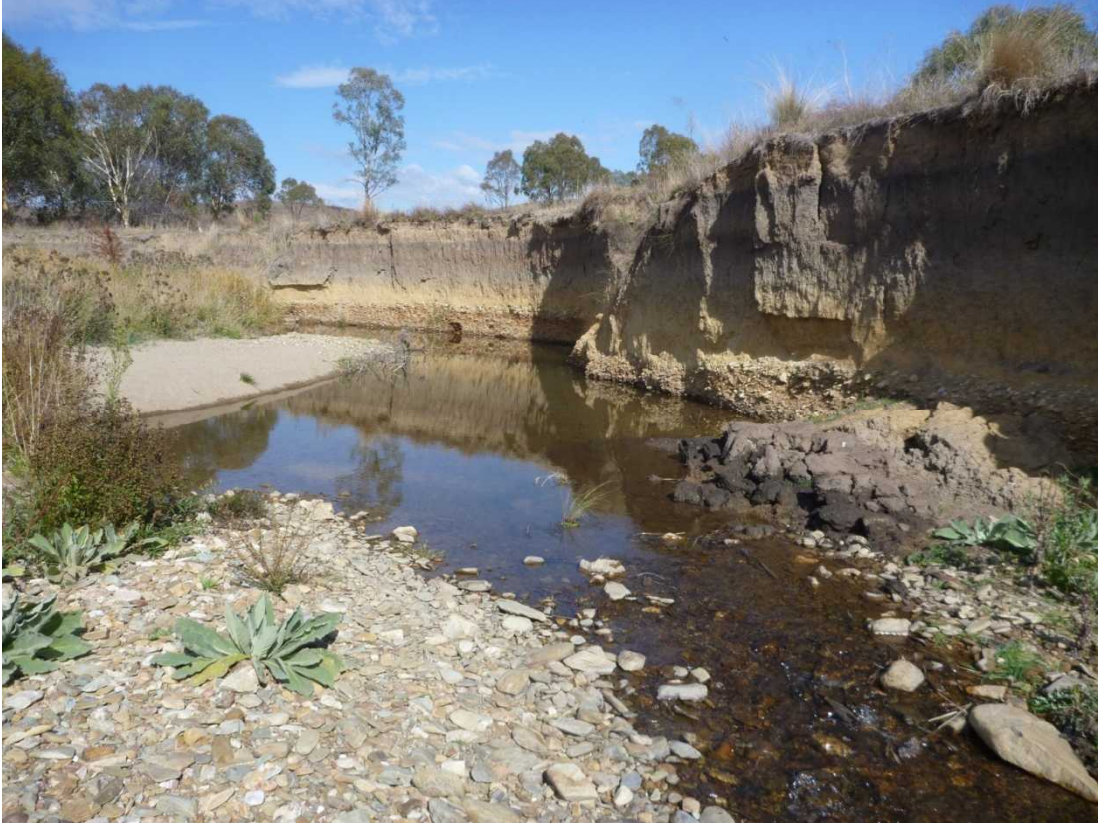
Photo 70 - BUR2C 29/4/2013

- Section of bank has slumped into channel.

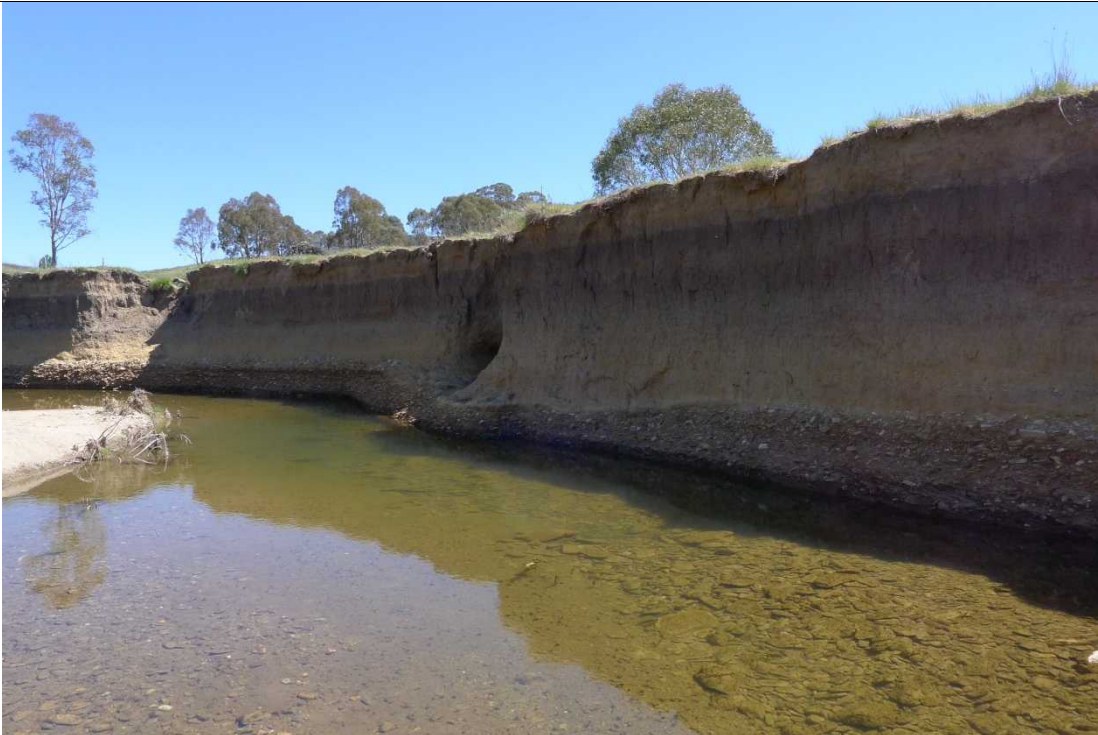
Photo 71 - BUR2C 30/10/2013

- Significant section of embankment scoured after Sept event

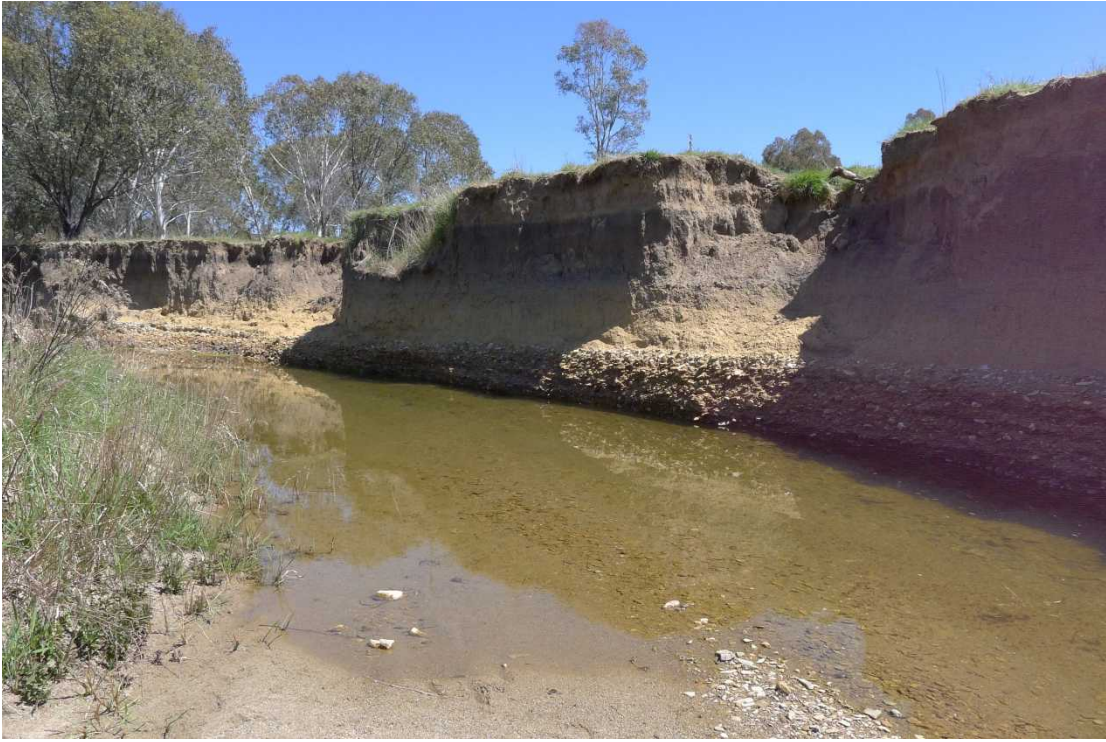
Photo 72 - BUR2C 30/10/2013

- significant slumping of embankment following Sept 2013 storm event

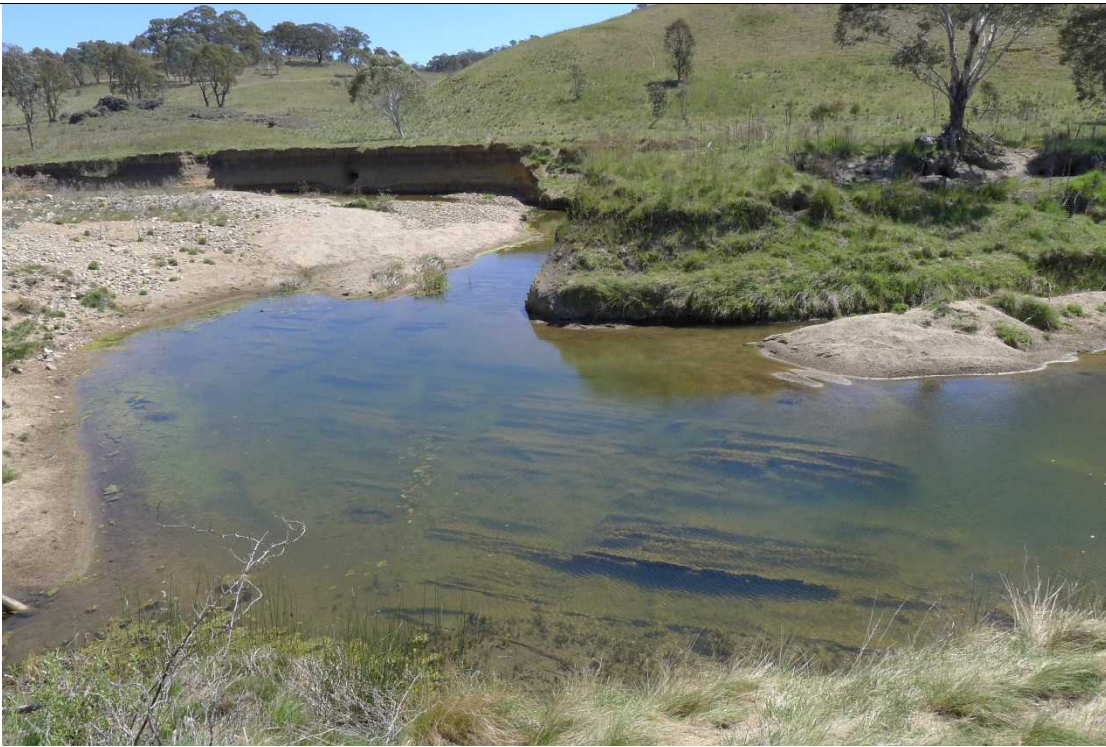
Photo 73 - BUR2C 30/10/2013

- Bank Scour from Sept event
- Reforming of point island bar following Sept event.

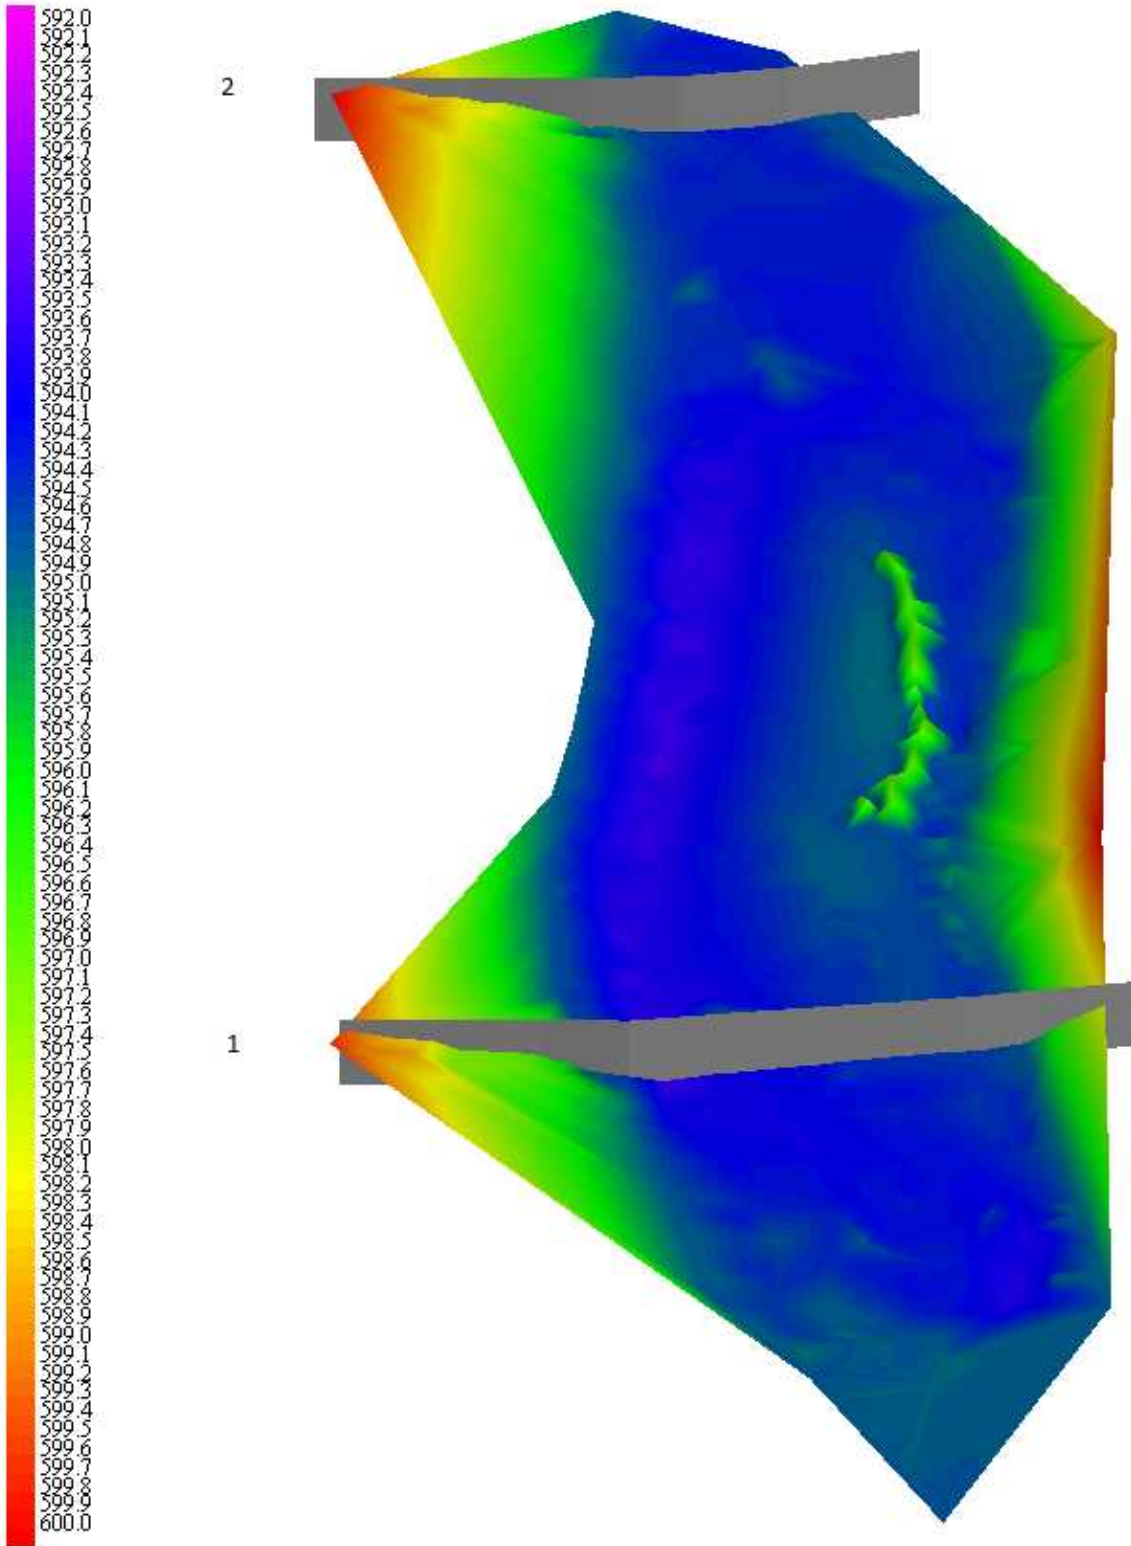
Figure 45 - Angle Crossing D/S DGPS Model (Jan 2013)

*DGPS Model corresponds to the pink cross-sections in Figure 44. This change in downstream sandbar due to the 2010-2012 flood events

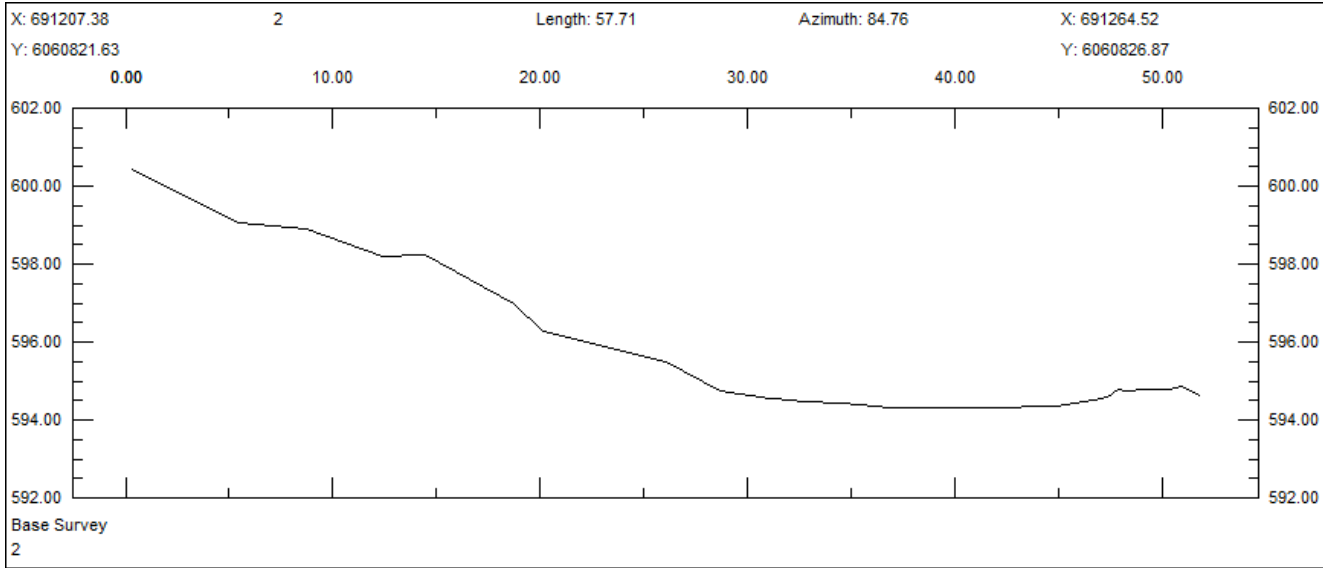
Figure 51 - Angle Crossing D/S 3D GPS XS-2

- DGPS cross section ends in-stream due to water level and vegetation not allowing access to opposite bank at time of survey
