Memo

Subject Upper Murrumbidgee ACWA Site Review
Date 14 March 2019
Distribution Brent Johnson (Icon Water)
Project Googong Dam catchment Actions for Clean Water Plan

1 Introduction

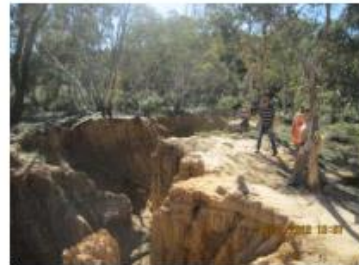
Headward erosion at tributary confluence with Buchan Creek

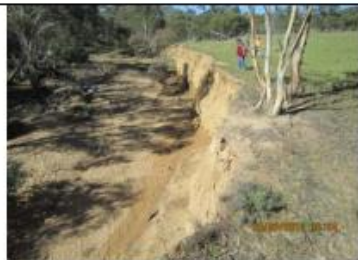
Bank erosion Buchan Creek

in further incision of the gully network. Downstream of the confluence of the gully with Buchan Creek, an 80m section of left bank, 4m in height, is evident. It is apparent that flows are actively undercutting banks.

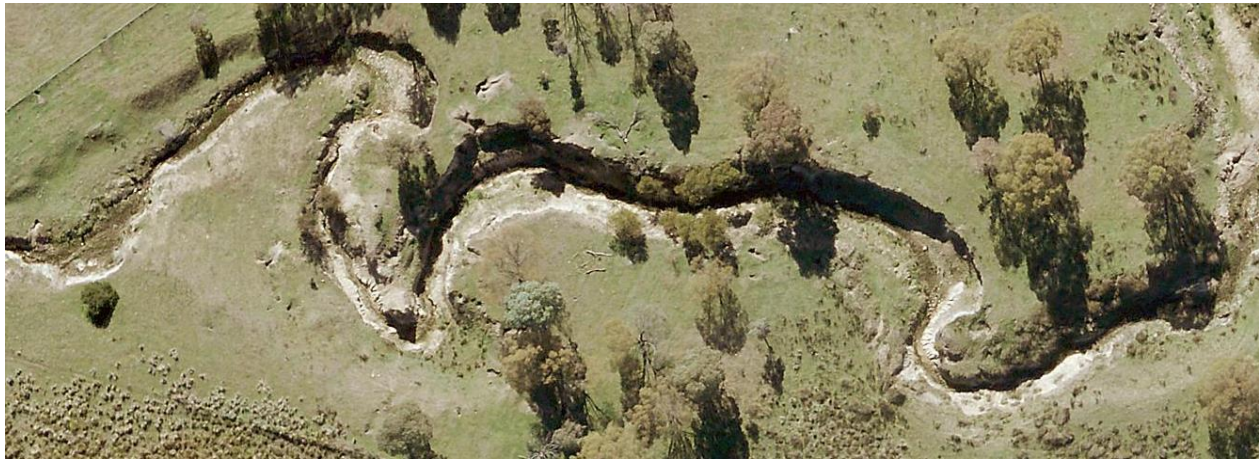
2017 aerial of the gully upstream of the confluence with Spring Station Creek

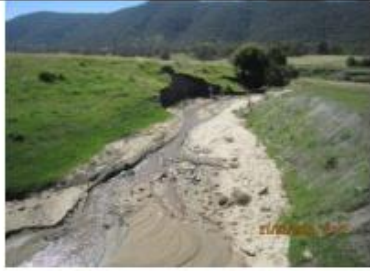
Large areas of fine sediment deposition

Management Option: Undertake sediment extraction in gully to reduce sediment delivery. Construct pile fields to manage migration of main waterway. Fencing and revegetation of site in consultation with landholder.

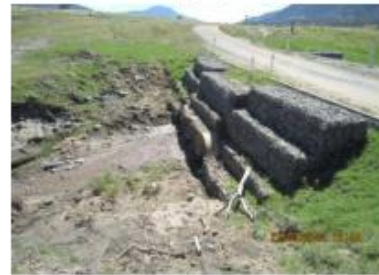
Rock gabion headwalls on Naas Road

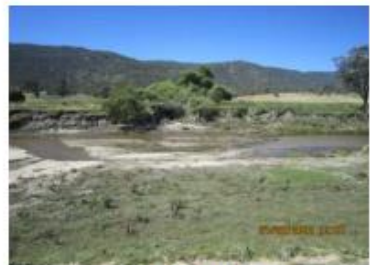
Sand deposition and bank erosion

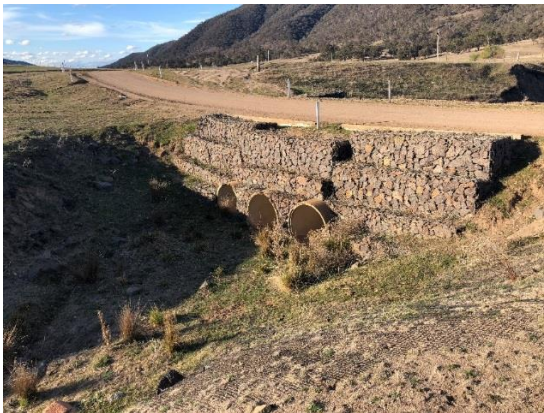
The site concerns the Naas River and a tributary gully. The tributary gully was previously assessed as containing a large amount of sediment, but at the time of inspection in this study very limited volumes of sediment were present. The culverts under Naas Road were observed to be clear of sediment. The culverts (including gabion walls) under Naas Road were very stable. Along the Naas River itself several kilometres of active bank erosion was observed, which is resulting in the mobilisation of a large amount of mixed grain size sediment. The risk assessment score below relates to the Naas River and not the tributary gully.

Rock gabion headwalls on Naas Road

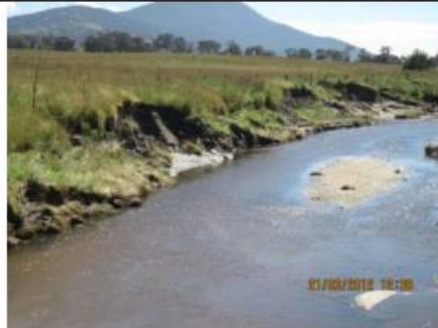
Active bank erosion evident

Management Option: Construct rock beaching to manage bank erosion. Fencing and revegetation recommended in consultation with the landholder(s).

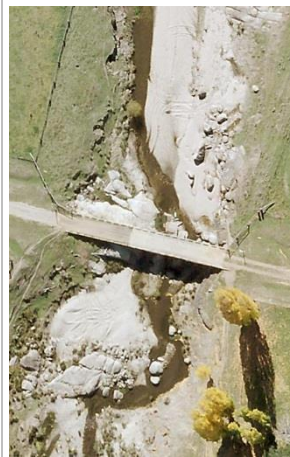
2017 Aerial of Naas River erosion and sediment deposition

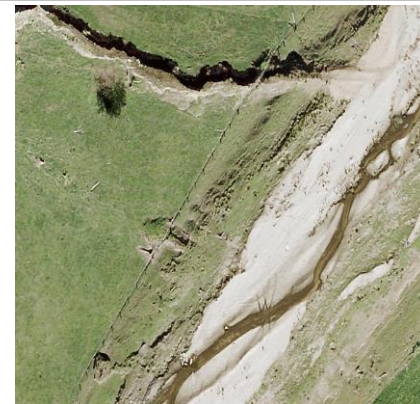
2017 Aerial of Naas River and tributary gully erosion and sediment build up, downstream of property access bridge.

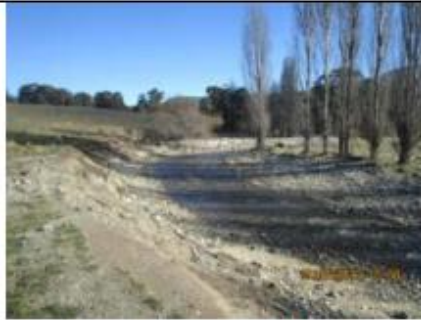
Sedimentation downstream of the bridge

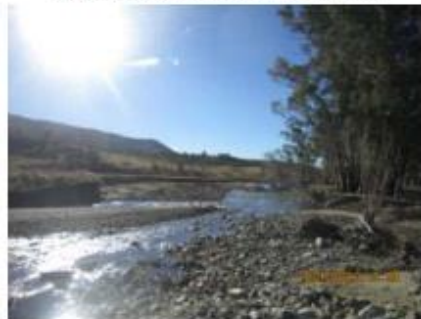
Major widening and sedimentation
