Memo

Subject Upper Murrumbidgee ACWA Site Review
Date 14 March 2019
Distribution Brent Johnson (Icon Water)
Project Googong Dam catchment Actions for Clean Water Plan

1 Introduction

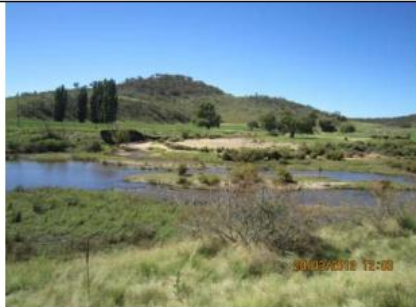
Confluence of Buchan and Bredbo River

This site is located at the confluence of Buchan Creek and the Bredbo River. It has been assessed as having a high connectivity for fine sediments. Fine sediments eroded from this creek are transferred to Bredbo River, which in turn has a high connectivity with the Murrumbidgee River.

Management Option: Stabilisation of eroding bank via construction of rock beaching. Fencing and revegetation of site in consultation with landholder.

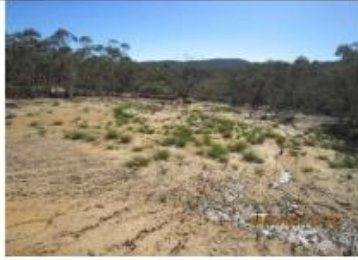
Sheet and rill erosion where land has been cleared of vegetation

Condition Assessment:
 A steep cleared slope has been subjected to rill and gully erosion. This area has been historically cleared of vegetation, which has decreased the resistance of the ground surface to erosion. Attempts have been made to roughen rills with use of wooden control structures, with limited effect. A 2m headcut is evident at the confluence of the gully with Buchan Creek. It is likely that this headcut will extend headward and result

Risk Rating: Extreme
Management Option: Undertake large woody debris stabilisation as alternative to rock beaching. Improve revegetation on site via mulching and revegetation.

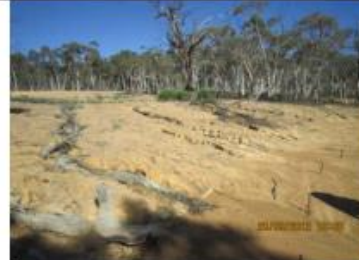
Gullies forming, at bottom slope of cleared area

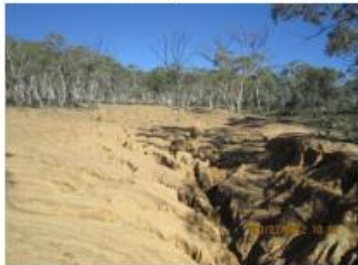
Gullies forming, at bottom slope of cleared area

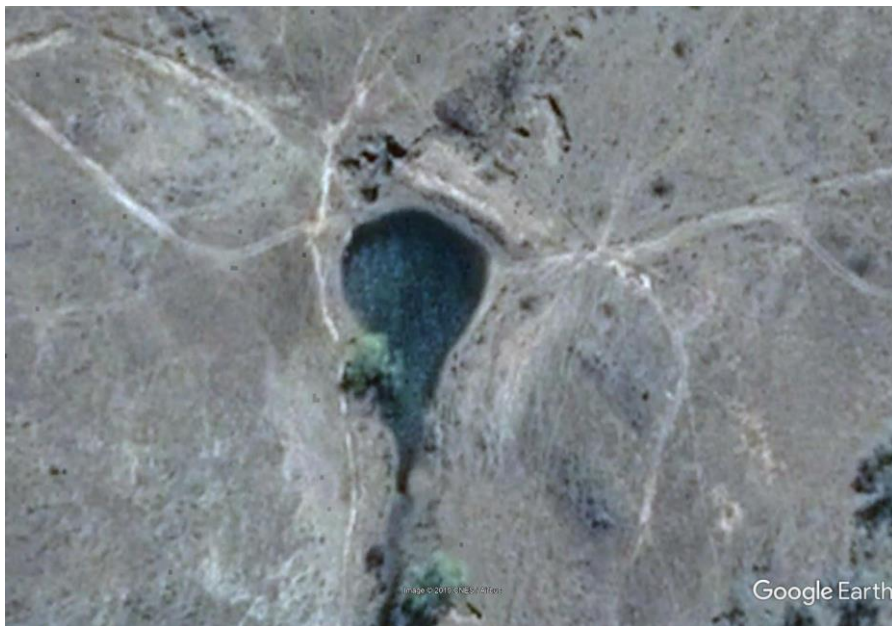
An existing farm dam located on a tributary of the Bredbo River is a risk of imminent failure due to recent overtopping of dam embankment. A lack of a dedicated spillway and overland flow path to control overtopping of the dam when full has led to a low point on the western side of the dam embankment directing overflow over the embankment and scouring away the embankment toe. This process has effectively set off a new head cut migrating back through the embankment. At the time of the site inspection the head cut was approximately 1 m away from initiating complete failure of the dam.

Without intervention imminent failure of the dam embankment is likely which would release both water and sediment stored within the base of the dam and set off a new phase of incision 1 to 2m deep in the tributary. This process would release a significant volume of sediment directly downstream to the nearby Bredbo River (500m downstream of the site).

Aerial imagery of the site from September 2018

Rebuild the failed dam embankment with clay core and incorporate dedicated spillway on eastern side set at least 500 mm below embankment crest. Rock armour spillway.

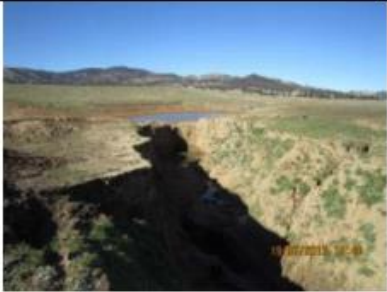
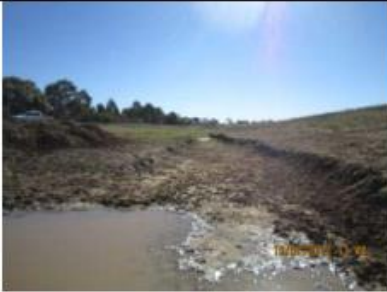
Erosion head at dam	Spillway to the north

Management Option: Back fill existing scour hole with a clay bank. Face with rock beaching. Define northern spillway to improve overflow stability from the dam. Fencing and revegetation of site in consultation with landholder.

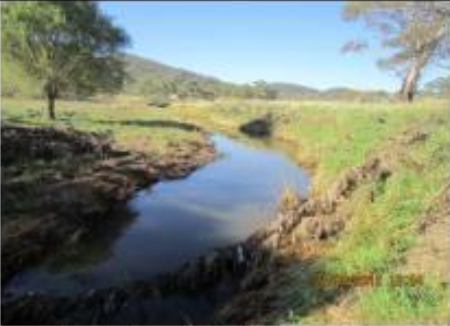
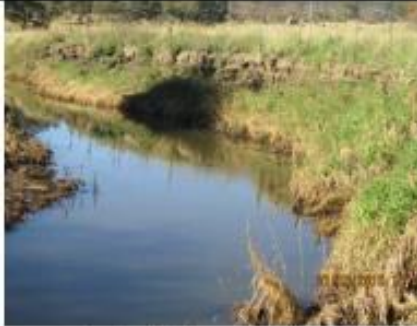
Murrumbucca Creek, facing upstream	Localised bank erosion along creek

Condition Assessment:			
Upstream of crossing, the silty/sand banks are eroding with minimal grassy vegetation present. Downstream of the crossing, bedrock control in channel is limiting further incision. This catchment appears to be a significant source of fine grained sediments to the Murrumbidgee. More significant incision, bank erosion and channel widening appears to be occurring in the lower reaches of this valley. This creek has been assessed as having high connectivity for fine sediments due to very fine grained sediments eroded from bed and banks of incising creek transferred efficiently to Murrumbidgee through gorge setting. This valley would once have been a swampy meadow, not an incised channel contributing large amount of sediments as it is today.			
Risk Assessment:			
Likelihood	Consequence	Trajectory	Risk
4	4	4-5	64-80
Risk Rating: Extreme			
Management Option: Install rock beaching to manage bank erosion. Fencing and vegetation of site to be undertaken in consultation with the landholder.

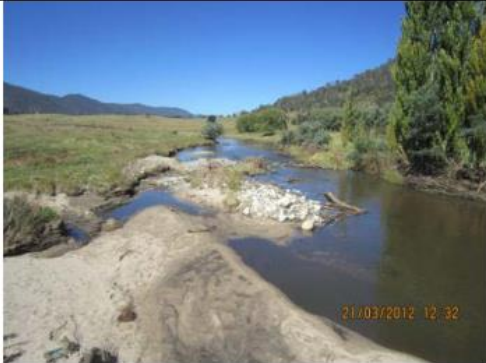
Facing downstream from Bobeyan Rd bridge

Management Option: Install rock beaching to manage bank erosion. Fencing and vegetation to be undertaken in consultation with the landholder.

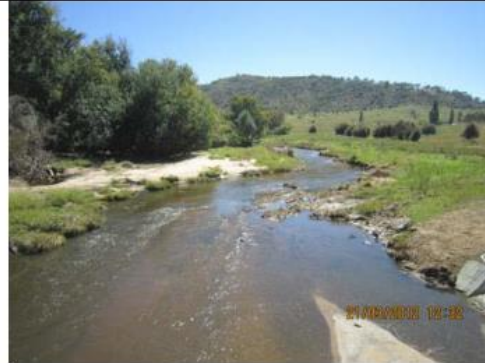
Facing upstream from Bobeyan Rd bridge

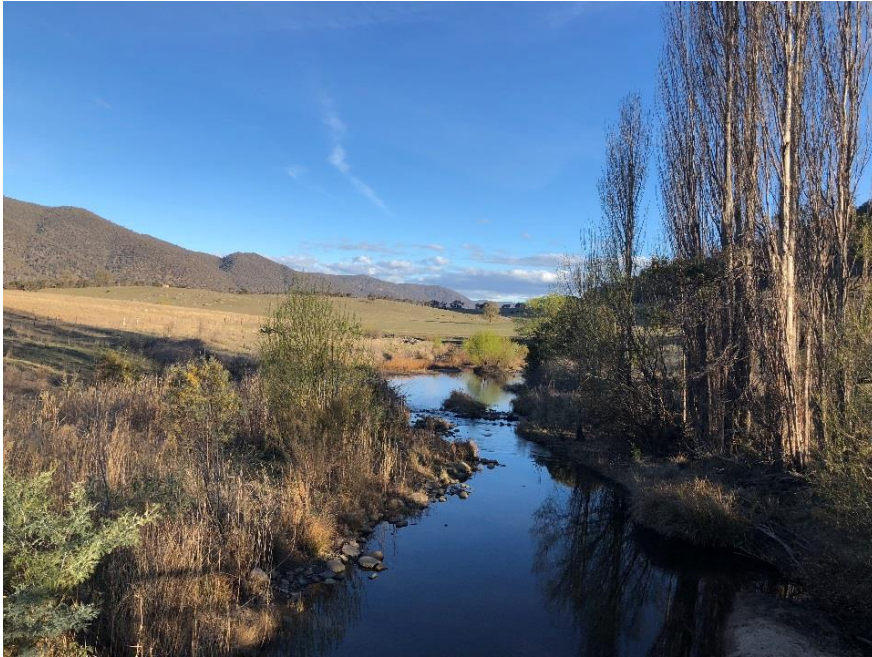
Site is located on the Gudgenby River not the Naas River, as erroneously noted in the previous assessment. Vegetation has established on both banks and channel is stable.

Facing downstream from Bobeyan Rd bridge

No need for management aside from broken fencing being fixed. Investigate erosion identified on bend upstream in the Gudgenby River as shown in figure below.

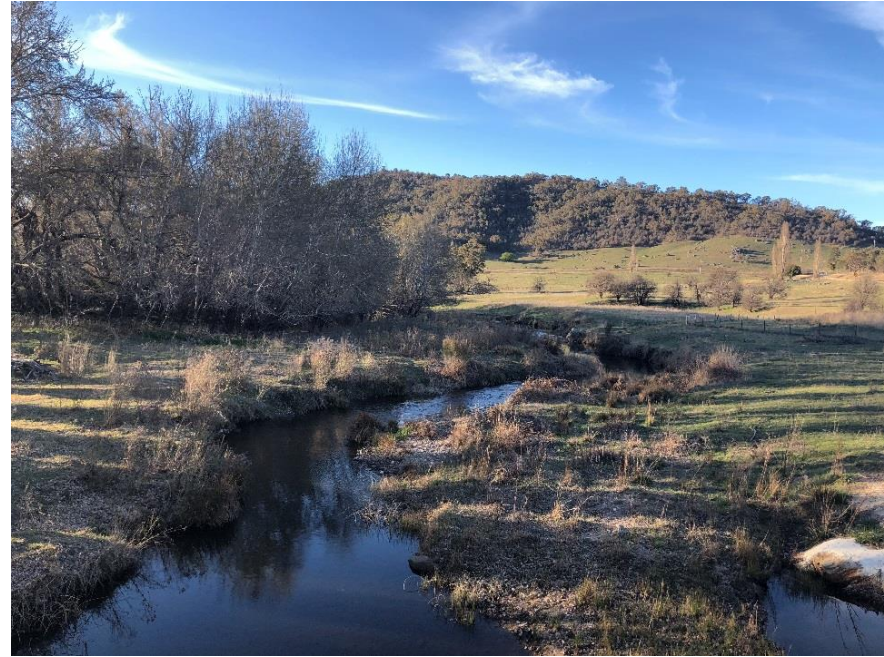
Facing upstream from Bobeyan Rd bridge

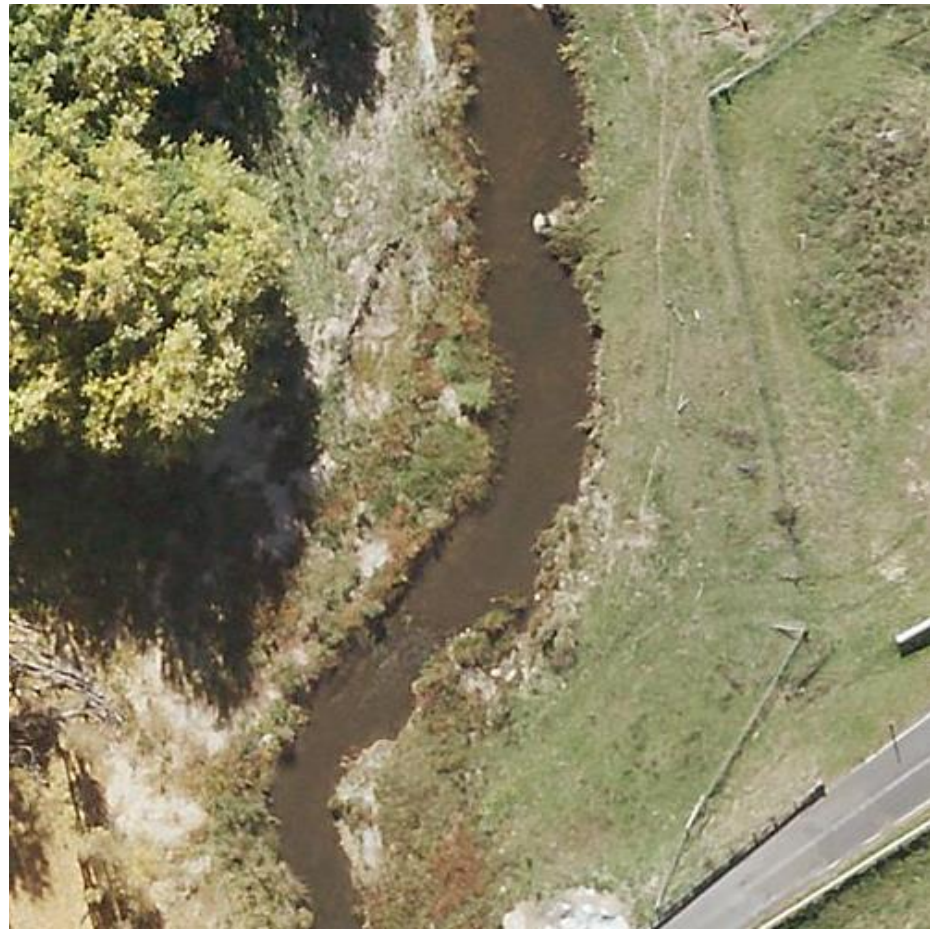
2017 aerial image of Gudgenby River downstream from Bobeyan Rd bridge

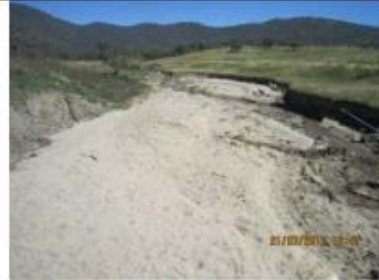
Naas River tributary gully, facing upstream

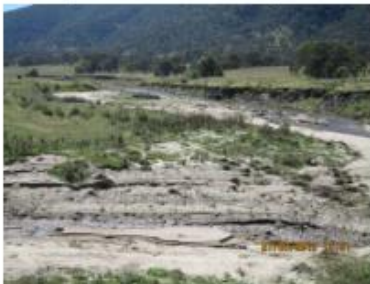
Naas River, facing downstream

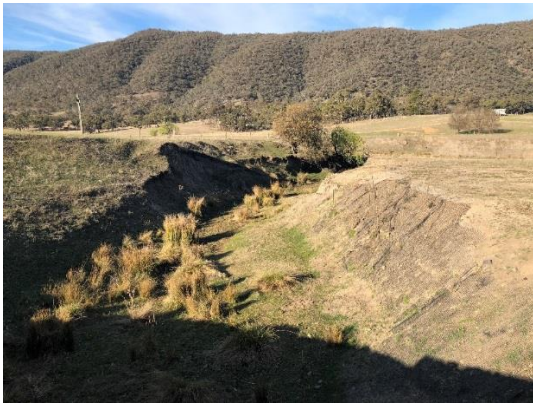
The site concerns the Naas River and a tributary gully. The tributary gully was previously assessed as containing a large amount of sediment, but at the time of inspection in this study very limited volumes of sediment were present. The culverts under Naas Road were observed to be clear of sediment. The culverts (including gabion walls) under Naas Road were very stable. Along the Naas River itself several kilometres of active bank erosion was observed, which is resulting in the mobilisation of a large amount of mixed grain size sediment. The risk assessment score below relates to the Naas River and not the tributary gully.

Naas River tributary gully, facing downstream

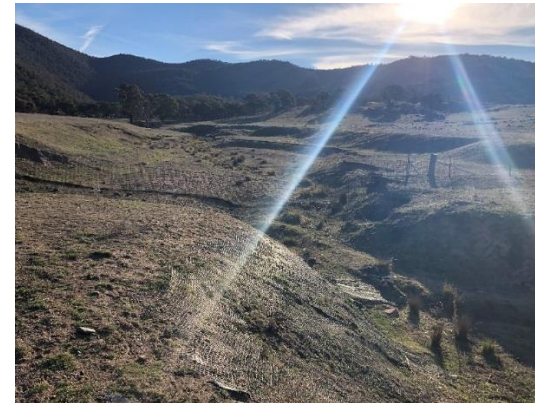
Naas River tributary gully, facing upstream

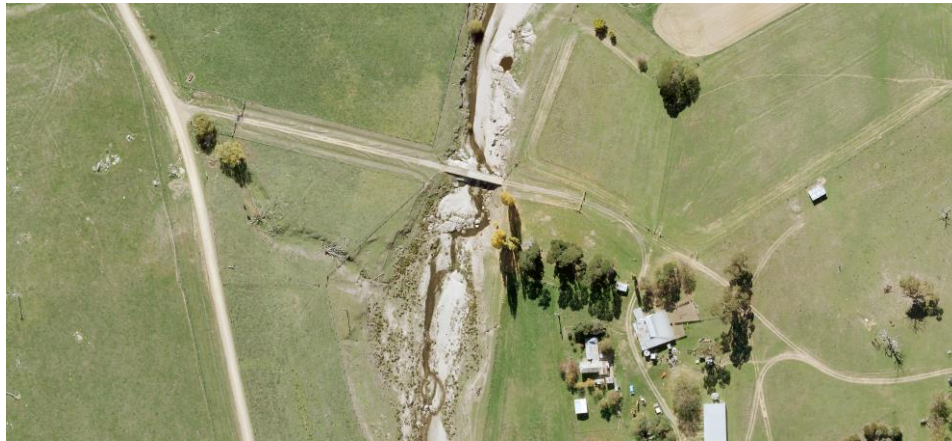
2017 aerial image of site 43

The site was not able to be accessed directly due to the landholder being unable and unwilling to participate further in the study, however just downstream active channel erosion could be seen from the road. Along the Naas River there is several kilometres of active channel erosion which is resulting in the mobilisation of a large amount of mixed grain size sediment.

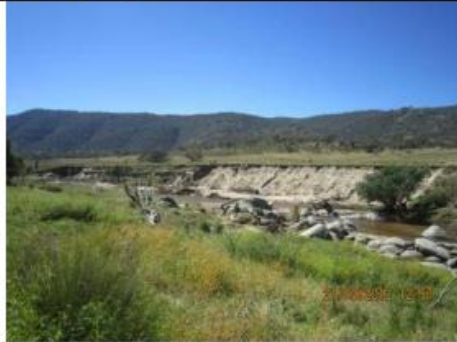
Naas River, facing downstream

Site 45			
Condition assessment			
Along the Naas River there is several kilometres of active channel erosion which is resulting in the mobilisation of a large amount of fine sediment as can be seen at this site. Risk assessment remains the same as previous assessment (access was not available at this site).			
Site photos

Management Option: Install rock beaching to manage bank erosion and channel widening. Fencing and revegetation recommended in consultation with the landholder.

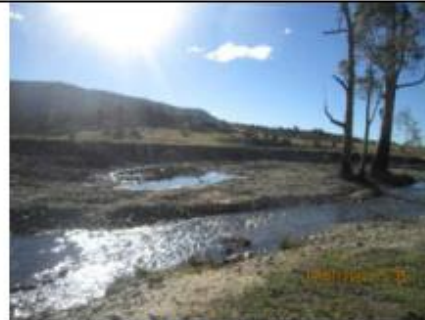
Channel braiding

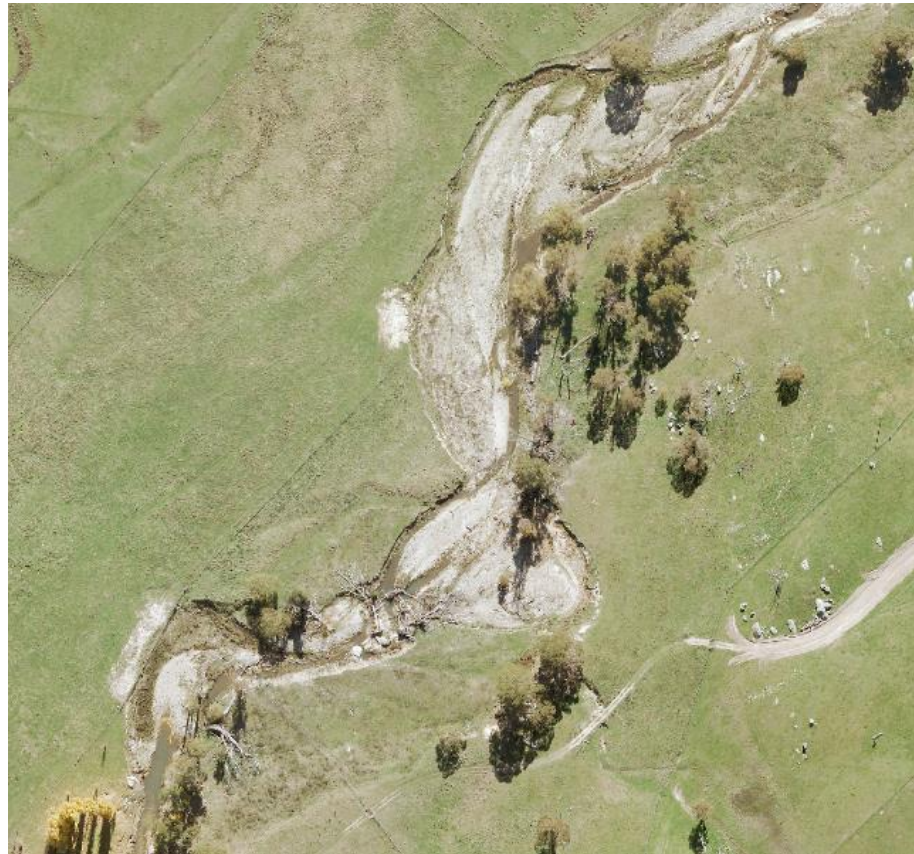
2017 aerial image of site 51

The upstream catchment has been subject to past catchment clearing, changes in catchment hydrology and subsequent channel change including large scale incision. While the incision process has now largely finished, on going bank adjustment through widening and migration continues. The sandy loam banks are vertical and undercut, and are upto 5 m high. The banks continue to adjust predominantly through bank migration. Without intervention ongoing bank adjustment has potential to liberate a significant amount of sediment into the receiving system.

Site 51			
Risk assessment			
<i>Likelihood</i>	<i>Consequence</i>	<i>Trajectory</i>	<i>Overall Score / risk</i>
4	4	4	64 / Extreme
Management options			
Works are required to halt ongoing bank migration and sediment liberation and are likely to include a mixture of alignment training measures (groynes and pile fields) and bank armouring (rock and logs).
